JOINT INVESTIGATION REPORT

INCIDENT NO: 2045702 JIV report S/N: 1043

1. Spill incident Number: 2045702 2. Type of incident* OIL SPILL
3. Name of Location UKPELEDE MANIFOLD
4. Name of nearest community UKPELEDE 5. State: RIVERS 6. LGA AKHADA WEST
7. Type of Production facility/Installation MANIFOLD
8. Asset owner/District THE SHELL PETROLEUM DEVELOPMENT COMPANY OF NIGERIA LIMITED/ PIPELINE

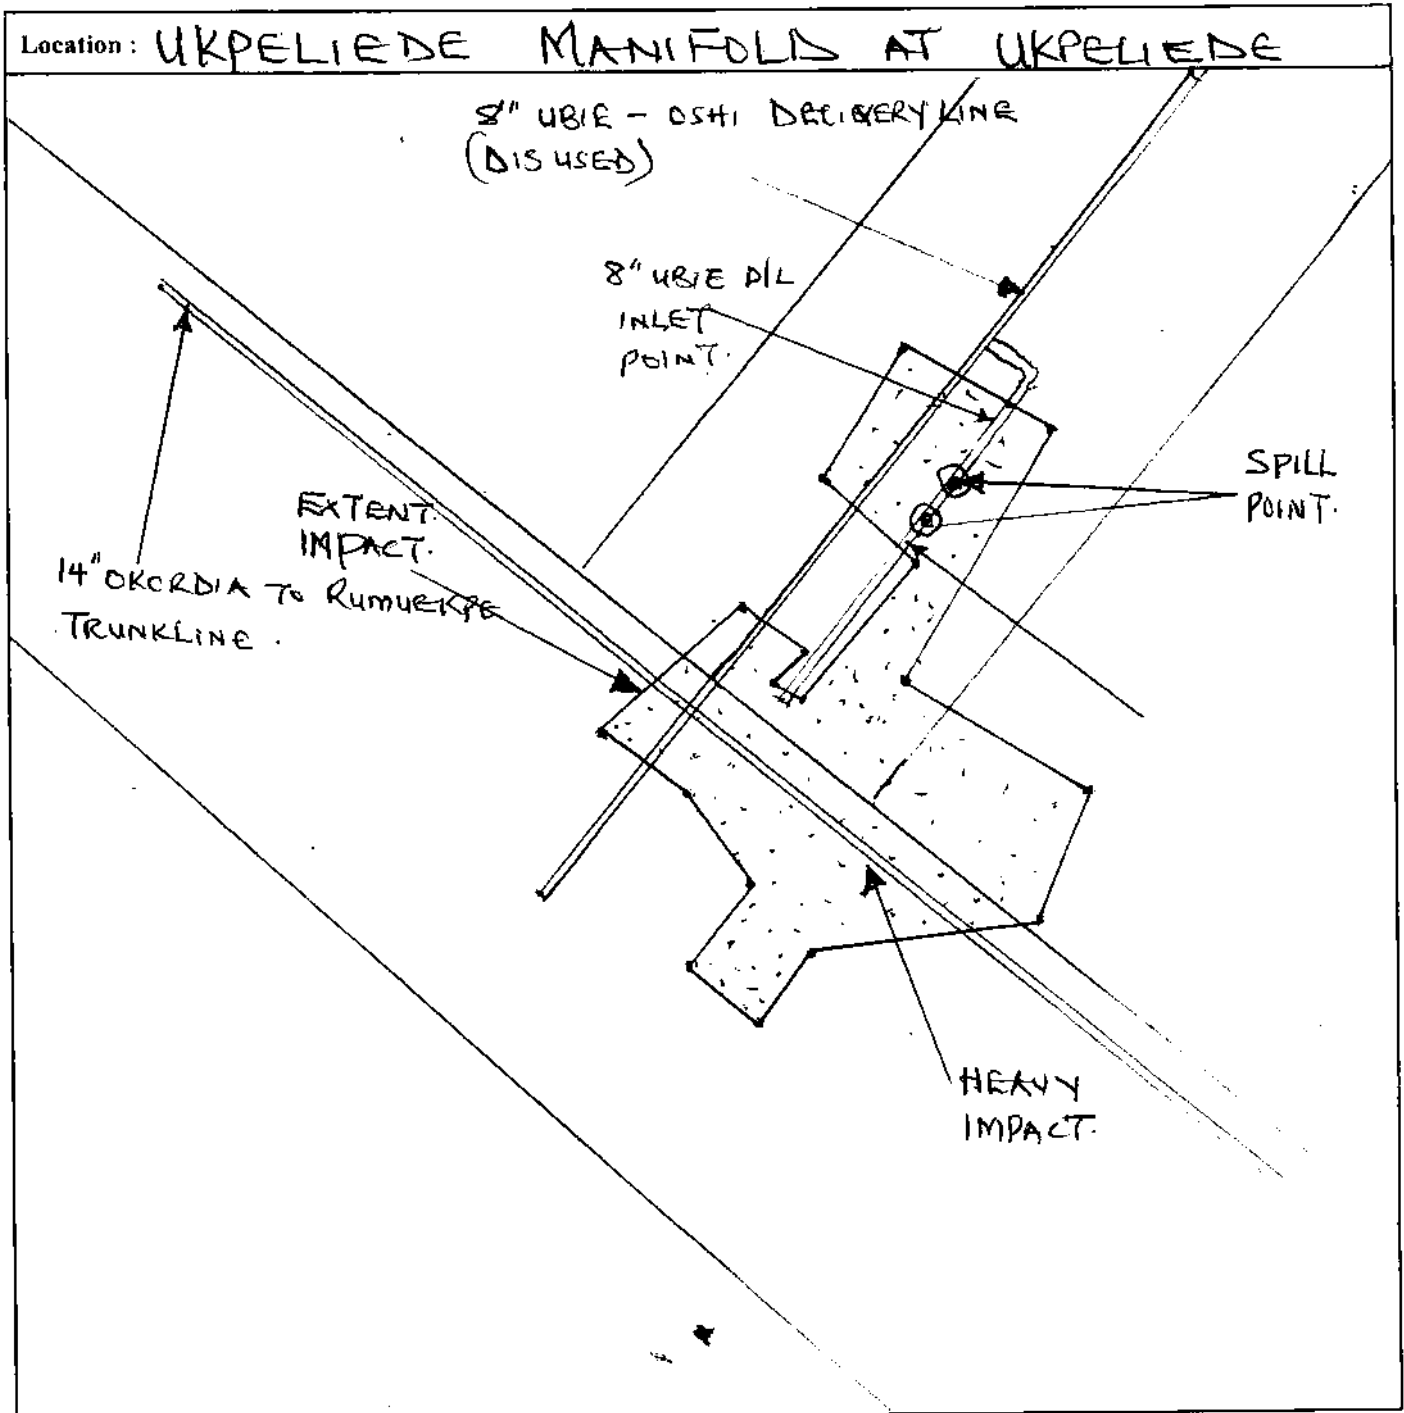
f. Appendix 1: Overview sketch of the site

Additional observations around the spill point: ON THE 8" UBIE DELIVERY LINE A 2" INLET PRESSURE GAUGE VALVE AND 2" INLET VENT WERE OBSERVED VANDALISED BY UNKNOWN PERSON(S)
