JOINT INVESTIGATION REPORT

INCIDENT NO: 2078117 JIV report S/N: 1056

1. Spill incident Number: 2078117 2. Type of incident* OIL SPILL
3. Name of Location AGBADA WELL 47L FLOWLINE
4. Name of nearest community OMUEKE (IGWURUTA) 5. State: RIVERS 6. LGA IKWERRE
7. Type of Production facility/Installation OIL FLOWLINE
8. Asset owner/District THE SHELL PETROLEUM DEVELOPMENT COMPANY OF NIGERIA LIMITED/ LAND EAST HUB

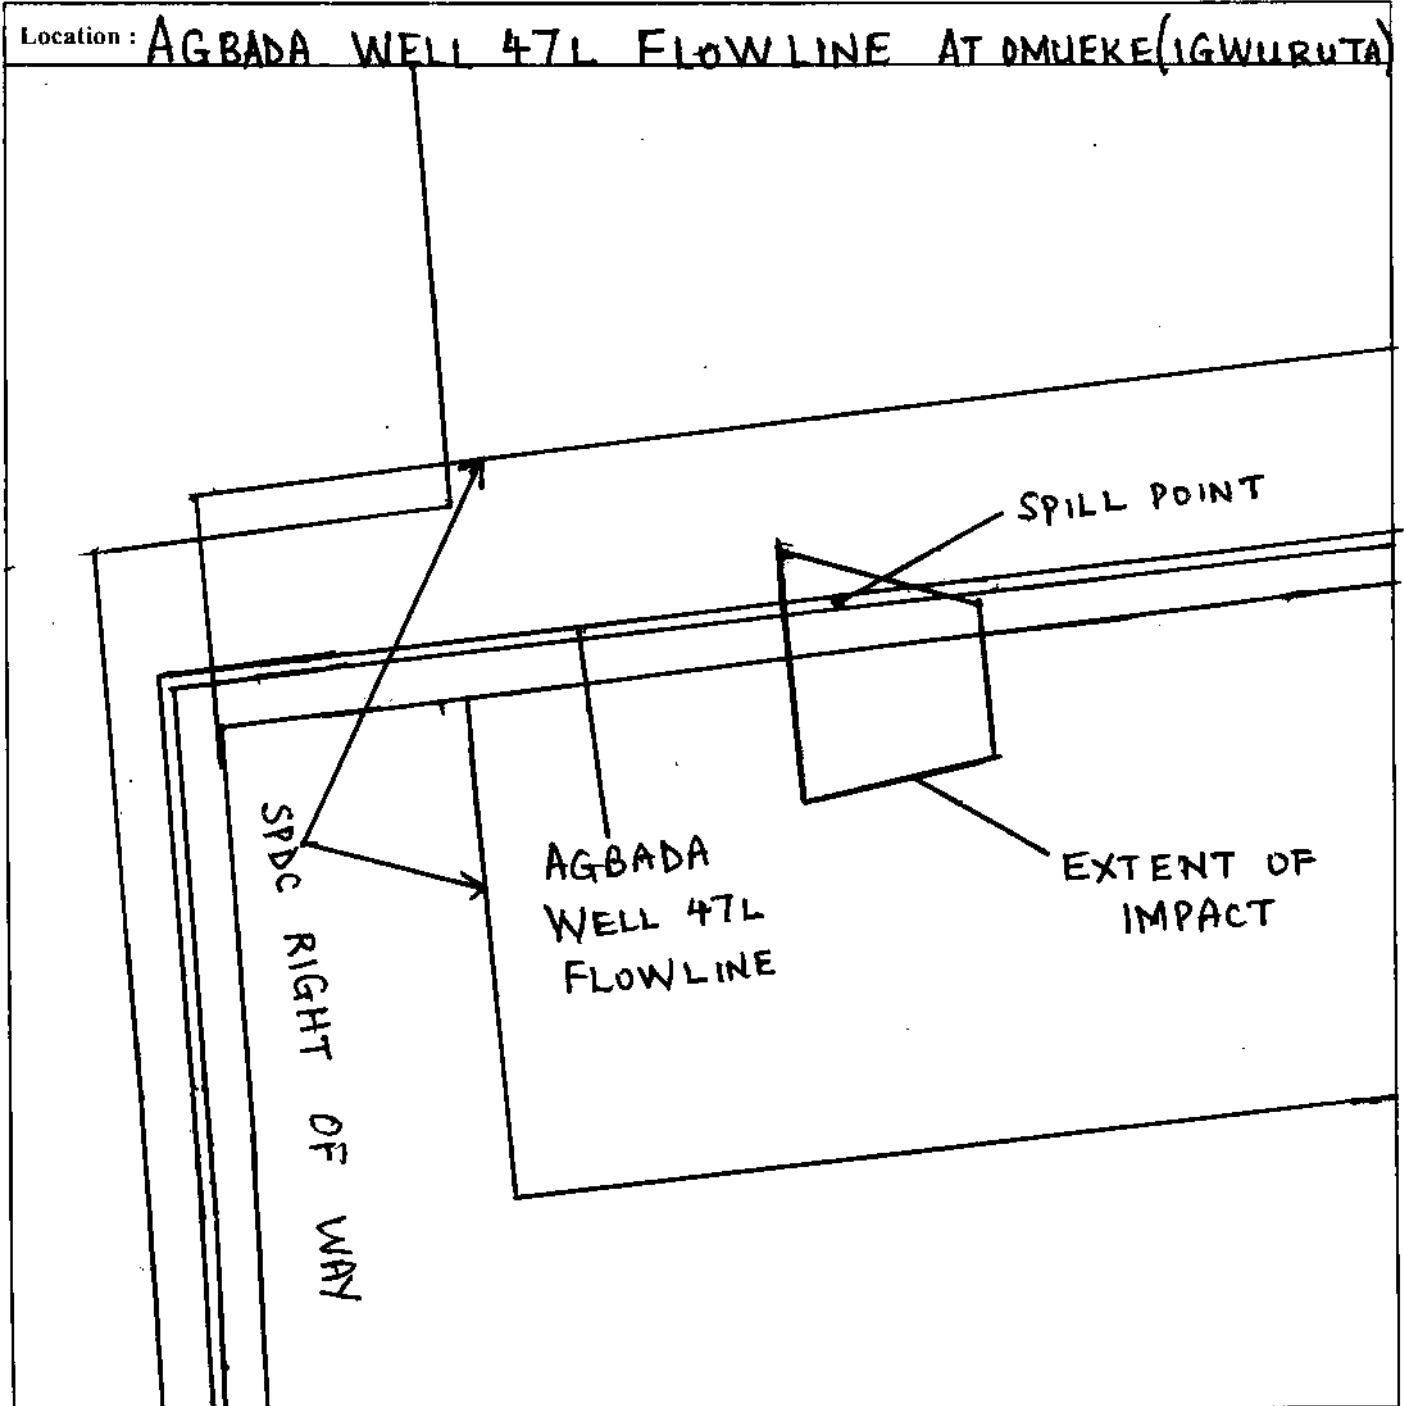
f. Appendix 1: Overview sketch of the site

Additional observations around the spill point: THE SPILL POINT WAS OBSERVED APPROXIMATELY 5 METRES FROM THE TARRED ACCESS ROAD. UPON EXPOSURE BY EXCAVATION, THREE (3) OTHER FLOWLINES WERE OBSERVED CLOSE TO THE WELL 47L FLOWLINE, NAMELY: AGBADA WELLS 52S, 47S AND 52L FLOWLINES.
