JOINT INVESTIGATION REPORT

INCIDENT NO: 2079259 JIV report S/N: 1129

1. Spill incident Number: 2079259 2. Type of incident* OIL SPILL
3. Name of Location 20" OTUMARA - ESCRAVOS PIPELINE
4. Name of nearest community UGBODEGUNGUN State: DELTA G. LGA WARRI SOUTH-WEST
7. Type of Production facility/Installation OIL PIPELINE
8. Asset owner/District THE SHELL PETROLEUM DEVELOPMENT COMPANY OF NIGERIA LIMITED / PIPELINES

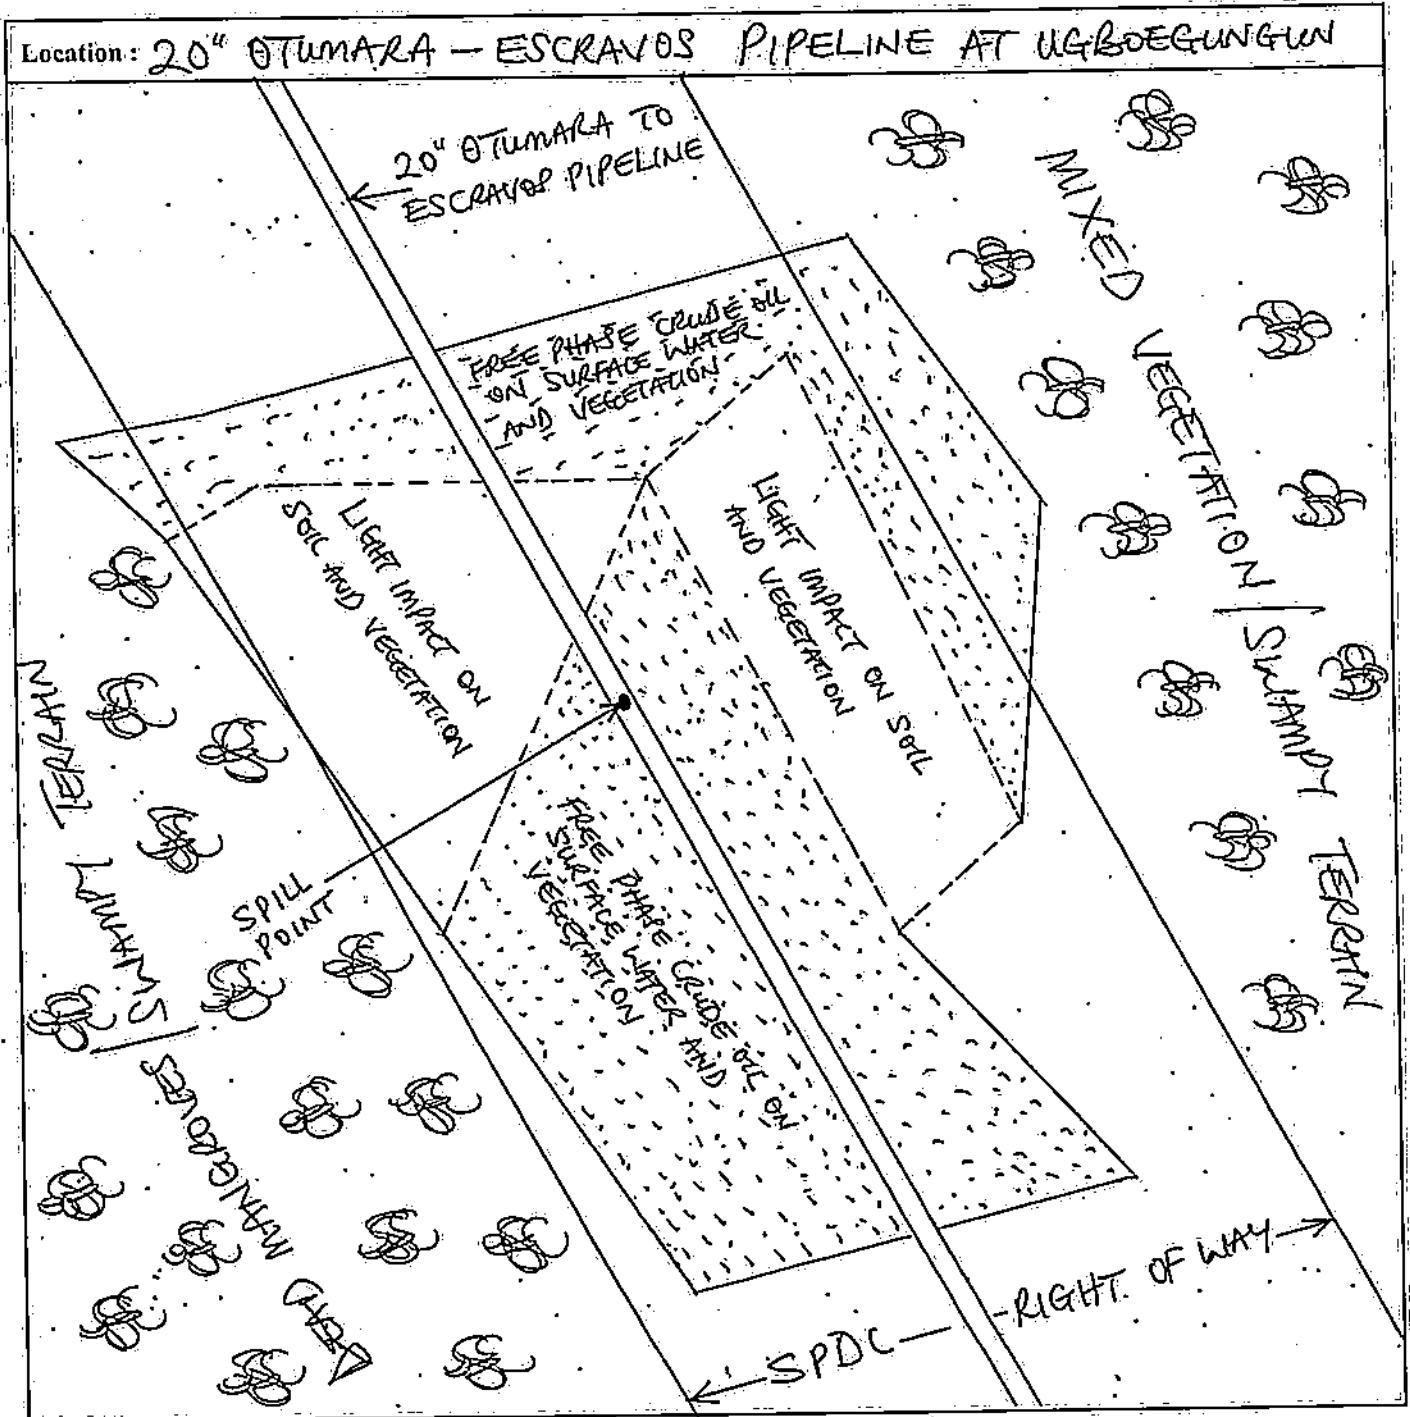
f. Appendix 1: Overview sketch of the site

Additional observations around the spill point: UPON EXPOSURE OF THE LEAK POINT, THE JOINT INVESTIGATION TEAM OBSERVED A FAILED 4" VALVE (LEAKING FROM THE WELD) ILLEGALLY ATTACHED TO THE 20" OTUMARA-ESCAVOS PIPELINE AT 1 O'CLOCK POSITION

SECTION OF 20" OTUMARA - ESCRAYOS PIPELINE AT UGBOGUNGUN SHOWING POSITION OF FAILED 4" VALVE AT 12 O' CLOCK.
