# JOINT INVESTIGATION REPORT

INCIDENT NO: 2084608 JIV report S/N: 1049

1. Spill incident Number: 2084608 2. Type of incident\* OIL SPILL  
3. Name of Location 12" ADIBAWA - OKORDIA PIPELINE  
4. Name of nearest community IKARAMA 5. State: BAYELSA 6. LGA YENAGDA  
7. Type of Production facility/Installation OIL PIPELINE  
8. Asset owner/District THE SHELL PETROLEUM DEVELOPMENT COMPANY OF NIGERIA LTD (SPDC)/PIPELINE

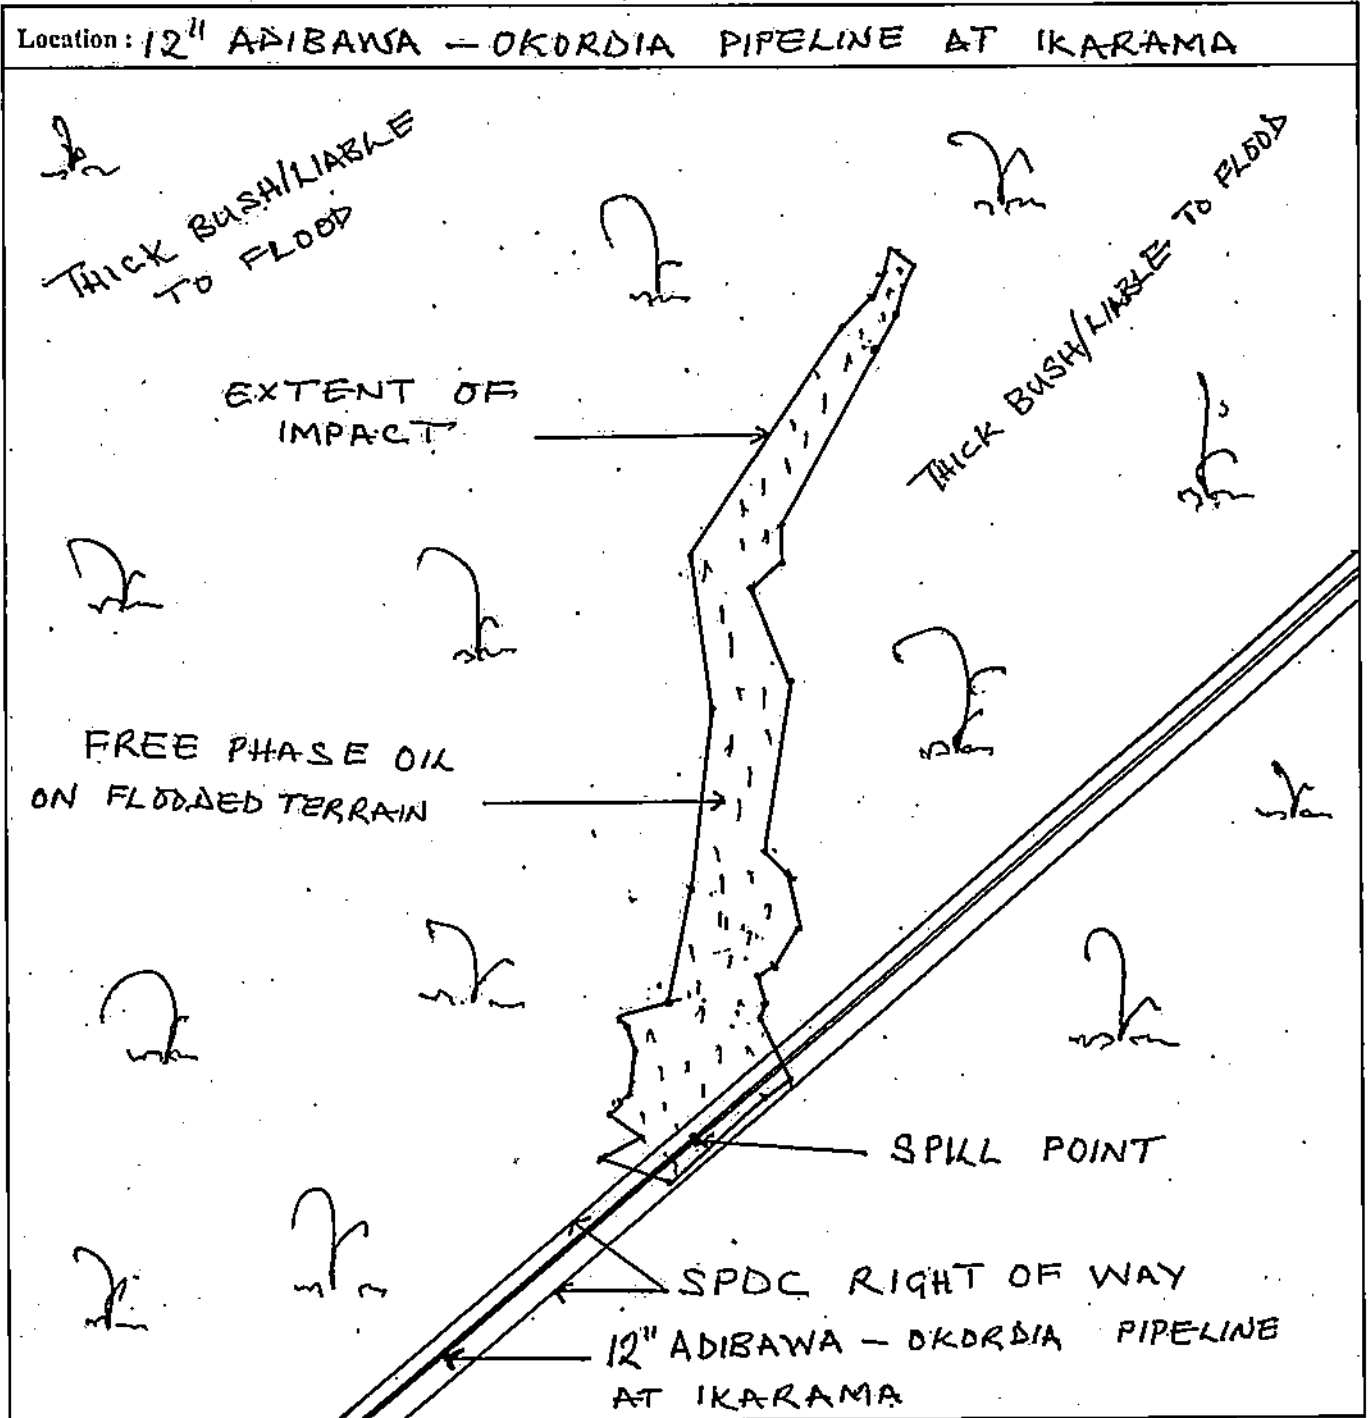
f. Appendix 1: Overview sketch of the site

Additional observations around the spill point: THE JOINT INVESTIGATION TEAM OBSERVED A HACK SAW CUT AT 10'O'CLOCK POSITION.
