# JOINT INVESTIGATION REPORT

INCIDENT NO: 2190827 JIV report S/N: 0167

- 1. Spill incident Number: 2190827      2. Type of incident\*: OIL SPILL
- 3. Name of Location: IMD RIVER 1 WELL 37 FLOWLINE
- 4. Name of nearest community: IGIRIUKWU (ONAZA)      5. State: ABIA      6. LGA: UKWA WEST
- 7. Type of Production facility/Installation: FLOWLINE
- 8. Asset owner/District: THE SHELL PETROLEUM DEVELOPMENT COMPANY OF NIGERIA LIMITED (SPDC) / HANO EAST HUB

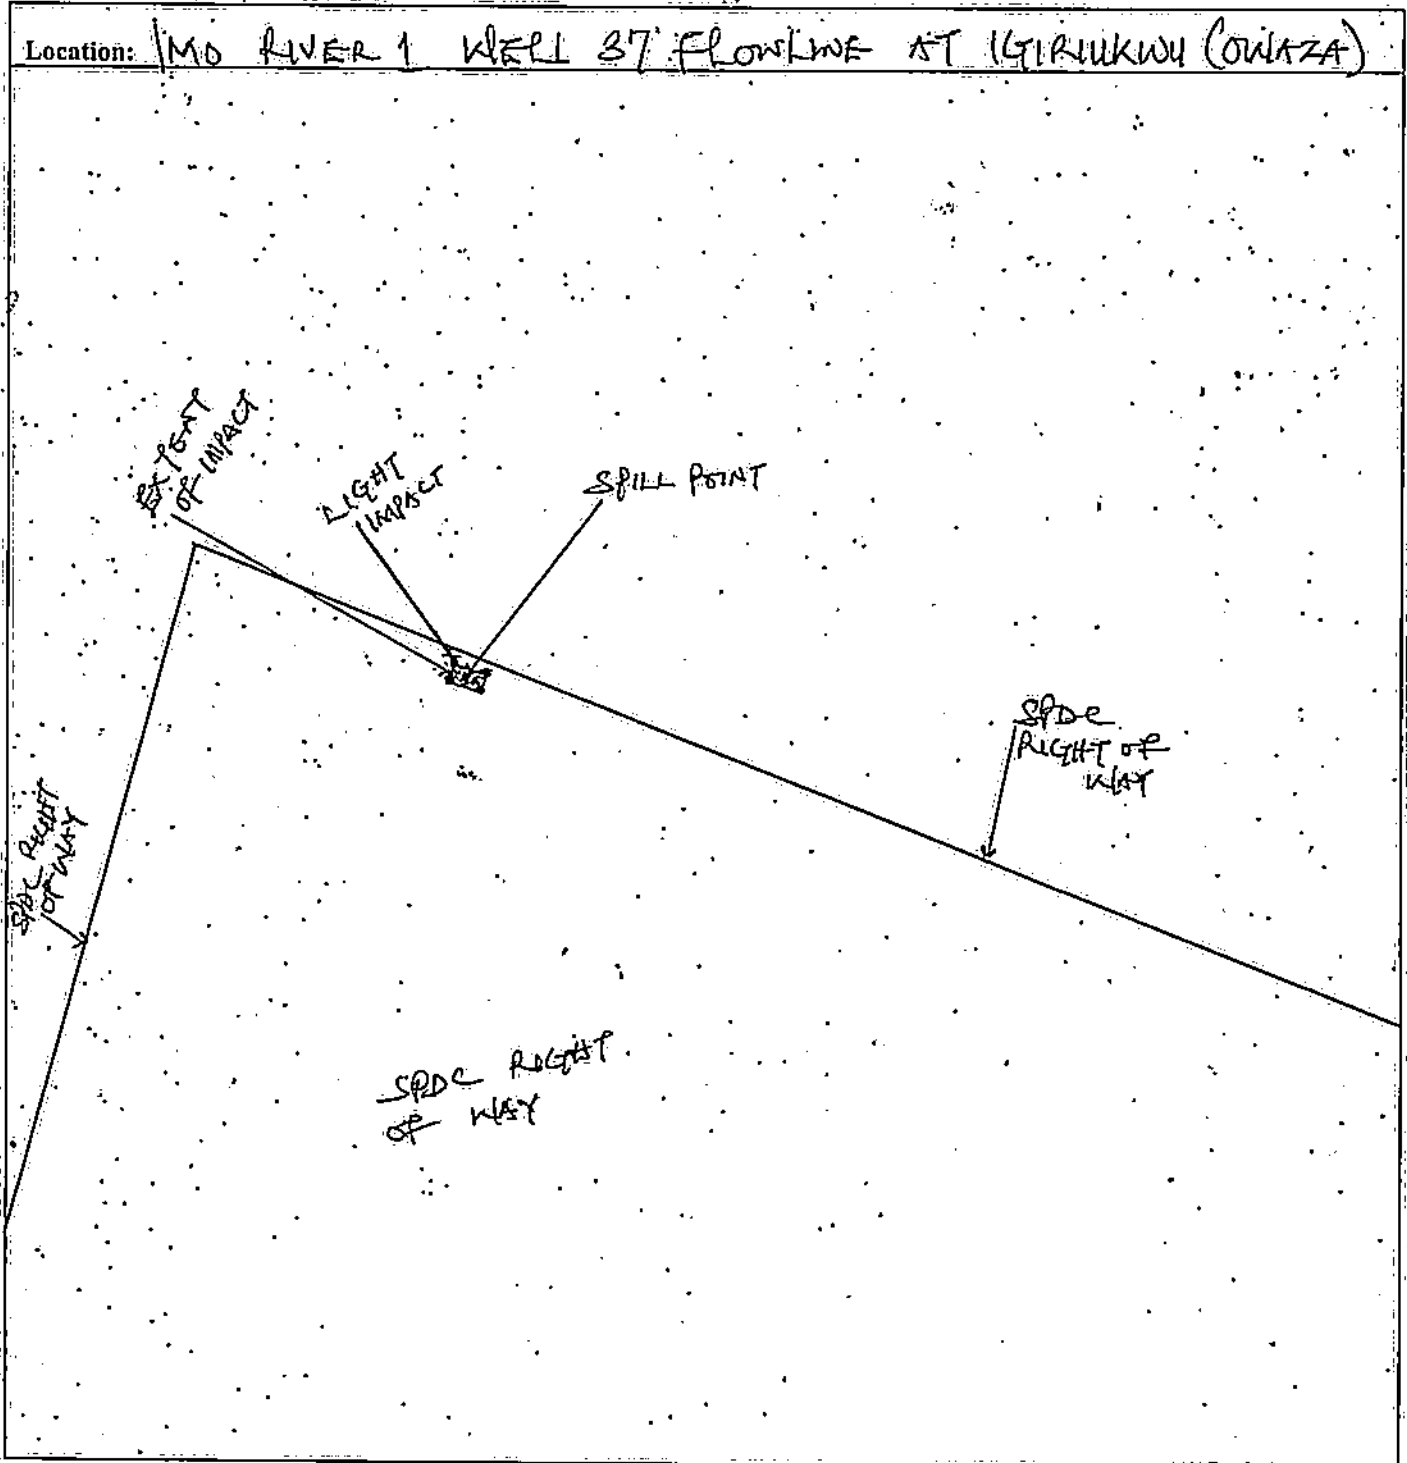
f. Appendix 1: Overview sketch of the site

Additional observations around the spill point: SANDSACK CONCEALING CRUDE OIL THEFT POINT WAS OBSERVED.
