# JOINT INVESTIGATION REPORT

INCIDENT NO: 2154925 JIV report S/N: 0088

1. Spill incident Number: 2154925 2. Type of incident\*: OIL SPILL  
3. Name of Location 24" NKPOKU - BOMU PIPELINE  
4. Name of nearest community BERA 5. State: RIVERS 6. LGA GOKANA  
7. Type of Production facility/Installation OIL PIPELINE  
8. Asset owner/District THE SHELL PETROLEUM DEVELOPMENT COMPANY OF NIGERIA LIMITED PIPELINE

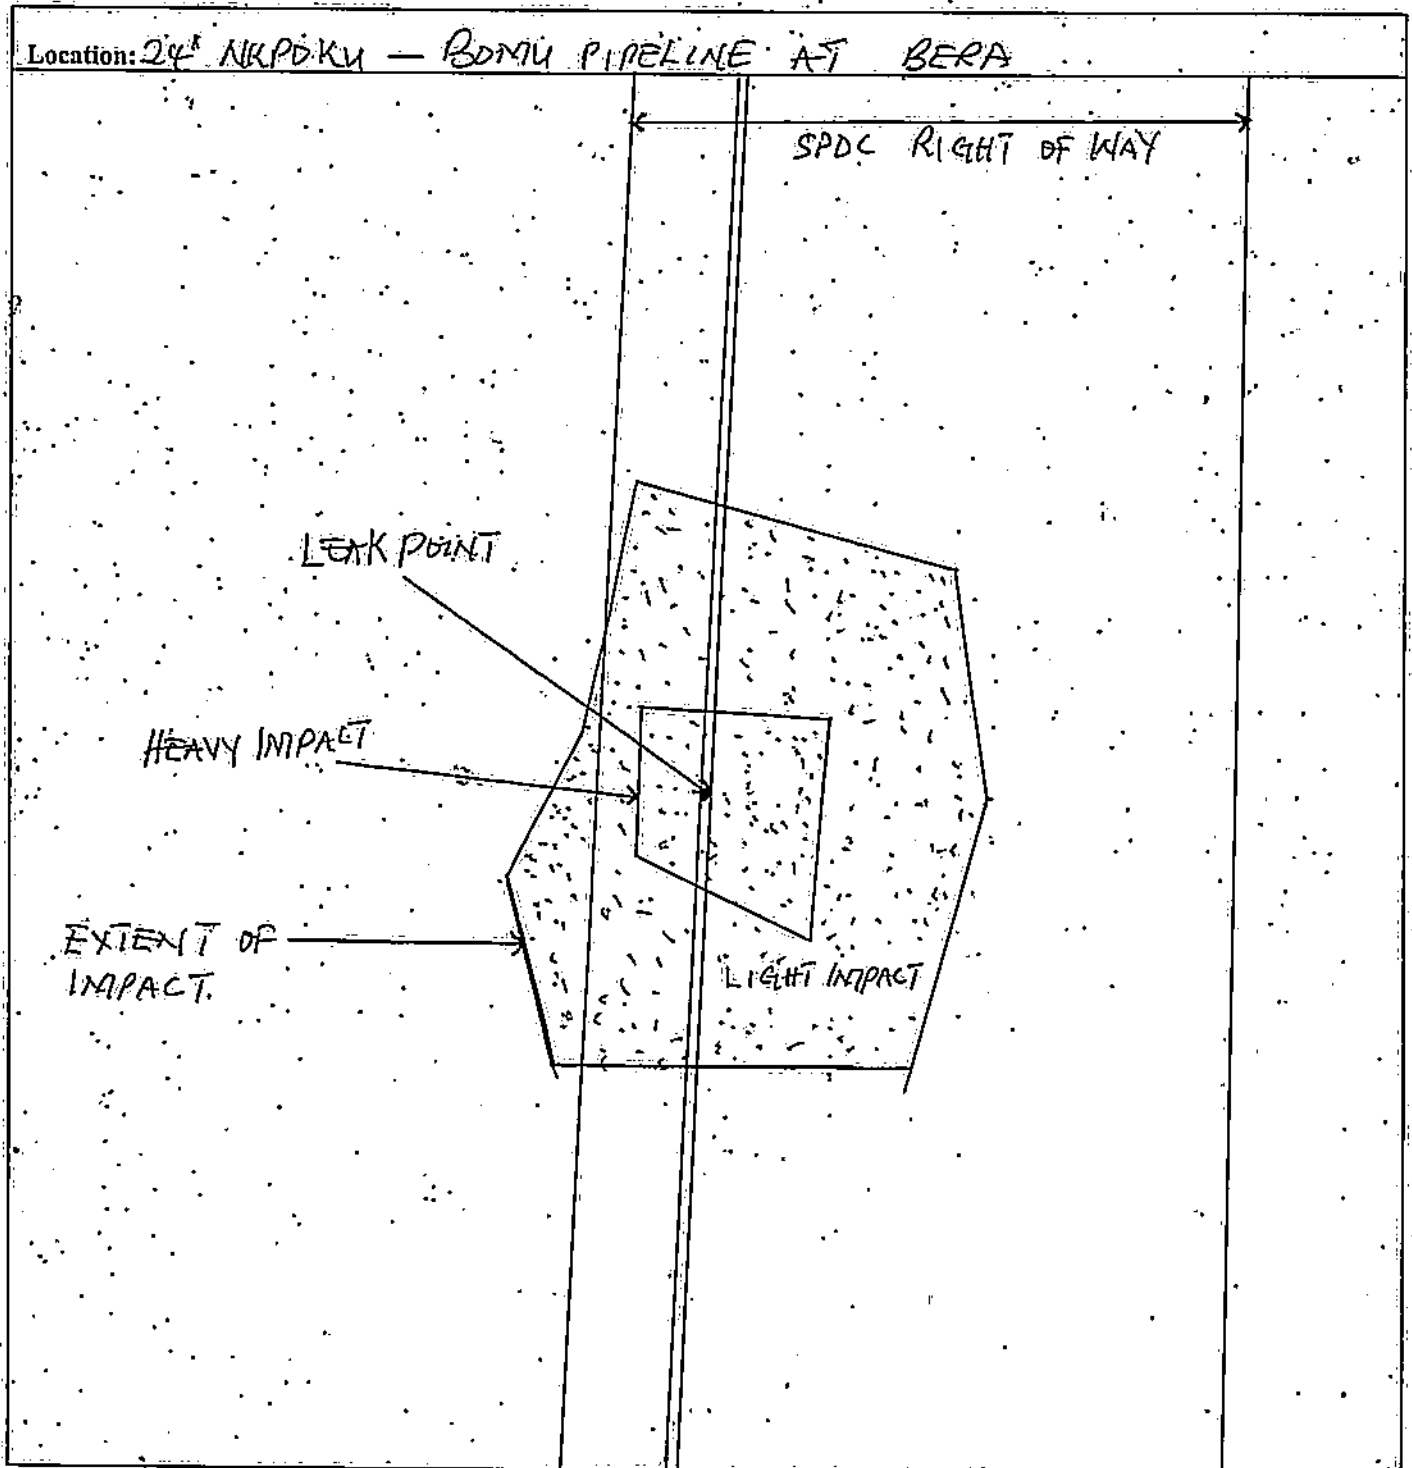
f. Appendix 1: Overview sketch of the site

Additional observations around the spill point: THE JOINT INVESTIGATION TEAM OBSERVED 10MM PARTLY DRILLED AND PARTLY PUNCHED HOLE AT 12 O'CLOCK POSITION BY UNKNOWN PERSONS). THE TEAM ALSO OBSERVED BURST SOIL WITHIN THE LEAK POINT AREA.

**E. GRAPHIC DESCRIPTION OF LEAK POINT** (while detailed report of the leak point should be contained in the leak report, overview sketch of the site should be added as an appendix) 1) A SECTION OF 24" NKPOKU-BOMU PIPELINE AT BERA SHOWING A PARTLY DRILLED AND PARTLY PUNCHED HOLE AT 12 O'CLOCK POSITION BY UNKNOWN PERSONS.

CRUDE OIL RECOVERY AND PIPELINE REPAIR BY CLAMPING ARE ONGOING.
