JOINT INVESTIGATION REPORT

INCIDENT NO: 2158670 JIV report S/N: 1143

1. Spill incident Number: 2158670 2. Type of incident* OIL SPILL
3. Name of Location 20" OTUMARA - ESCRAVOS PIPELINE
4. Name of nearest community IGBOEGUNGUM 5. State: DELTA 6. LGA WARRI SOUTH - WEST
7. Type of Production facility/installation OIL PIPELINE
8. Asset owner/District THE SHELL PETROLEUM DEVELOPMENT COMPANY OF NIGERIA LIMITED / PIPELINE

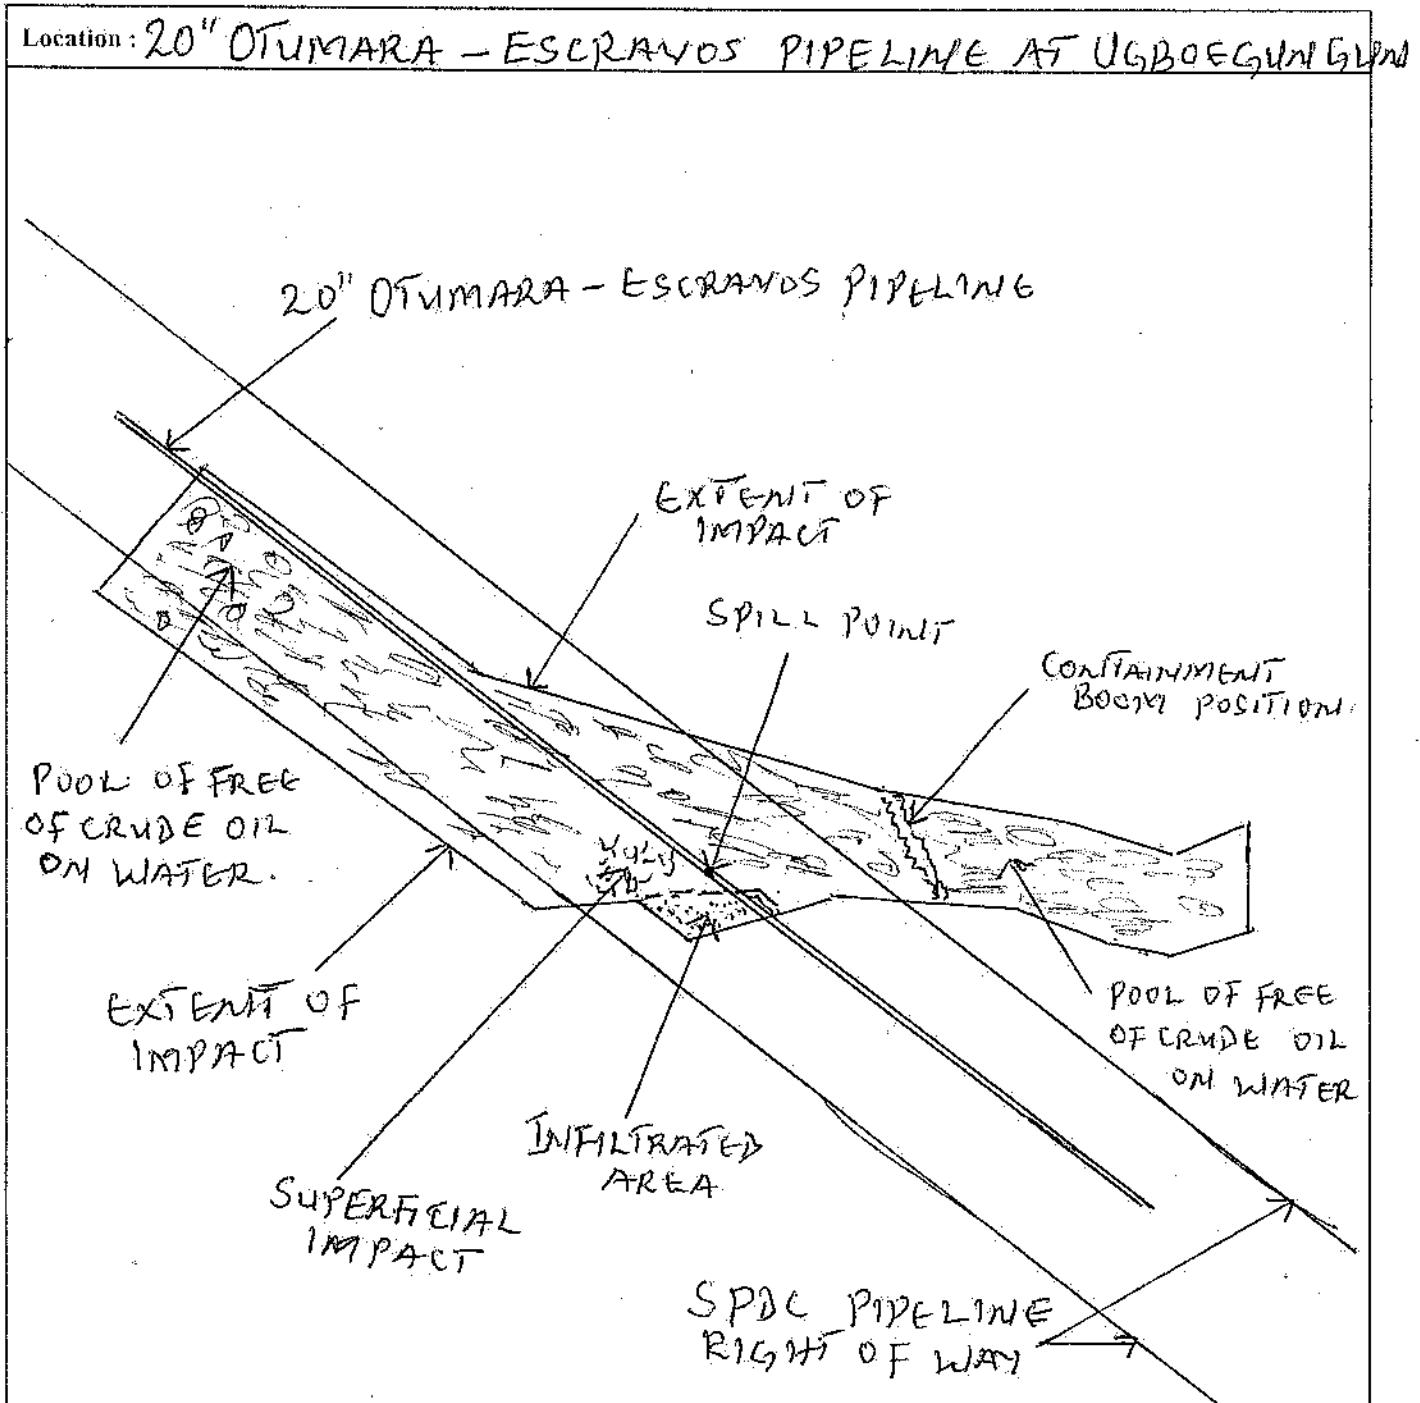
f. Appendix 1: Overview sketch of the site

Additional observations around the spill point: 2" FLANGE ILLEGALLY ATTACHED TO THE 20" OTUMARA - ESCRAVOS PIPELINE AT 12 O'CLOCK POSITION WAS OBSERVED BY THE JOINT INVESTIGATION TEAM.
