# JOINT INVESTIGATION REPORT

INCIDENT NO: 2324256 JIV report S/N:0269

1. Spill incident Number: 2324256 2. Type of incident\*: OIL SPILL  
3. Name of Location 4" IMO RIVER 2 WELL 21L FLOWLINE  
4. Name of nearest community ODAGWA 5. State: RIVERS 6. LGA ETCHE  
7. Type of Production facility/Installation FLOWLINE  
8. Asset owner/District THE SHELL PETROLEUM DEVELOPMENT COMPANY OF NIGERIA LIMITED / LAND EAST HUB

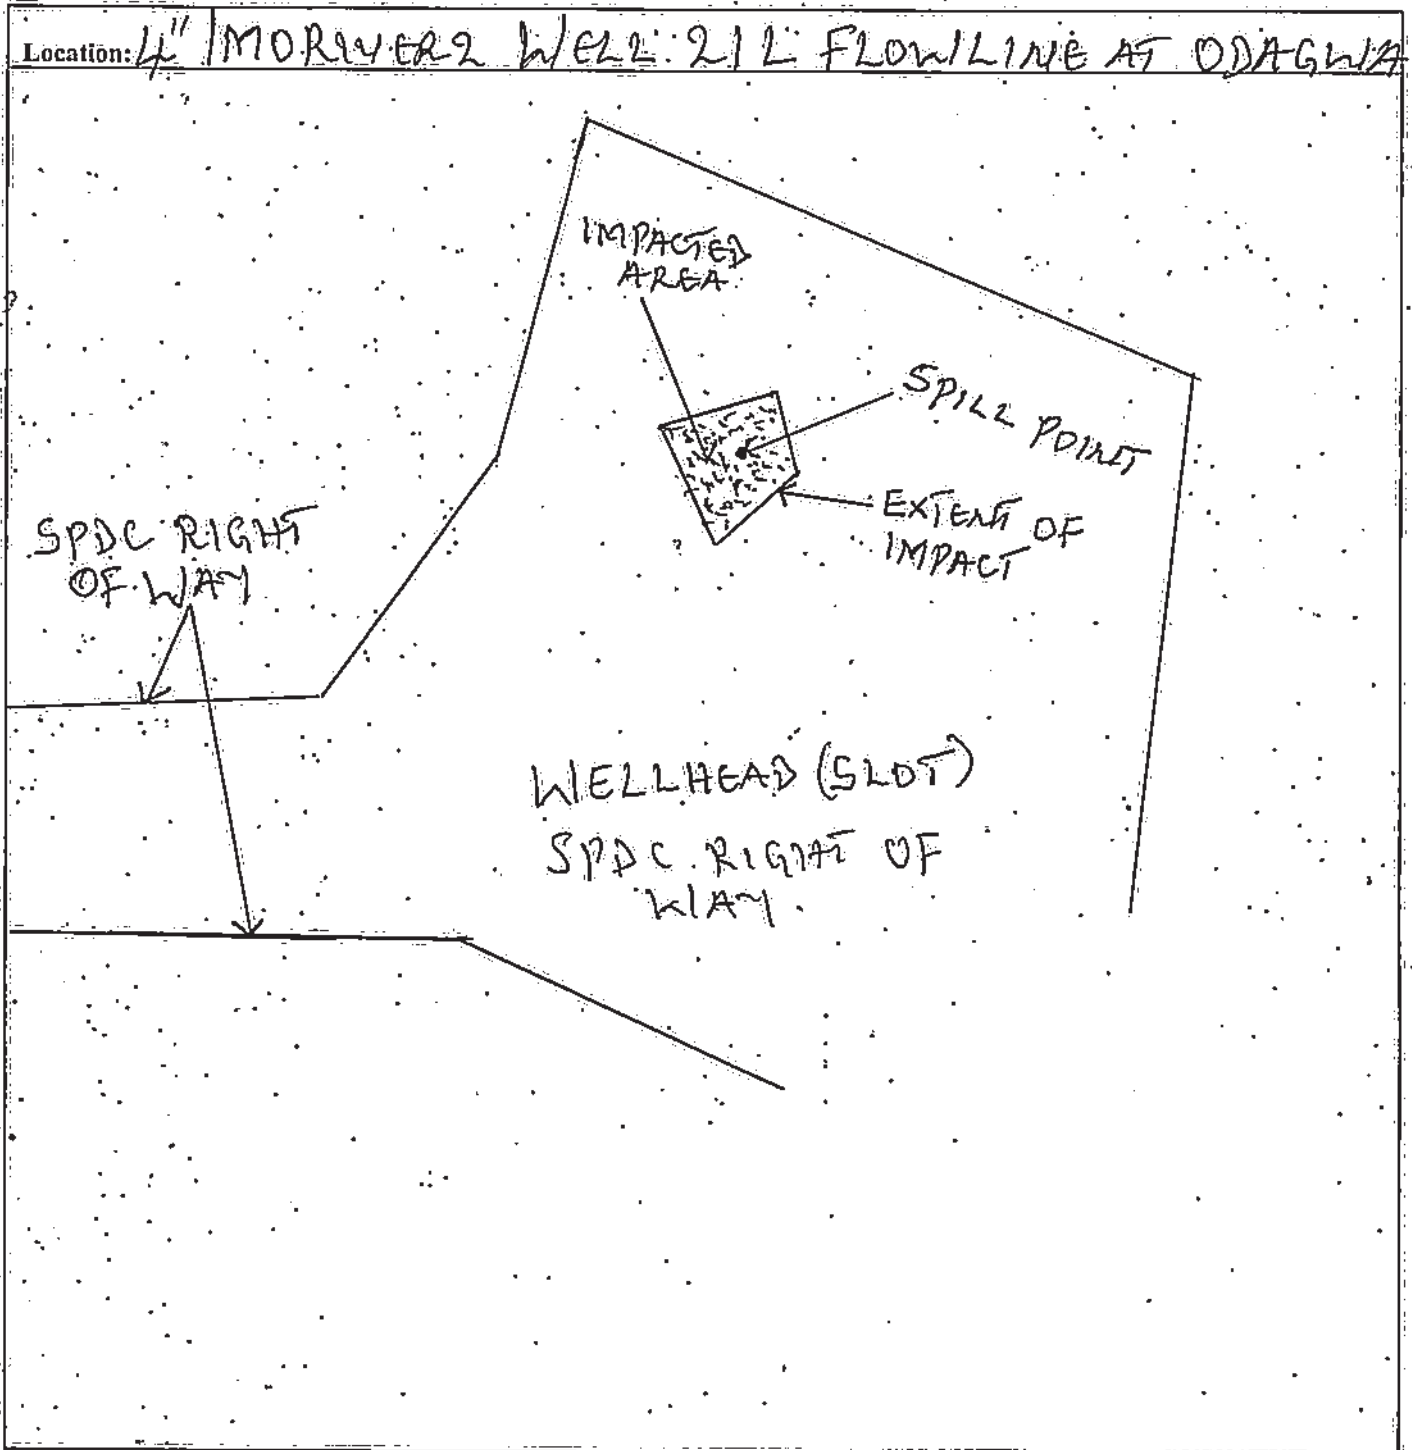
f. Appendix 1: Overview sketch of the site

Additional observations around the spill point: THE JOINT INVESTIGATION TEAM OBSERVED LOCALLY FABRICATED CLAMP WITH 1" BALL VALVE, ILLEGALLY ATTACHED TO 4" IMO RIVER 2 WELL 21L FLOWLINE.
