# JOINT INVESTIGATION REPORT

INCIDENT NO: 2331867 JIV report S/N: 0294

1. Spill incident Number: 2331867 2. Type of incident\*: OIL SPILL  
3. Name of Location: 12" IMO RIVER 2 - OGALE PIPELINE  
4. Name of nearest community: IGIPIUKKIU OWAZA 5. State: ABIA 6. LGA: UKWA-WEST  
7. Type of Production facility/Installation: OIL PIPELINE  
8. Asset owner/District: THE SHELL PETROLEUM DEVELOPMENT COMPANY OF NIGERIA LIMITED (SPDC) / PIPELINE

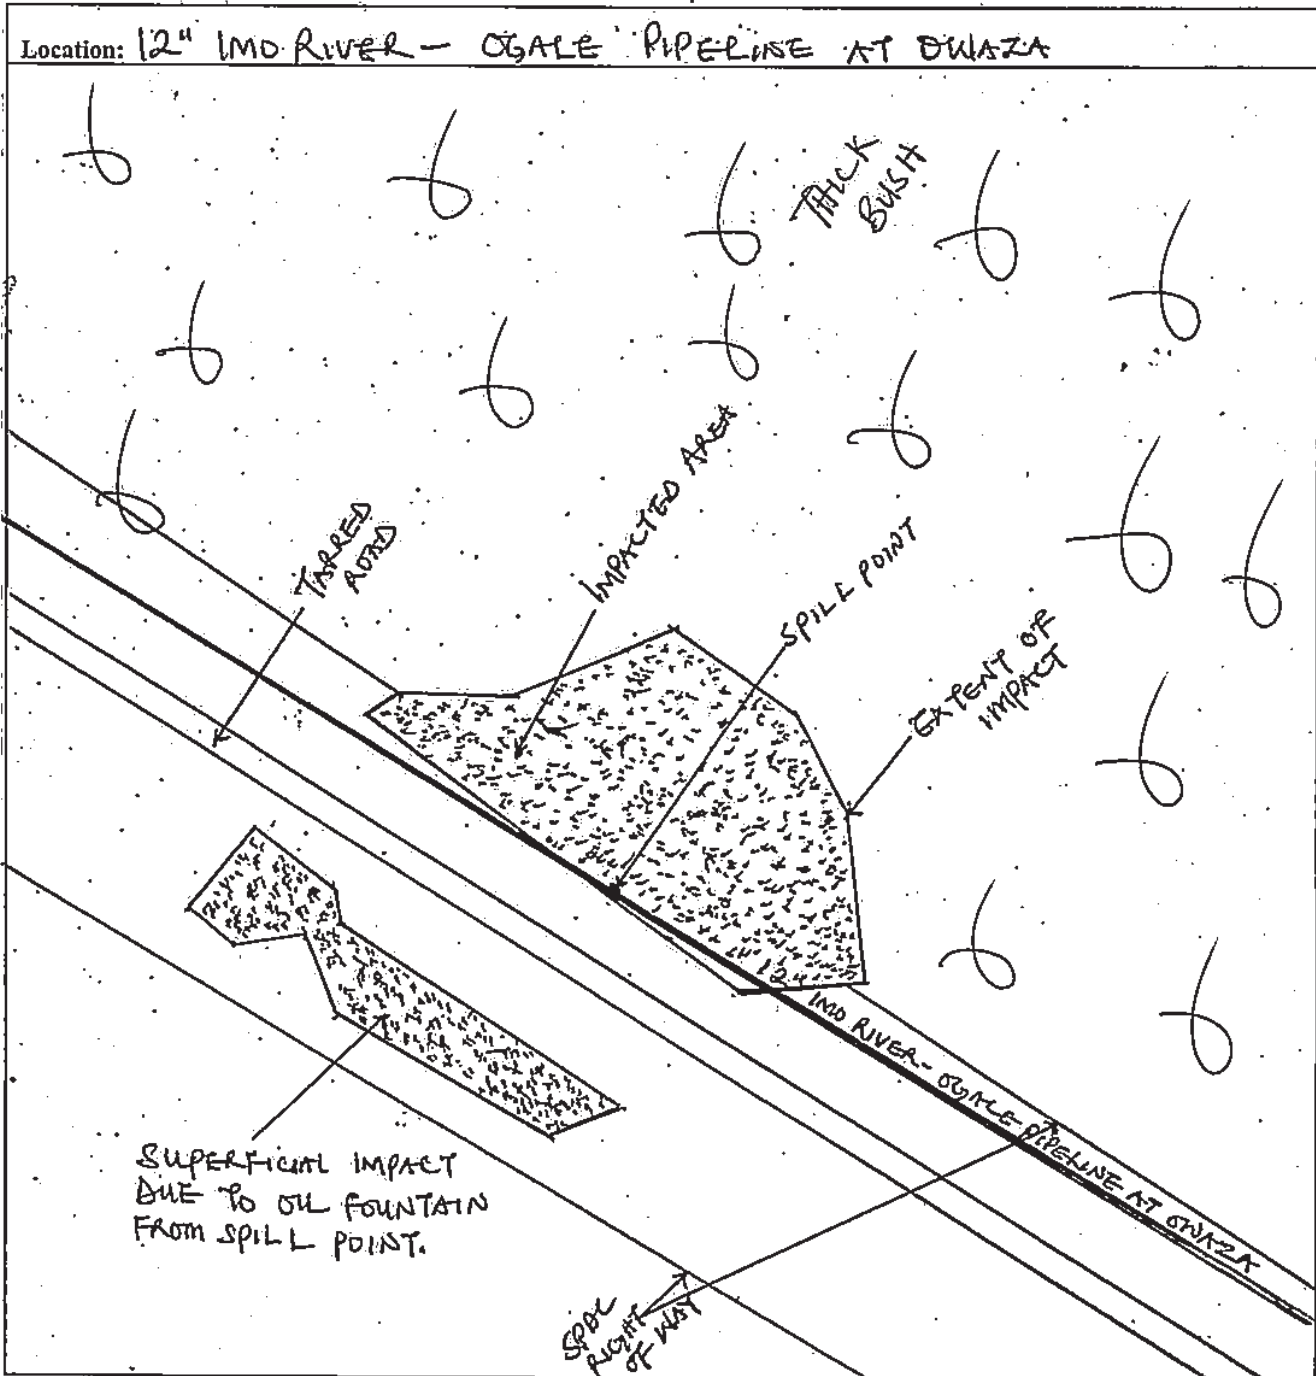
f. Appendix 1: Overview sketch of the site

**E. GRAPHIC DESCRIPTION OF LEAK POINT** (while detailed report of the leak point should be contained in the leak report, overview sketch of the site should be added as an appendix 1) A SECTION OF 12" INS RIVER-OGALE PIPELINE AT ONIWA SHOWING A 1" BALL VALVE AND A LOCALLY FABRICATED CLAMP AT 12 O'CLOCK POSITION BY UNKNOWN PERSONS.
