# JOINT INVESTIGATION REPORT

INCIDENT NO: 2264342 JIV report S/N: 0244

1. Spill incident Number: 2264342 2. Type of incident\* OIL SPILL  
3. Name of Location 18" ASSA - RUMUEKPE (TRUNKLINE) PIPELINE  
4. Name of nearest community AWARA 5. State: IMO 6. LGA OHAST EGBEMA  
7. Type of Production facility/Installation OIL PIPELINE  
8. Asset owner/District THE SHELL PETROLEUM DEVELOPMENT COMPANY OF NIGERIA LIMITED PIPELINE

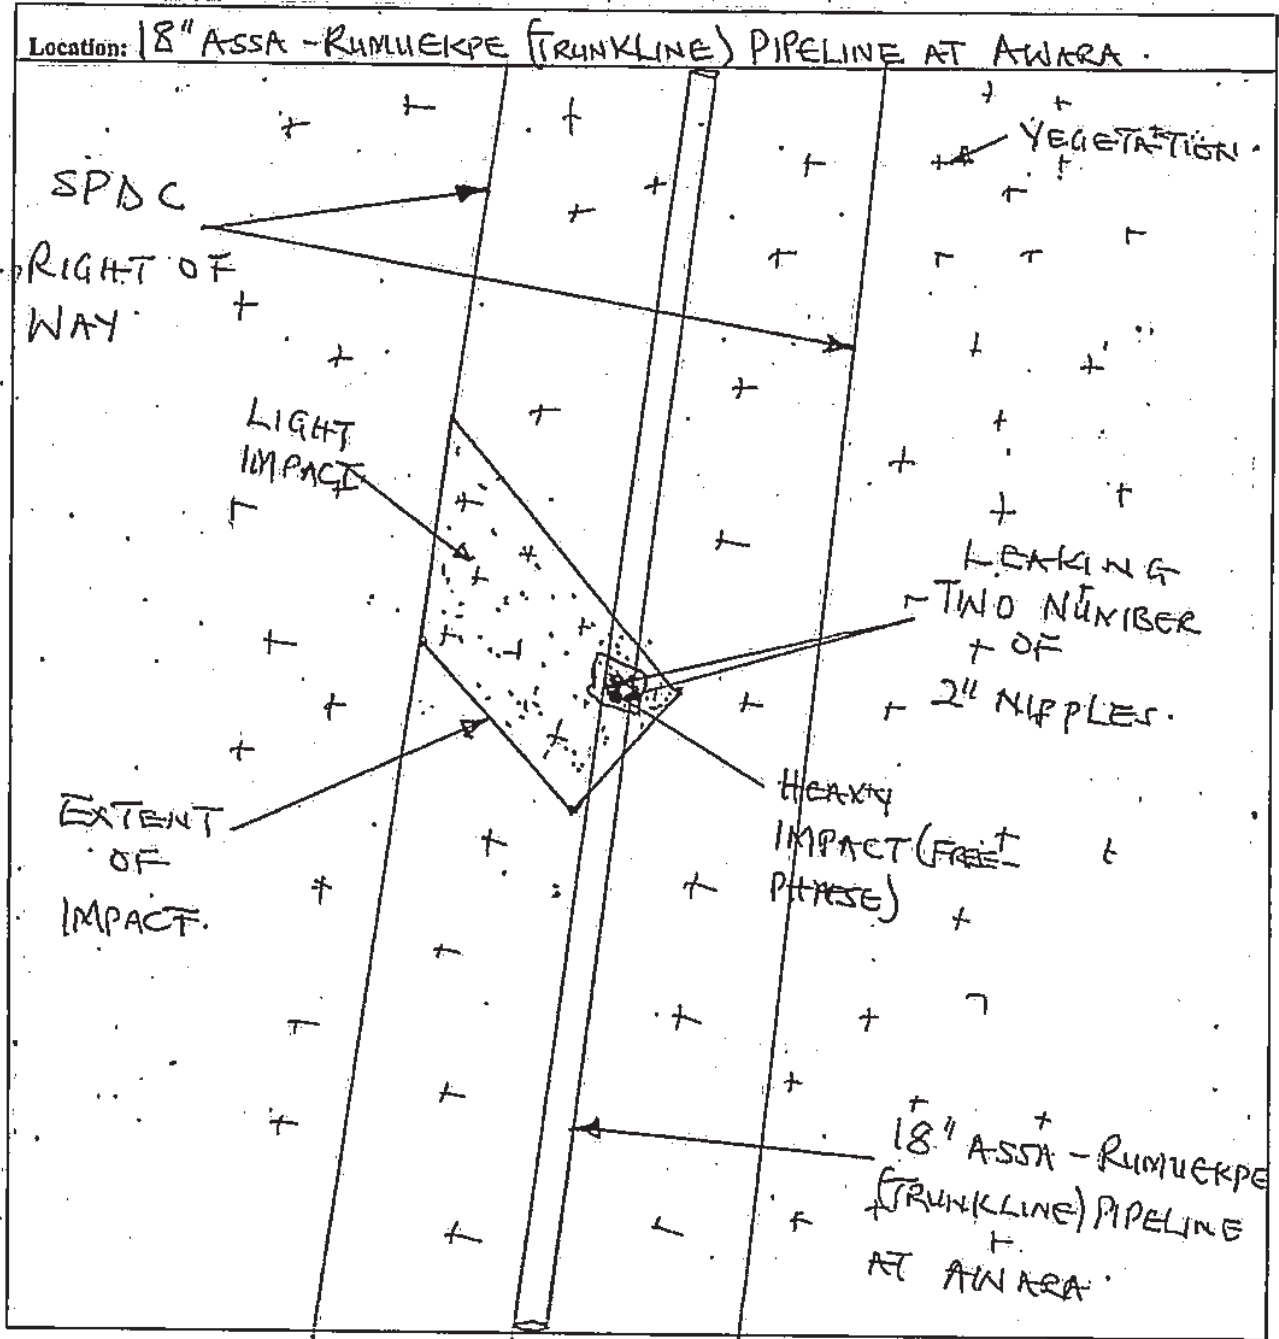
f. Appendix 1: Overview sketch of the site

Additional observations around the spill point: ON EXCAVATION OF THE INCIDENT POINT THE JOINT INVESTIGATION TEAM OBSERVED ~~(A) (THE) (THE)~~ THE USE OF SAND BAGS TO CONSEAL THE ILLEGAL THEFT POINTS.

**AT AWARA SHOWING:- FAILED 2 NUMBERS OF 2" LEAKING NIPPLES..**

FAILED 2\*NUMBER OF 2" BALL VALVE  
NIPPLES INSTALLED AT 12 O' CLOCK POSITION.

CRUDE RECOVERY WORK AND REPAIR WORK BY CLAMPING  
ON-GOING AND WAS LATER COMPLETED.
