# JOINT INVESTIGATION REPORT

INCIDENT NO: 2240479 JIV report S/N: 0196

1. Spill incident Number: 2240479 2. Type of incident\*: OIL SPILL  
3. Name of Location 10" DEEBU CREEK-NUN RIVER (DELIVERY LINE) PIPELINE.  
4. Name of nearest community DIPOROMA 5. State: BAYELSA 6. LGA SOUTHERN-ITAM  
7. Type of Production facility/Installation OIL PIPELINE  
8. Asset owner/District THE SHELL PETROLEUM DEVELOPMENT COMPANY OF NIGERIA LIMITED/PIPELINE.

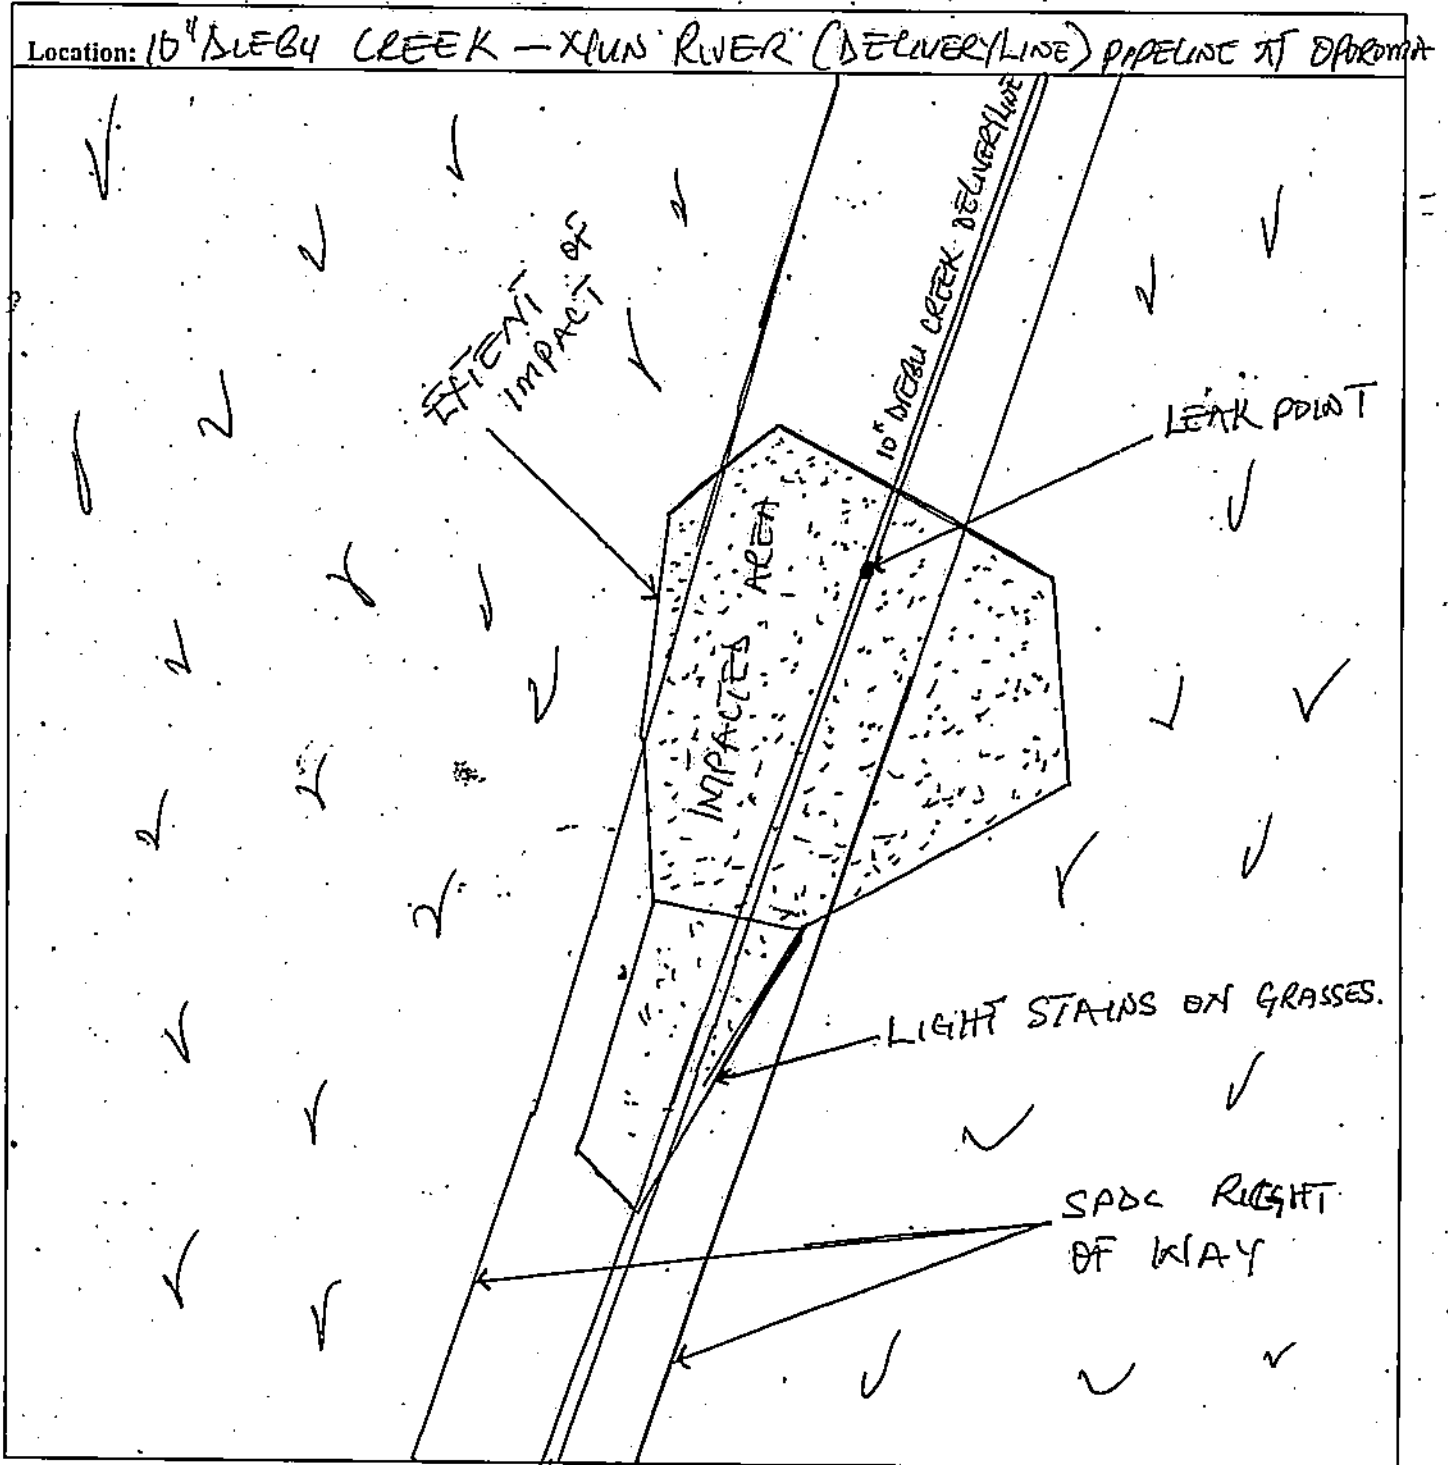
f. Appendix 1: Overview sketch of the site

**E. GRAPHIC DESCRIPTION OF LEAK POINT** (while detailed report of the leak point should be contained in the leak report, overview sketch of the site should be added as an appendix 1) A SECTION OF 16" DEBU CREEK - NUN RIVER (DELIVERY LINE) PIPELINE AT OPODMA SHOWING A HACKSAW CUT AT 12 O'CLOCK POSITION BY UNKNOWN PERSONS.
