JOINT INVESTIGATION REPORT

INCIDENT NO: 2283270 JIV report S/N: 0245

1. Spill incident Number: 2283270 2. Type of incident*: OIL SPILL
3. Name of Location 28" BONU - BONNY TRANS NIGER PIPELINE
4. Name of nearest community PATRICK WATER SIDE 5. State: RIVERS 6. LGA GOKANA
7. Type of Production facility/Installation OIL PIPELINE
8. Asset owner/District THE SHELL PETROLEUM DEVELOPMENT COMPANY OF NIGERIA LIMITED PIPELINE

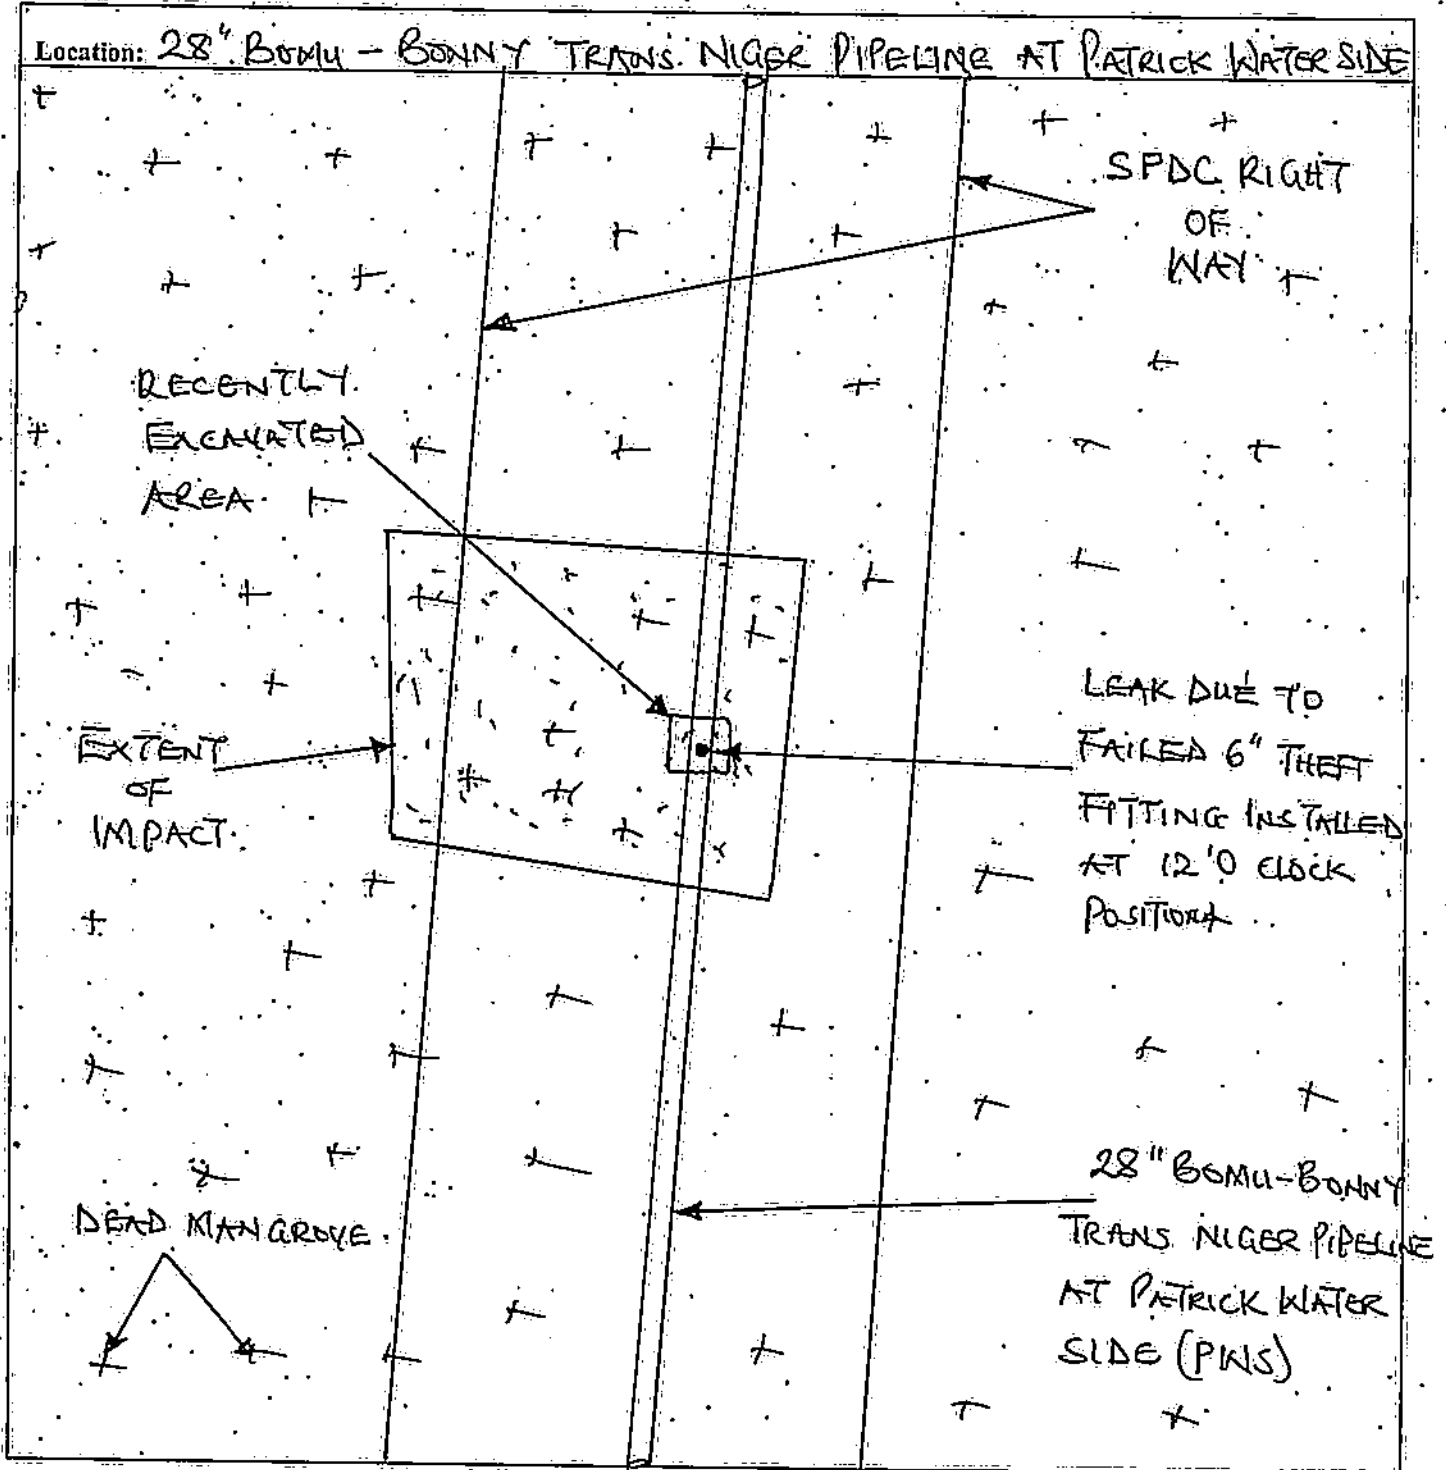
f. Appendix 1: Overview sketch of the site

SHOWING: - ONE SIX (6") FAILED BALL VALVE INSTALLED AT 12 O'CLOCK POSITION.

TEMPORARY REPAIR BY BLIND FLANGING COMPLETED
