JOINT INVESTIGATION REPORT

INCIDENT NO: 2280272 JIV report S/N: 0169

1. Spill incident Number: 2280272 2. Type of incident: FIRE/OIL SPILL
3. Name of Location: 28" BOMU - BUNNY TRANS NIGER PIPELINE
4. Name of nearest community: OWOKIRI 5. State: RIVERS 6. LGA: ANDONI
7. Type of Production facility/Installation: APL PIPELINE
8. Asset owner/District: THE SHELL PETROLEUM DEVELOPMENT COMPANY OF NIGERIA LIMITED PIPELINE

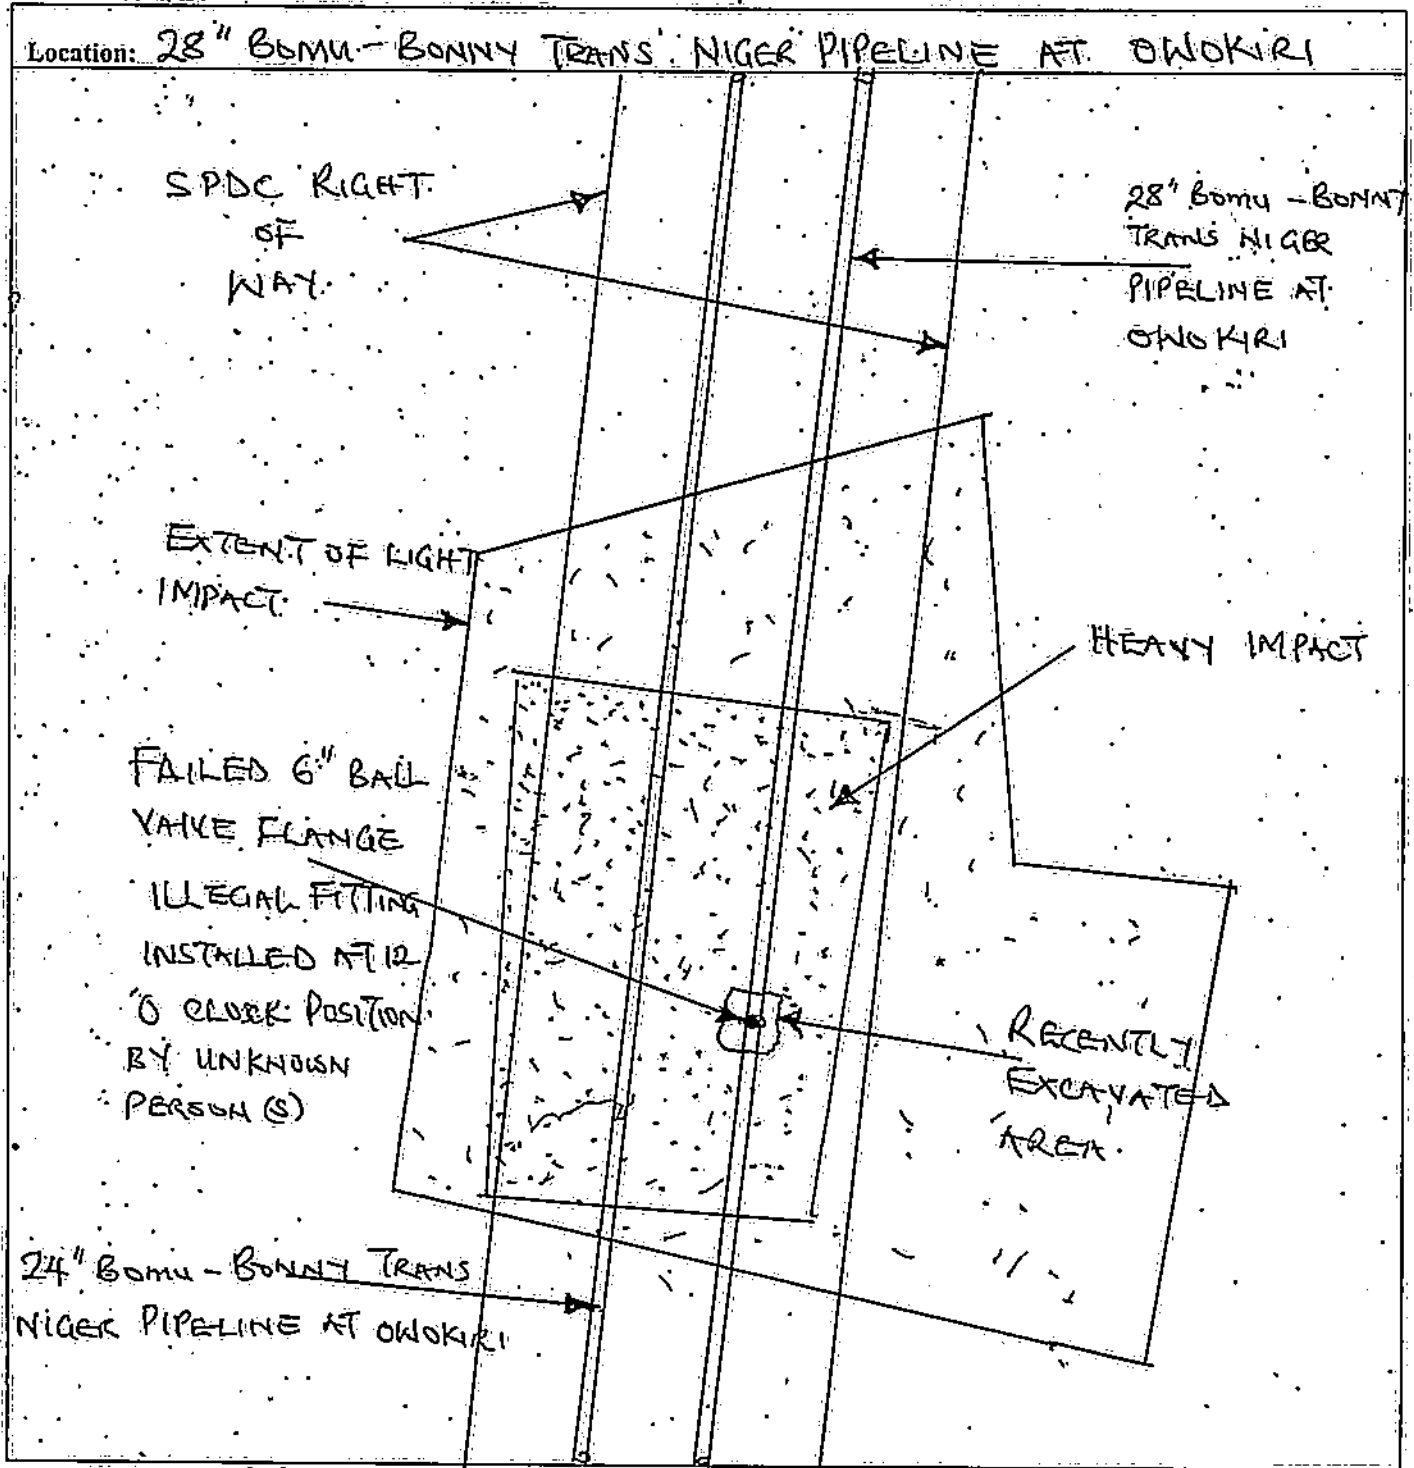
f. Appendix 1: Overview sketch of the site

SECTIONAL VIEW OF 28" BOMU-BONNY TRANS NIGER PIPELINE AT
ONOKIRI SHOWING: - FAILED 6" BALL VALVE FLANGE INSTALLED AT 12
O'CLOCK POSITION BY UNKNOWN PERSON(S)
