JOINT INVESTIGATION REPORT

INCIDENT NO: 2301224 JIV report S/N: 0268

1. Spill incident Number: 2301224 2. Type of incident*: OIL SPILL
3. Name of Location 36" NKPOKU BOMU PIPELINE
4. Name of nearest community ATALI 5. State: RIVERS 6. LGA OBIO-AKPOR
7. Type of Production facility/Installation OIL PIPELINE
8. Asset owner/District THE SHELL PETROLEUM DEVELOPMENT COMPANY OF NIGERIA LIMITED | PIPELINE

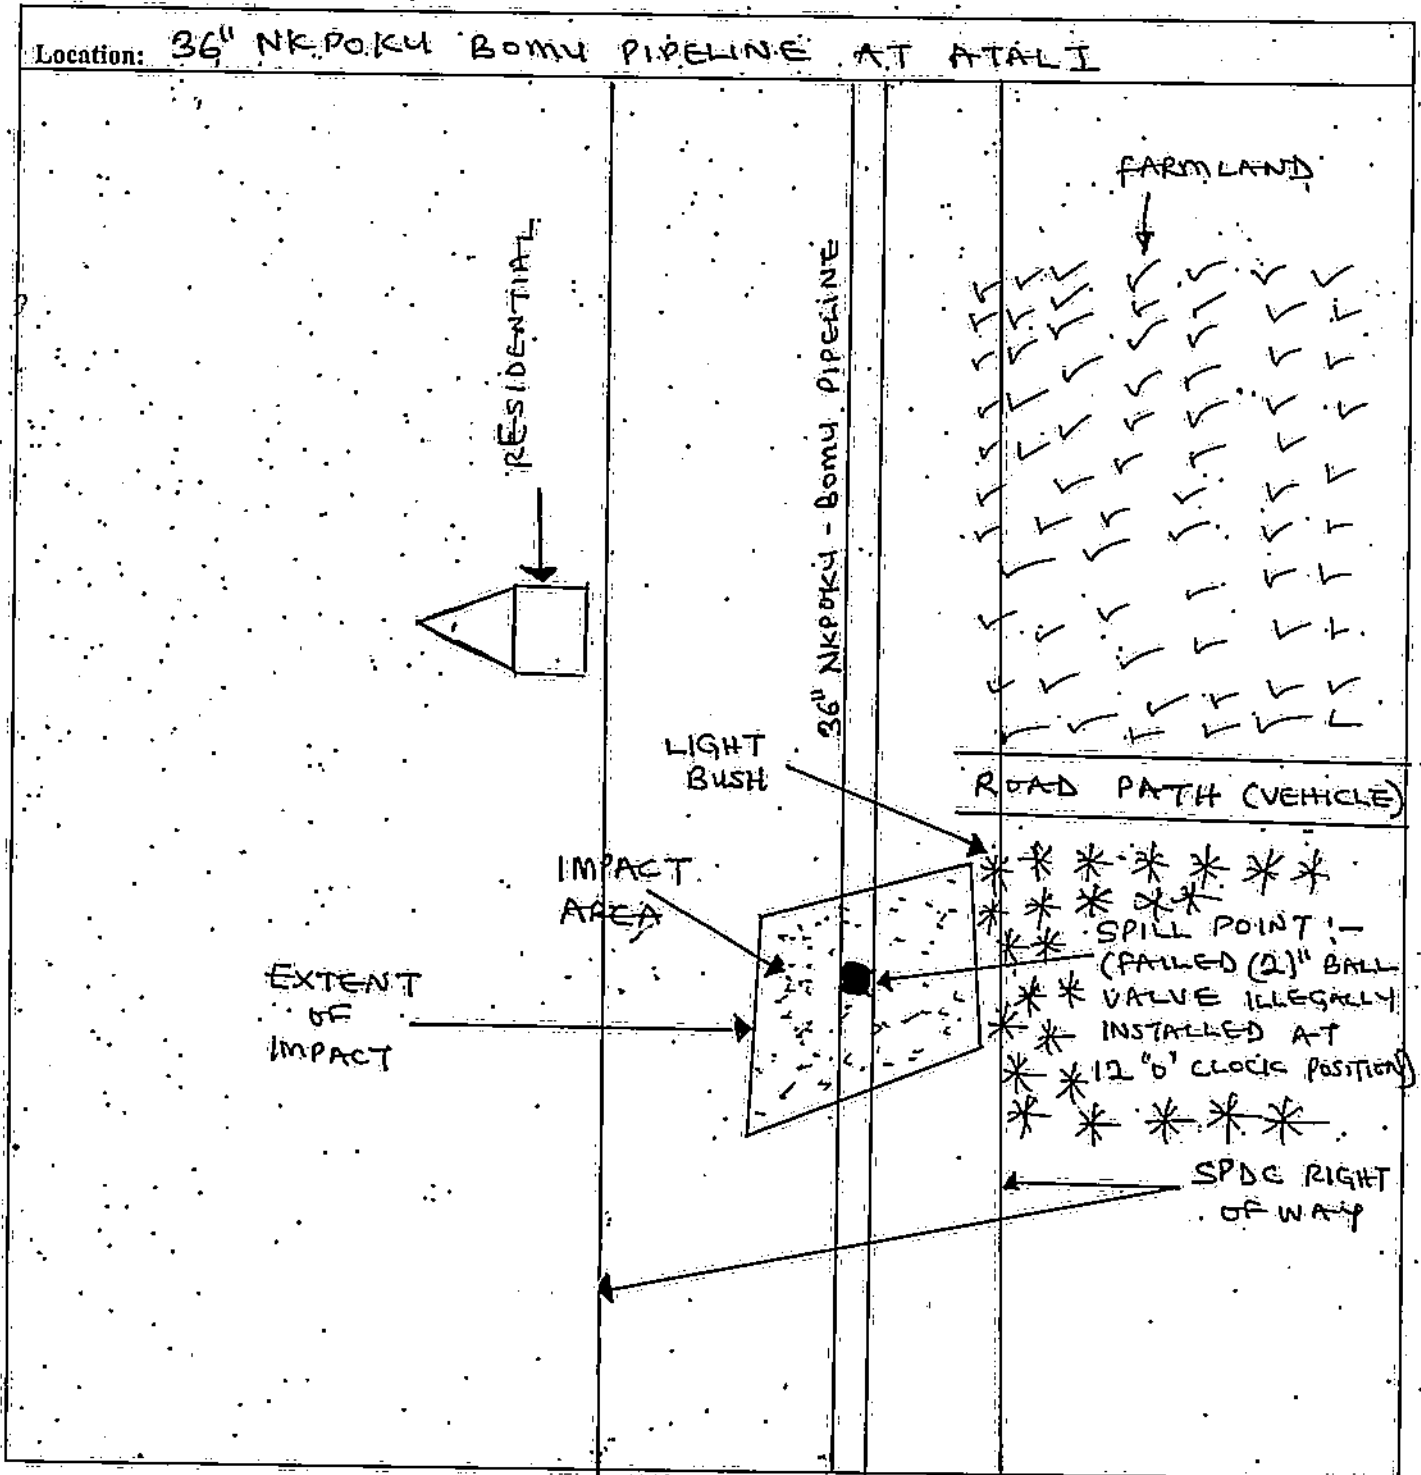
f. Appendix 1: Overview sketch of the site

| <input checked="" type="checkbox"/> Failed Weld-on illegal hot tap valve | <input type="checkbox"/> Failed Clamp | <input type="checkbox"/> Missing Pipeline/Flowline |
