JOINT INVESTIGATION REPORT

INCIDENT NO: 2359133 JIV report S/N: 0121

1. Spill incident Number: 2359133 2. Type of incident*: OIL SPILL
3. Name of Location 12" IMO RIVER - OGALE PIPELINE
4. Name of nearest community UMUOLOLO 5. State: ABIA 6. LGA UKWA-WEST
7. Type of Production facility/Installation OIL PIPELINE
8. Asset owner/District THE SHELL PETROLEUM DEVELOPMENT COMPANY OF NIGERIA LIMITED (SPDC)/PIPELINE

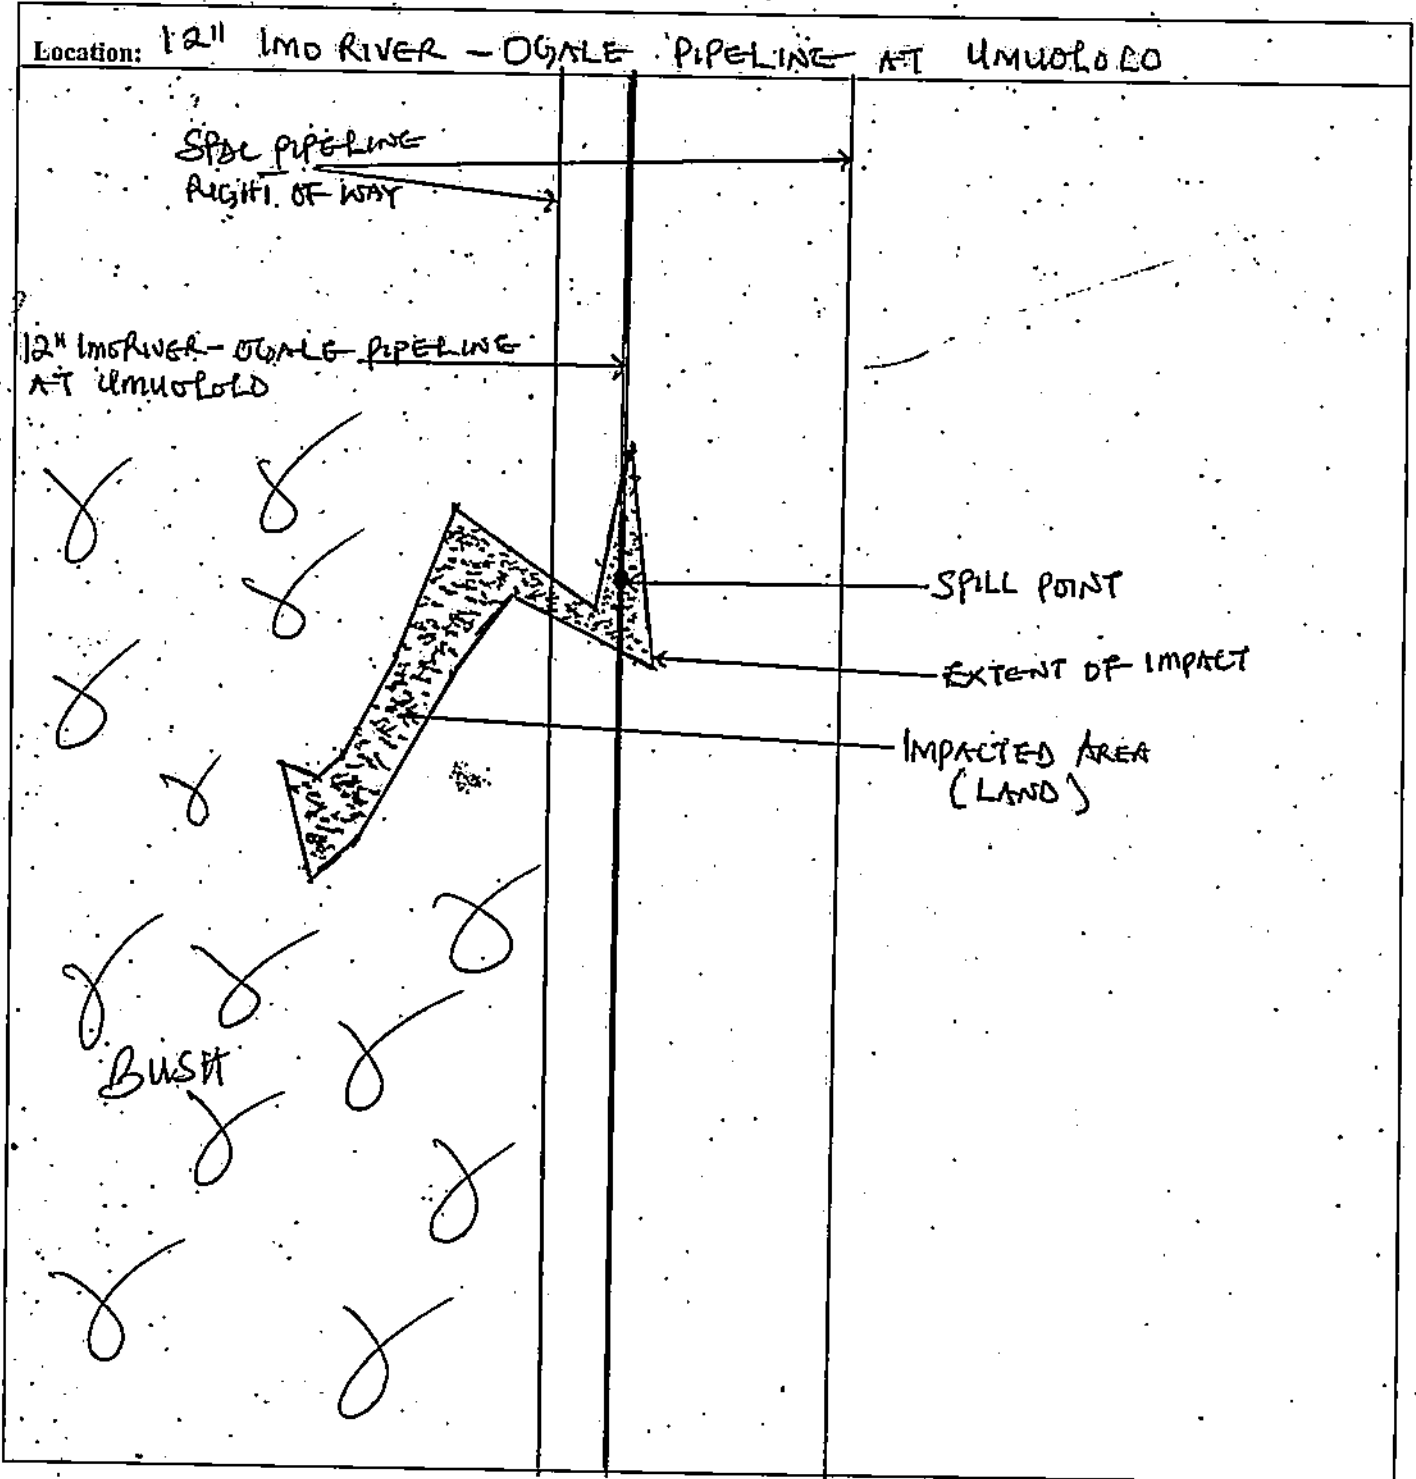
f. Appendix 1: Overview sketch of the site

Additional observations around the spill point: THE JOINT INVESTIGATION TEAM OBSERVED A 1" BALL VALVE ATTACHED TO A LOCAL FABRICATED CLAMP WITH A 1" GALVANIZED PIPE ALL INSTALLED AT 12 O'CLOCK POSITION BY UNKNOWN PERSONS.

REPAIR BY CLAMPING
