JOINT INVESTIGATION REPORT

INCIDENT NO: 2497225 JIV report S/N: 1030078

1. Mountain Incident Number: 2497225 2. Type of incident: OIL SPILL
3. Name of Location: 20" TRANS - ESCRANOS PIPELINE
4. Name of nearest community: UGBOEGUNG State: DELTA Local Authority: IGBA WARRI SOUTH WEST
7. Type of Production facility/Installation: OIL PIPELINE
8. Asset owner/District: THE SHELL PETROLEUM DEVELOPMENT COMPANY / PIPELINE

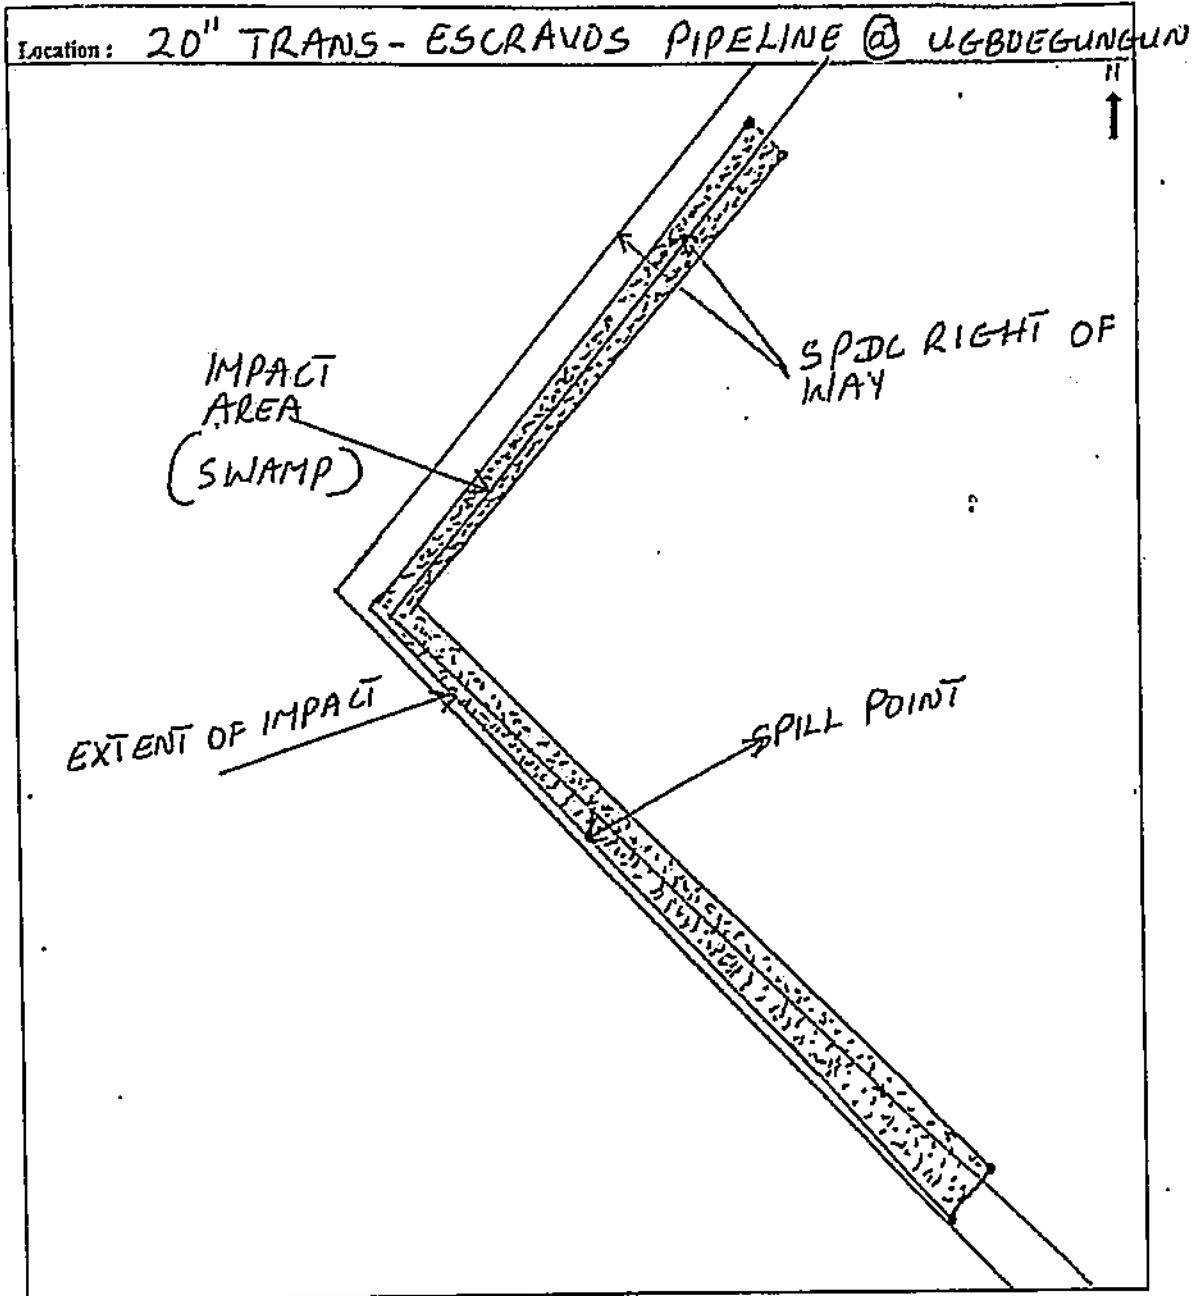
f. Appendix 1: Overview sketch of the site

A SECTION OF 20" TRANS-ESCAUDS PIPELINE AT OGBOEGUNGUN SHOWING A FAILED WELD-ON 4" FLANGE INSTALLED AT 12 O'CLOCK POSITION BY UNKNOWN PERSON.
