JOINT INVESTIGATION REPORT

INCIDENT NO: 2449874 JIV report S/N: 1030141

1. Fountain Incident Number: 2449874 2. Type of incident* OIL SPILL
3. Name of Location 12" IMO RNER - OGALE (TRUNK LINE) PIPELINE
4. Name of nearest community OKOTHA 5. State: ABIA 6. LGA UKWA WEST
7. Type of Production facility/Installation OIL PIPELINE
8. Asset owner/District THE SHELL PETROLEUM DEVELOPMENT COMPANY OF NIGERIA LIMITED / PIPELINE

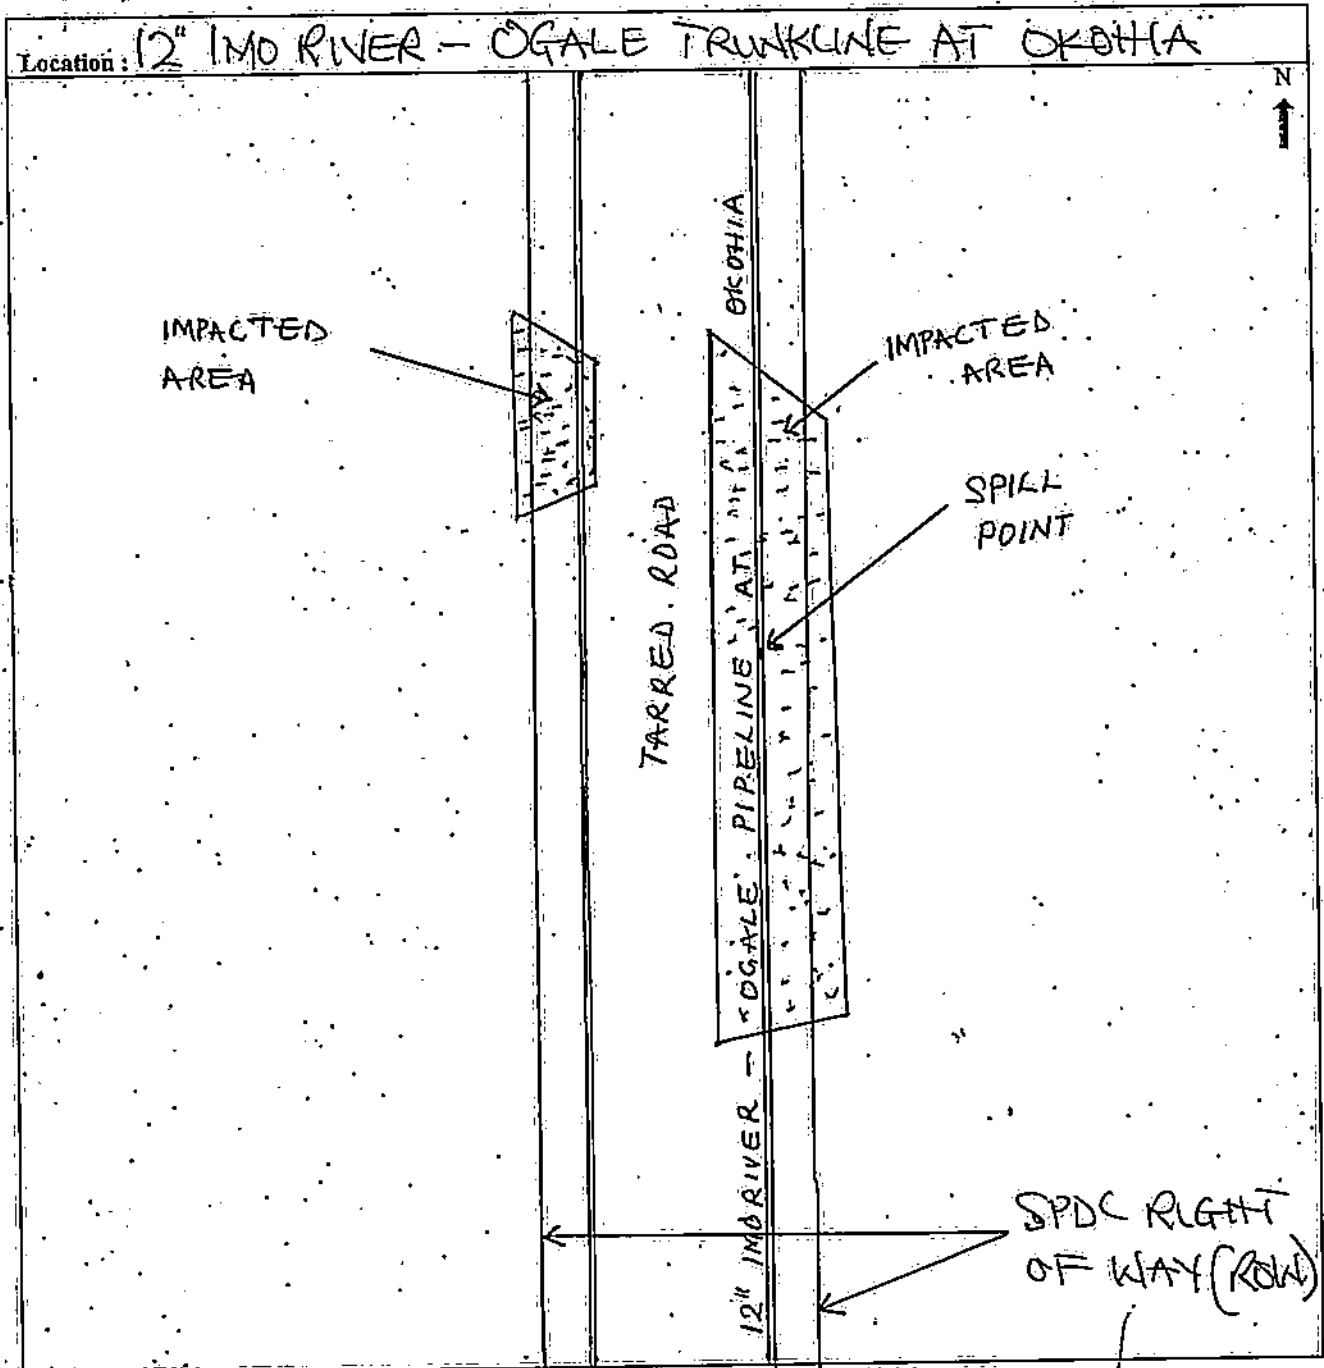
f. Appendix 1: Overview sketch of the site

E. GRAPHIC DESCRIPTION OF LEAK POINT (while detail report of the leak point should be contained in the leak report, overview sketch of the site should be added as an appendix I) A SECTION OF 12" (MD RIVER-OGALE TRUNKLINE AT OKOHA SHOWING 1" ILLEGAL CONNECTION (LOCALLY FABRICATED CLAMP) INSTALLED AT 12 O' CLOCK POSITION BY UNKNOWN PERSON(S).

REPAIR BY CLAMPING ONGOING.
