JOINT INVESTIGATION REPORT

INCIDENT NO: 2542268 JIV report S/N: 1030213

1. Fountain Incident Number: 2542268 2. Type of incident* OIL SPILL
3. Name of Location 20" TRANS - ESCRAVOS PIPELINE AT UGBDEGUN GUN
4. Name of nearest community UGBDEGUN GUN State: DELTA 6. LGA WARRI SOUTH WEST
7. Type of Production facility/Installation PIPELINE
8. Asset owner/District THE SHELL PETROLEUM DEVELOPMENT COMPANY NIGERIA LIMITED / PIPELINE

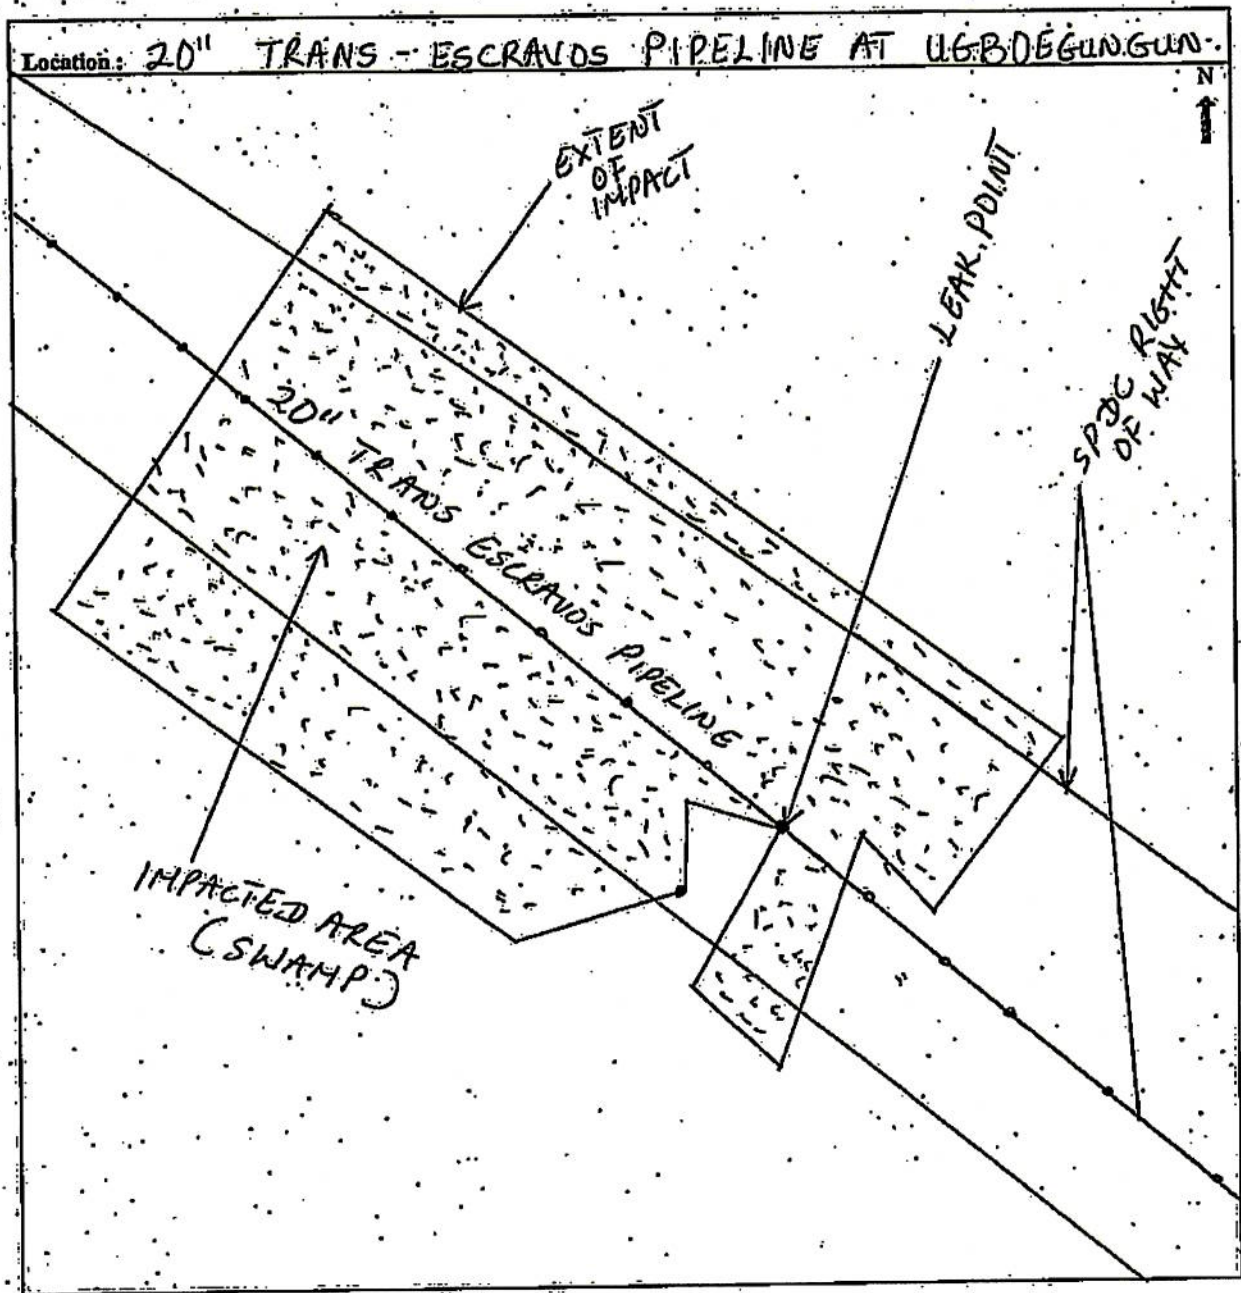
f. Appendix: Overview sketch of the site

| <input checked="" type="checkbox"/> Failed Weld-on illegal hot tap valve | <input type="checkbox"/> Failed Clamp, | <input type="checkbox"/> Missing Pipeline/Flowline |
