JOINT INVESTIGATION REPORT

INCIDENT NO: 2559407 JIV report S/N: 1030230

1. Fountain Incident Number: 2559407 2. Type of incident* OIL SPILL
 3. Name of Location 20th NEW KOLOCREEK - RUMUGKPE PIPELINE
 4. Name of nearest community ORUMA 5. State: BAYELSA 6. LGA OGBIA
 7. Type of Production facility/Installation OIL PIPELINE
 8. Asset owner/District TITE SHELL PETROLEUM DEVELOPMENT COMPANY OF NIGERIA LIMITED (SPDC) / PIPELINE

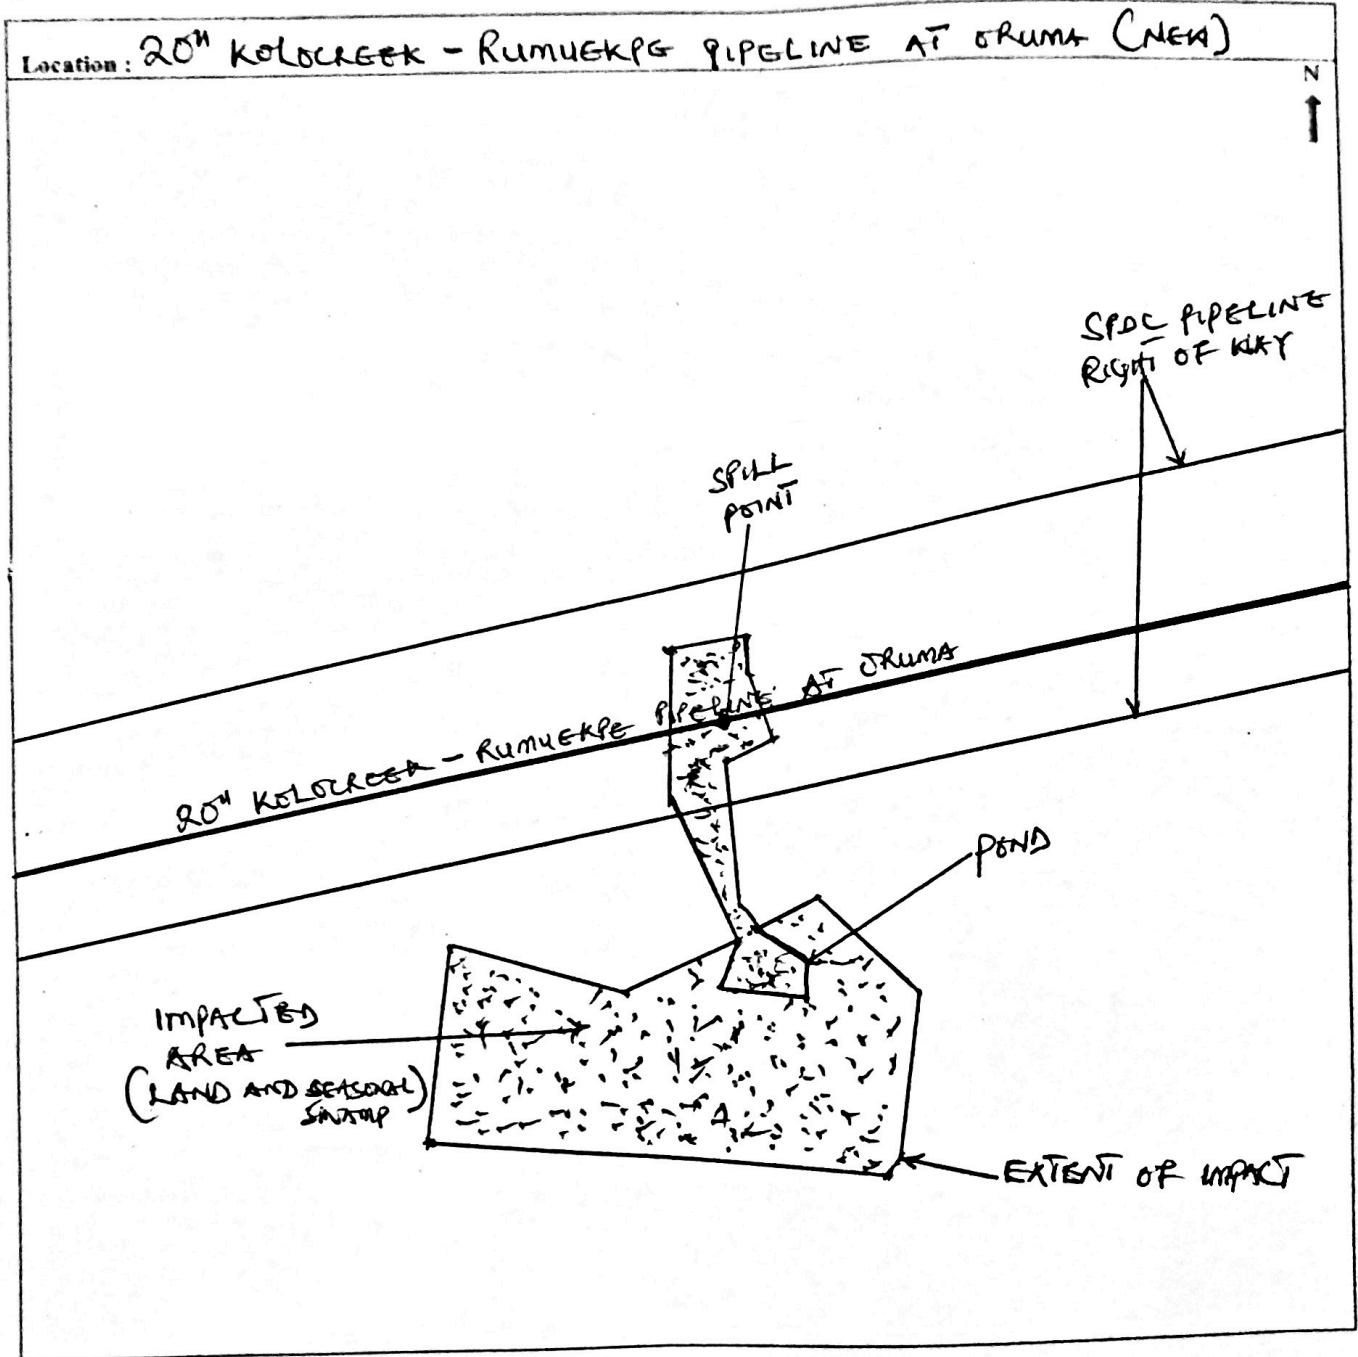
f. Appendix 1: Overview sketch of the site

E. GRAPHIC DESCRIPTION OF LEAK POINT (while detail report of the leak point should be contained in the leak report, overview sketch of the site should be added as an appendix) A SECTION OF 20" KOLACREEK-RUMUEREKI PIPELINE AT ORUMA SHOWING A 12MM DRILLED HOLE AT 11 O'CLOCK POSITION DONE BY UNKNOWN PERSONS.
