# JOINT INVESTIGATION REPORT

INCIDENT NO: 2774574 JIV report S/N: 0607

1. Fountain Incident Number: 2774574 2. Type of incident\* OIL SPILL  
3. Name of Location SOKU WELL 14L  
4. Name of nearest community SOKU 5. State: RIVERS 6. LGA AKUKUTORU  
7. Production Facility/Installation WELL HEAD  
8. Asset Owner/Hub THE SHELL PETROLEUM DEVELOPMENT COMPANY OF NIGERIA LIMITED (SPDC) / CENTRAL EAST HUB

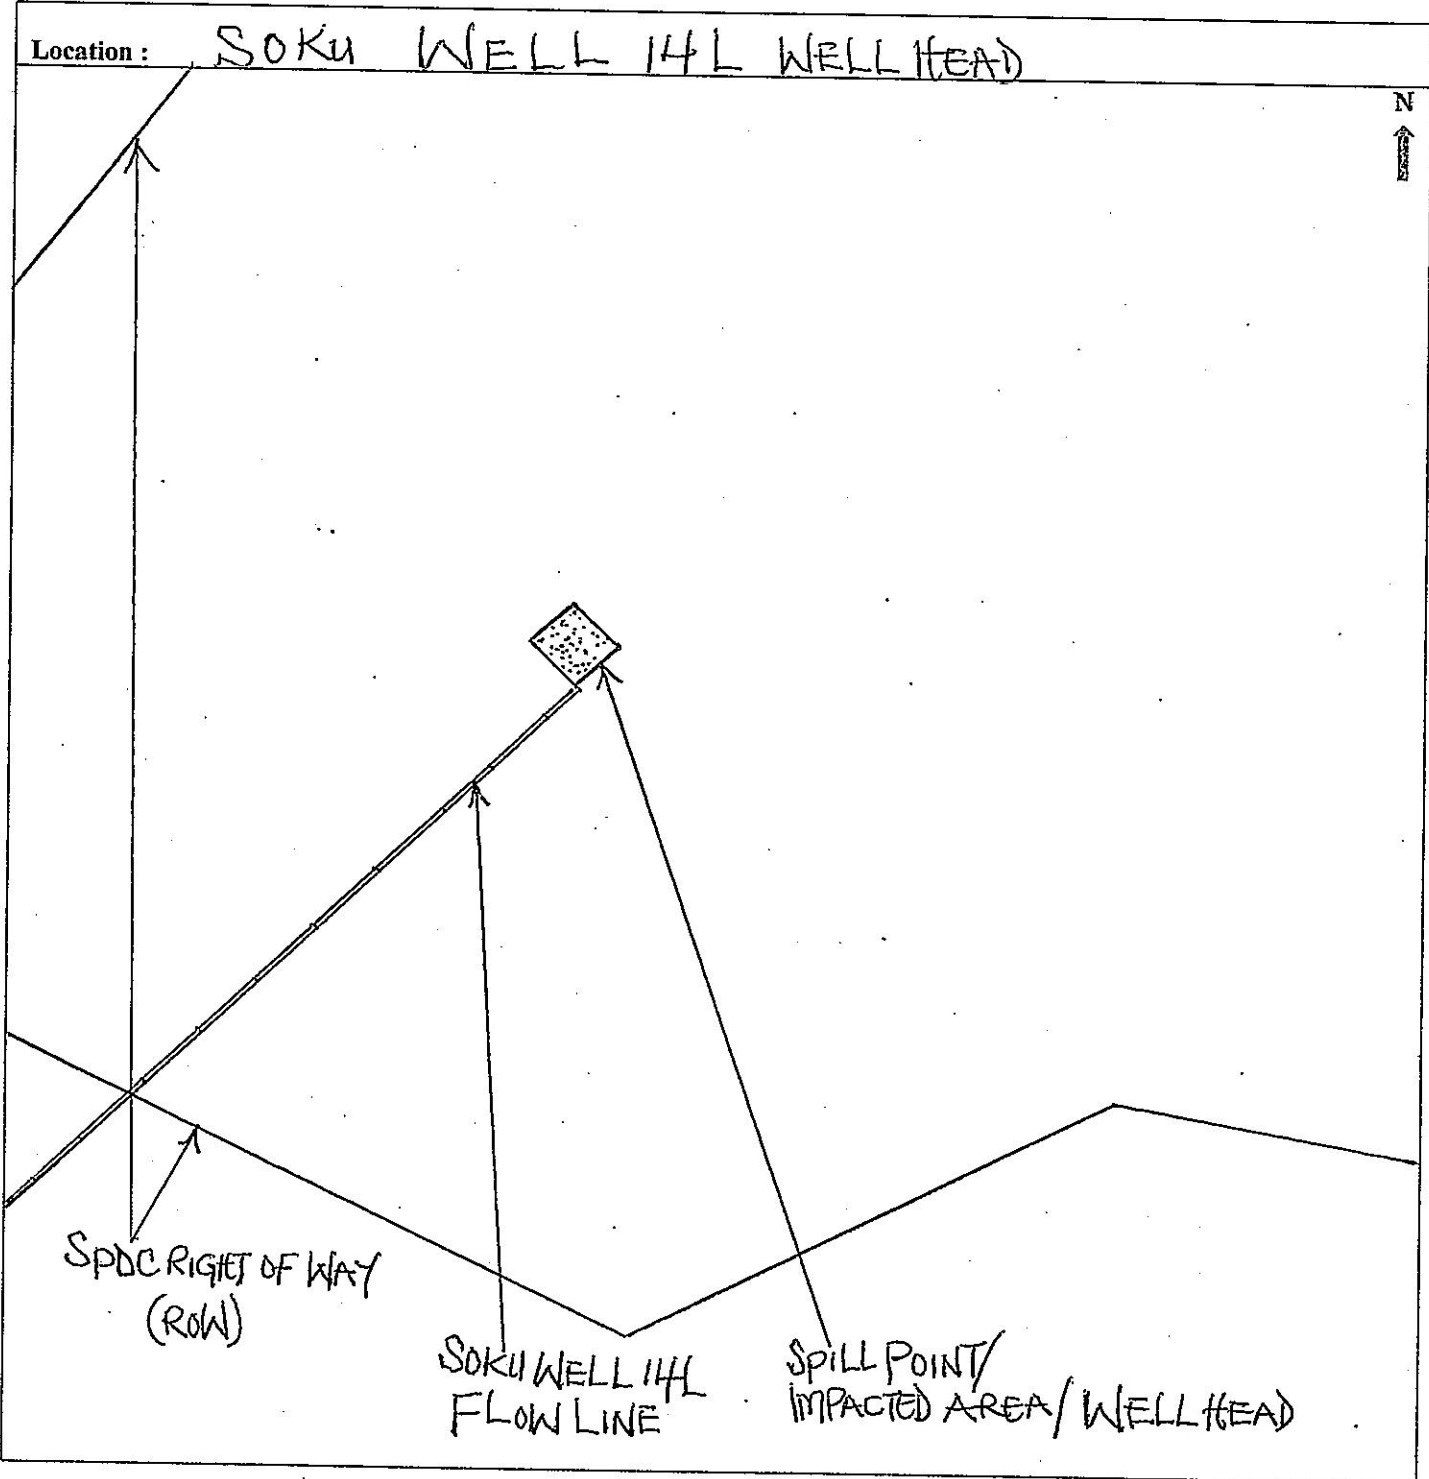
f. Appendix 1: Overview sketch of the site

Tear ( )  
 Others (specify) PARTIALLY CLOSED KEROTEX VALVE

**E. GRAPHIC DESCRIPTION OF LEAK POINT** *(while detailed description of the leak point should be contained in the leak report, overview sketch of the site should be added as appendix 1)* A SECTION OF SOKU WELL 14L WELL HEAD AT SOKU SHOWING A PARTIALLY CLOSED KEROTEX VALVE AFTER WELL HEAD MAINTENANCE

| i. Joint investigation of the incident site found that there is no residual impact after the initial response and JIT therefore recommend that the site be closed out <input checked="" type="checkbox"/> |
