# JOINT INVESTIGATION REPORT

INCIDENT NO: 2781793 JIV report S/N: 0620

1. Fountain Incident Number: 2781793 2. Type of incident\* OIL SPILL  
3. Name of Location 12" IMOR I - OGALE PIPELINE  
4. Name of nearest community OKOJIA 5. State: ABIA 6. LGA UKWA WEST  
7. Production Facility/Installation PIPELINE  
8. Asset Owner/Hub THE SHELL PETROLEUM DEVELOPMENT COMPANY OF NIGERIA LIMITED (SPDC)/PIPELINE

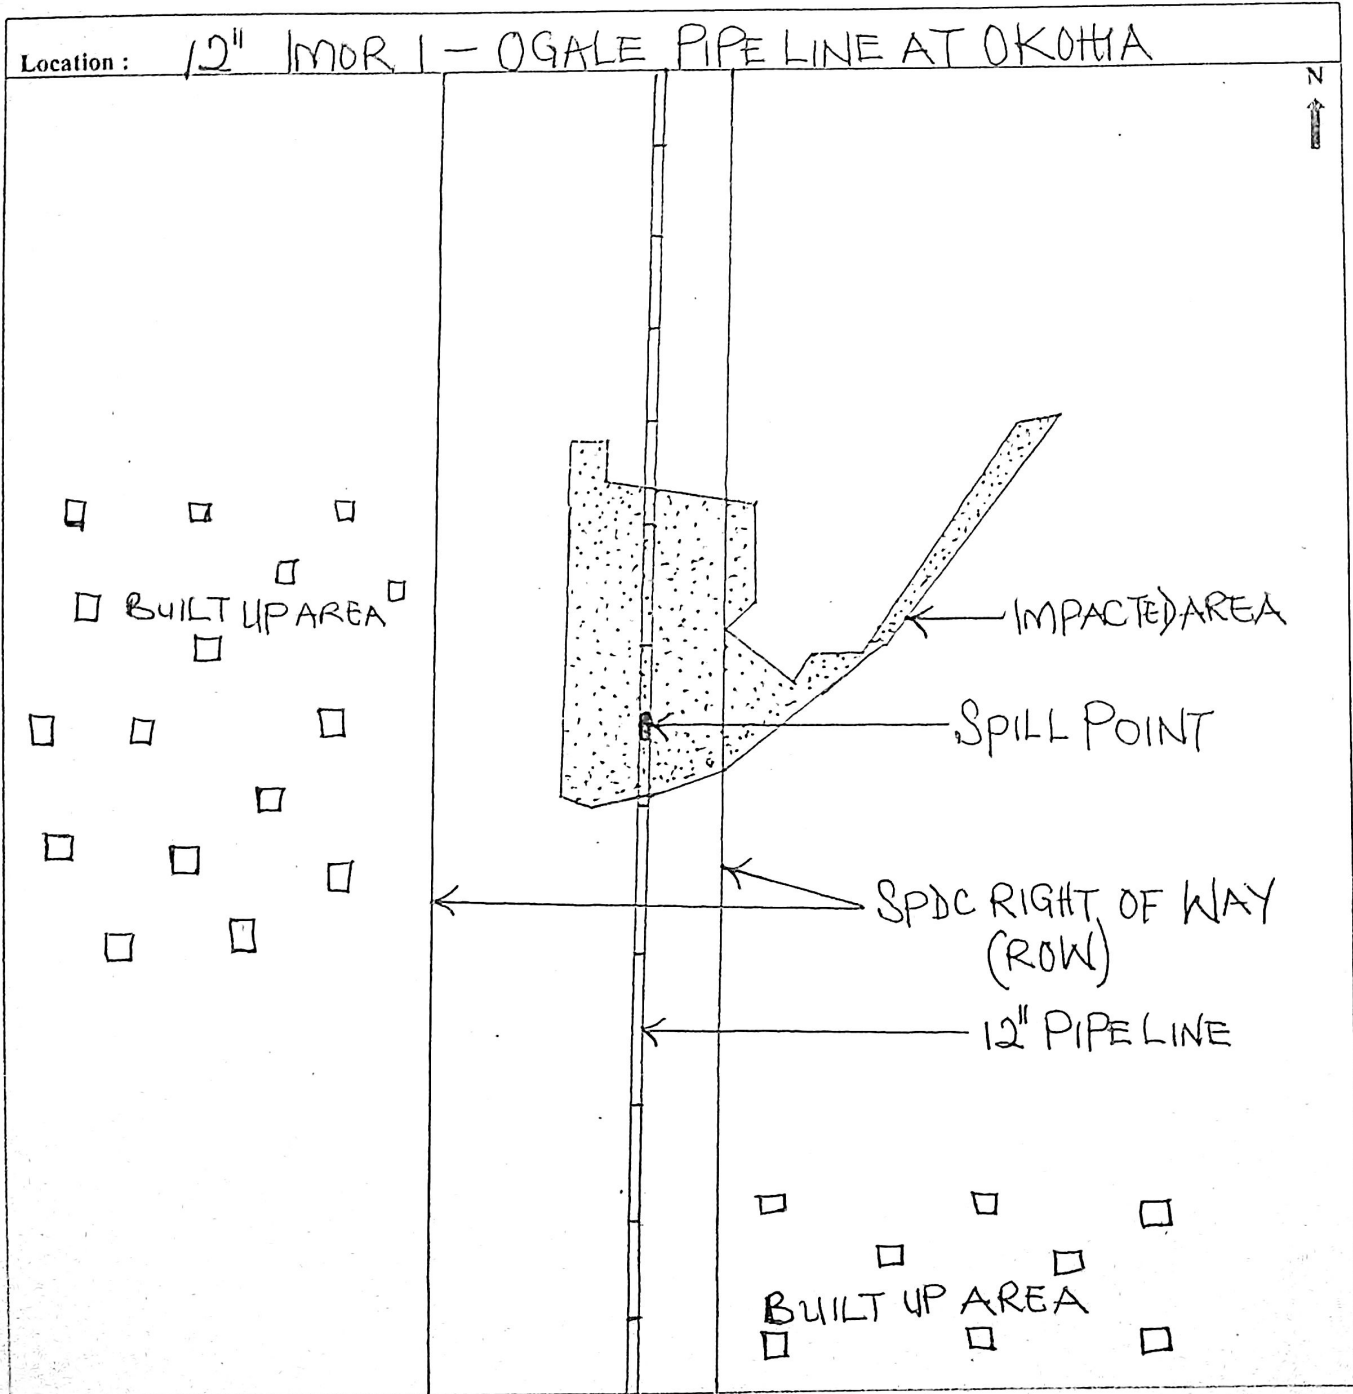
f. Appendix 1: Overview sketch of the site

**E. GRAPHIC DESCRIPTION OF LEAK POINT** (while detailed description of the leak point should be contained in the leak report, overview sketch of the site should be added as appendix 1) A SECTION OF 12" IMOR 1 - OGALE PIPE LINE AT OKOTIA SHOWING A LOCAL FABRICATED CLAMP FITTED WITH 1/2" VALVE INSTALLED AT 12 O'CLOCK POSITION BY UNKNOWN PERSON(S).
