JOINT INVESTIGATION REPORT

INCIDENT NO: 2730748 JV report SN: 0583

1. Facility Incident Number 2730748 & Type of Incident FIRE / OIL SPILL
2. Name of Location 8th ISIMIRI - IMO RIVER GAZ DELIVERAYLINE
3. Name of nearest community UNDELECHI near ABIA & LGA UKWA-NWEST
4. Production Facility Name OIL PIPELINE
5. Asset Owner Name THE SHELL PETROLEUM DEVELOPMENT COMPANY OF NIGERIA LIMITED / PIPELINE

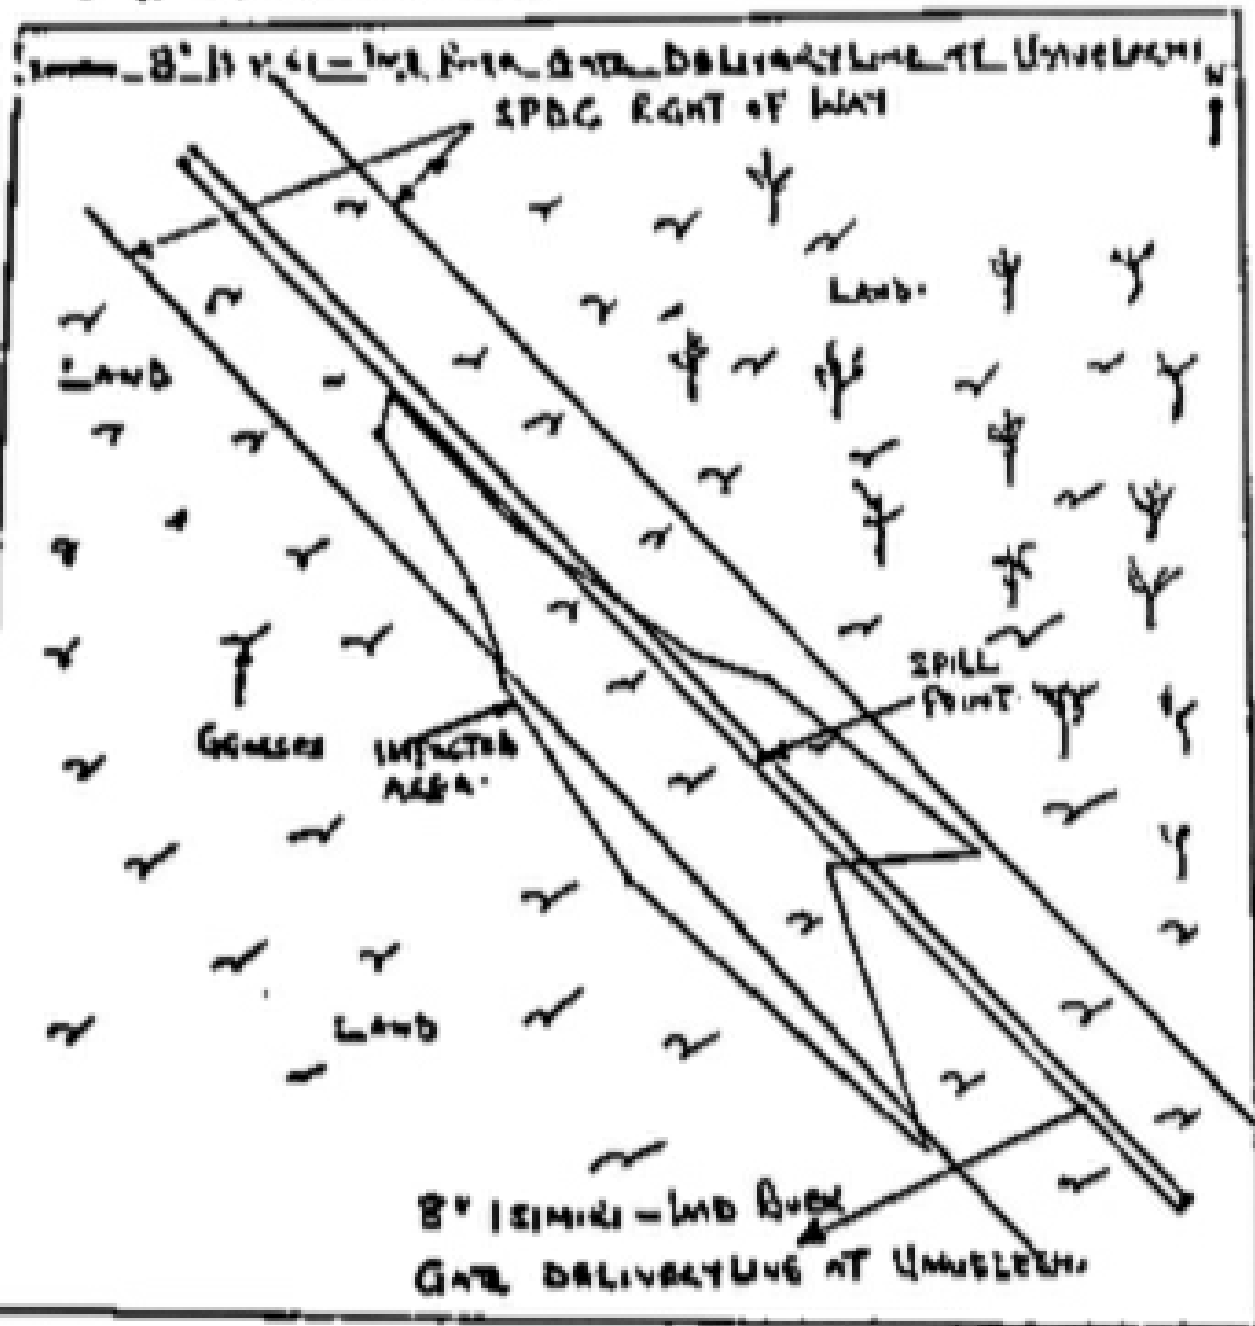
1. Appendix 1. Overview sketch of the site

| <input checked="" type="checkbox"/> Weld failure (crack) hot tap valve | <input type="checkbox"/> Flare Clang | <input type="checkbox"/> Moving Pipeline/flow line |

SECTIONAL VIEW OF 8" ISIMIRI - IND RIVER GATE DRIVEWAY LINE AT UMUELECHI SHOWING: A 2" FAILED BALL VALVE INSTALLED AT 12' O'CLOCK POSITION.
