JOINT INVESTIGATION REPORT

INCIDENT NO: 2843235 JIV report S/N:

1. Fountain Incident Number: 2843235 2. Type of incident* OIL SPILL
3. Name of Location 4" IMO RIVER 2-1 TEST LINE AND 2" IMO RIVER 1-2 GASLIFT LINE
4. Name of nearest community IGIRUKWO 5. State: ABIA 6. LGA UKWA WEST
7. Production Facility/Installation TEST LINE
8. Asset Owner/Hub THE SHELL PETROLEUM DEVELOPMENT COMPANY OF NIGERIA LIMITED (SPDC)

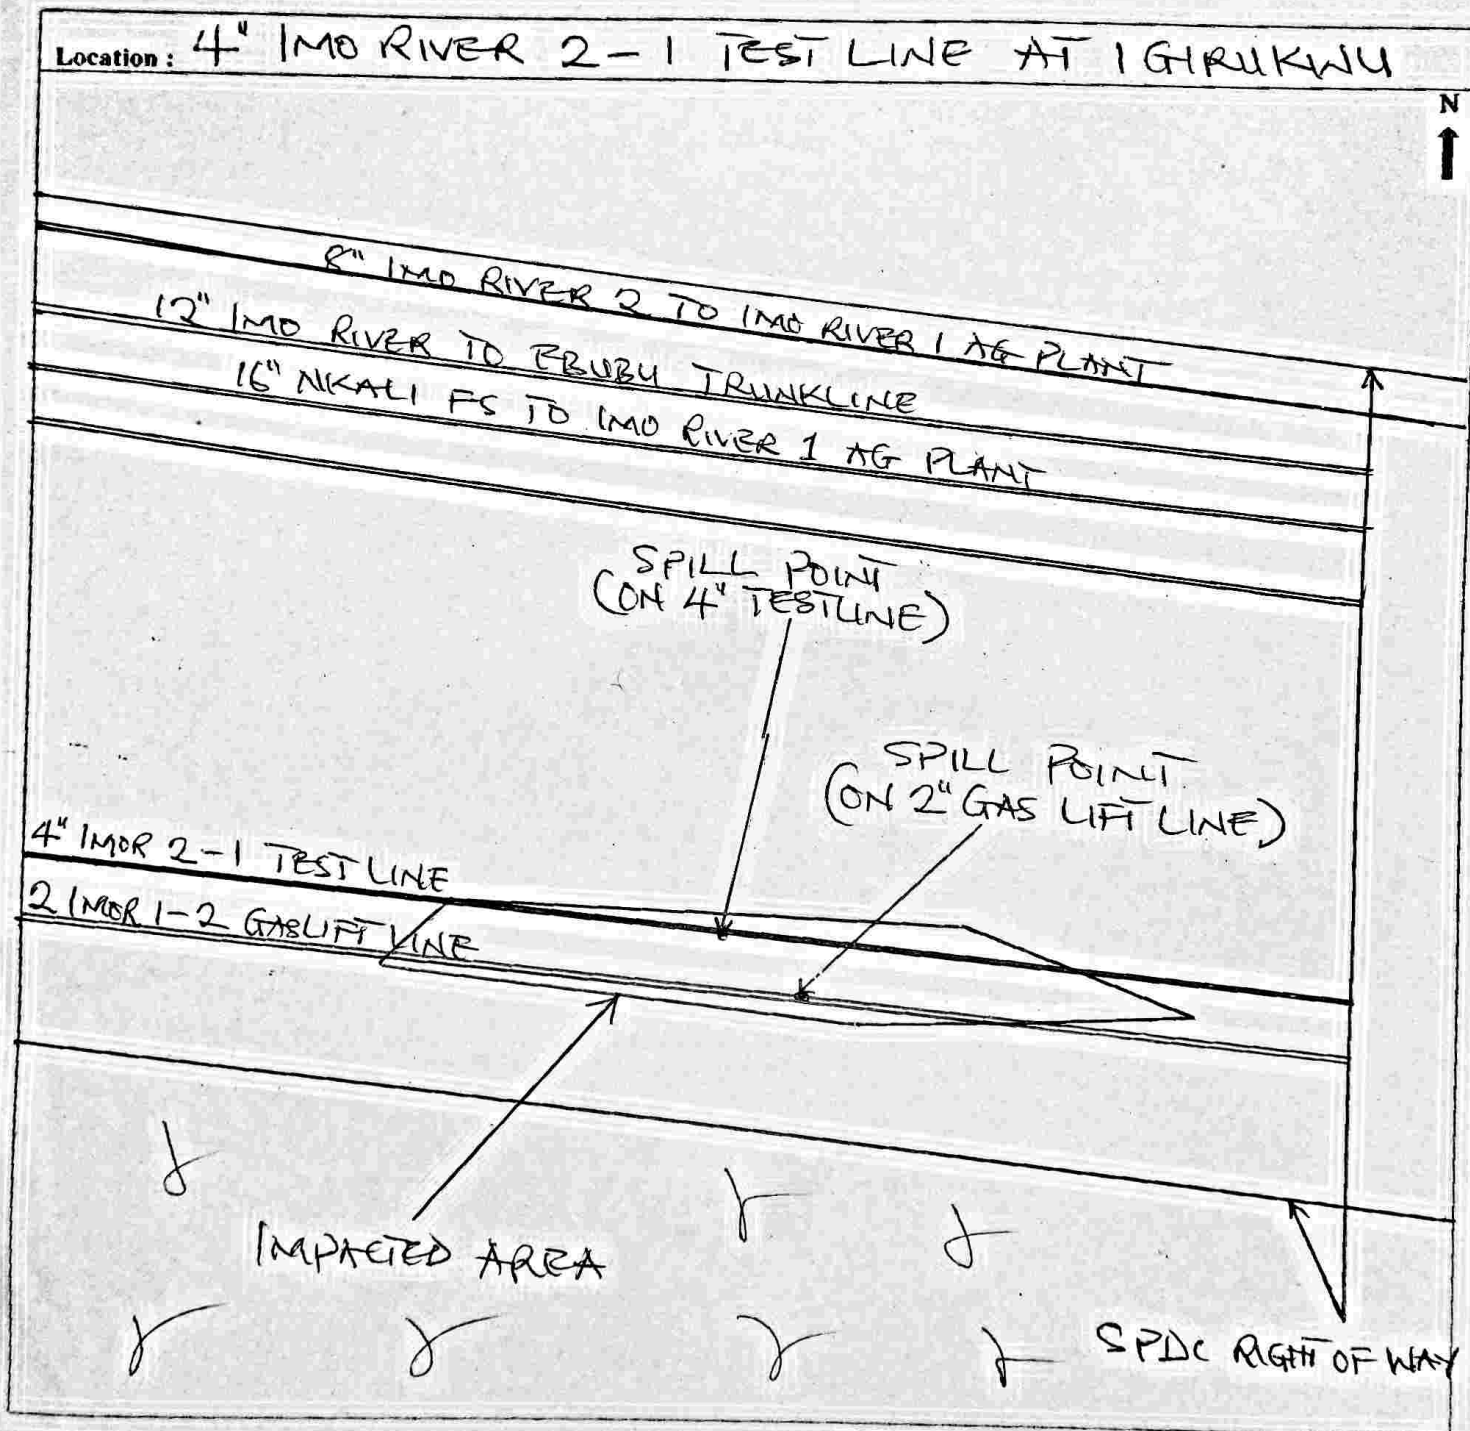
f. Appendix 1: Overview sketch of the site

Additional observations around the spill point: THE JOINT INVESTIGATION TEAM OBSERVED A HACKSAW CUT (38MM LONG) AT 10-8 O'CLOCK POSITION ON THE 2" IMO RIVER 1-2 GASLIFT LINE PARALLEL TO THE 4" IMO RIVER 2-1 TEST LINE

E. GRAPHIC DESCRIPTION OF LEAK POINT (while detailed description of the leak point should be contained in the leak report, overview sketch of the site should be added as appendix 1) SECTIONS OF 4" IMO RIVER 2-1 TESTLINE AT IGIRUKWU SHOWING A HACKSAW CUT AT 10-7 O'CLOCK POSITION AND 2" IMO RIVER GASLIFT LINE SHOWING A HACKSAW CUT AT 10-8 O'CLOCK POSITION CAUSED BY UNKNOWN PERSONS

REPAIR BY CLAMPING ONGOING
