# JOINT INVESTIGATION REPORT

INCIDENT NO: 3046649 JIV report S/N: 0001049

1. Fountain Incident Number: 3046649 2. Type of incident\* OIL SPILL  
3. Name of Location 18" ASSA - RUMUKEPE PIPELINE  
4. Name of nearest community DCHIA 5. State: IMO 6. LGA OHAJI EGBENIA  
7. Production Facility/Installation CRUDE OIL PIPELINE  
8. Asset Owner/Hub THE SHELL PETROLEUM DEVELOPMENT COMPANY  
OF NIGERIA LIMITED / PIPELINE

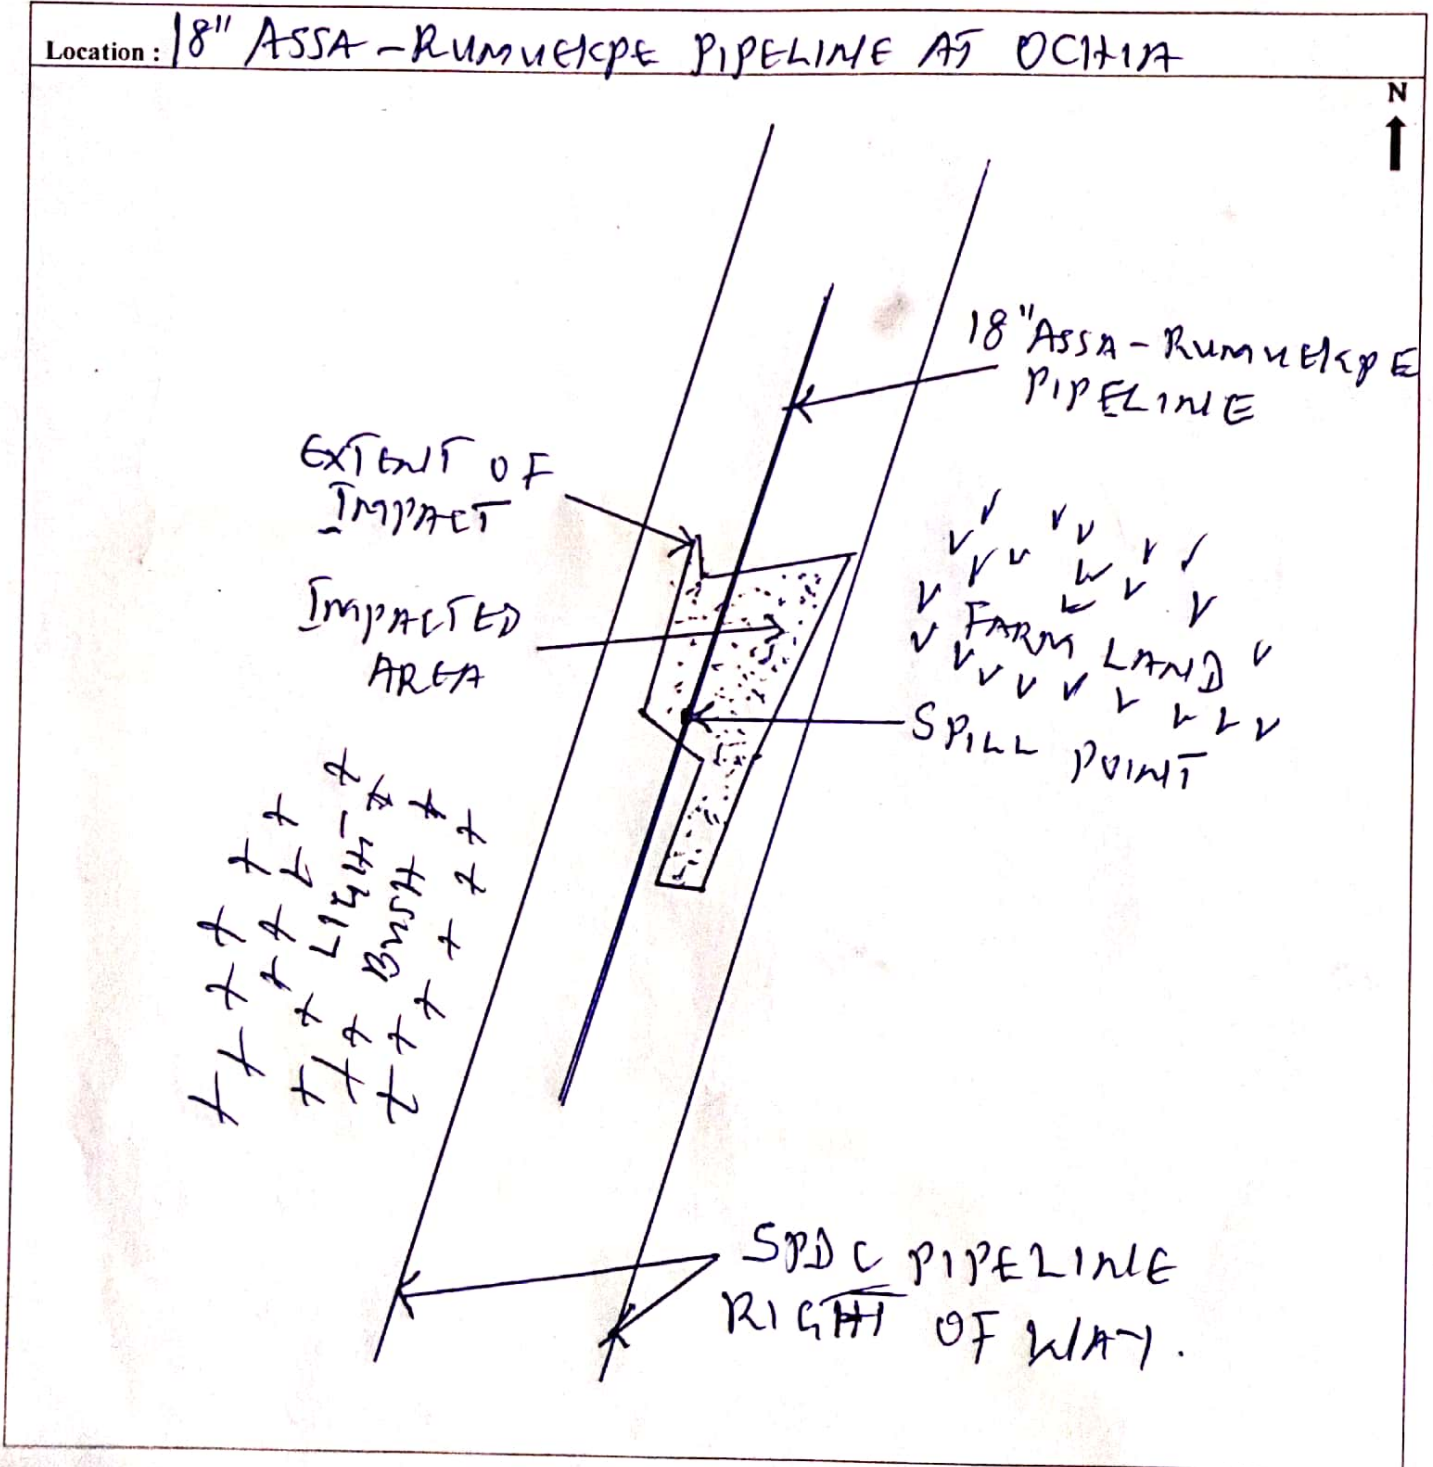
## f. Appendix 1: Overview sketch of the site

Additional observations around the spill point: DURING THE JOINT INVESTIGATION VISIT, THE TEAM OBSERVED LEAK FROM THE EARLIER REPORTED NON LEAKING POINT OF ILLEGAL CONNECTION WITH FID: 2461898. FLEXIBLE HOSES WERE ALSO OBSERVED.

| <input checked="" type="checkbox"/> Failed Weld-on illegal hot tap valve | <input type="checkbox"/> Failed Clamp, | <input type="checkbox"/> Missing Pipeline/Flowline |
