# JOINT INVESTIGATION REPORT

INCIDENT NO: 3029566 JIV report S/N: 0001015

1. Fountain Incident Number: 3029566 2. Type of incident\* OIL SPILL  
3. Name of Location 20" TRANS ESCRAVOS PIPELINE  
4. Name of nearest community UGBOGUNGUN State: DELTA 6. LGA WARRI SOUTH WEST  
7. Production Facility/Installation PIPELINE  
8. Asset Owner/Hub THE SHELL PETROLEUM DEVELOPMENT COMPANY NIGERIA LIMITED / PIPELINE

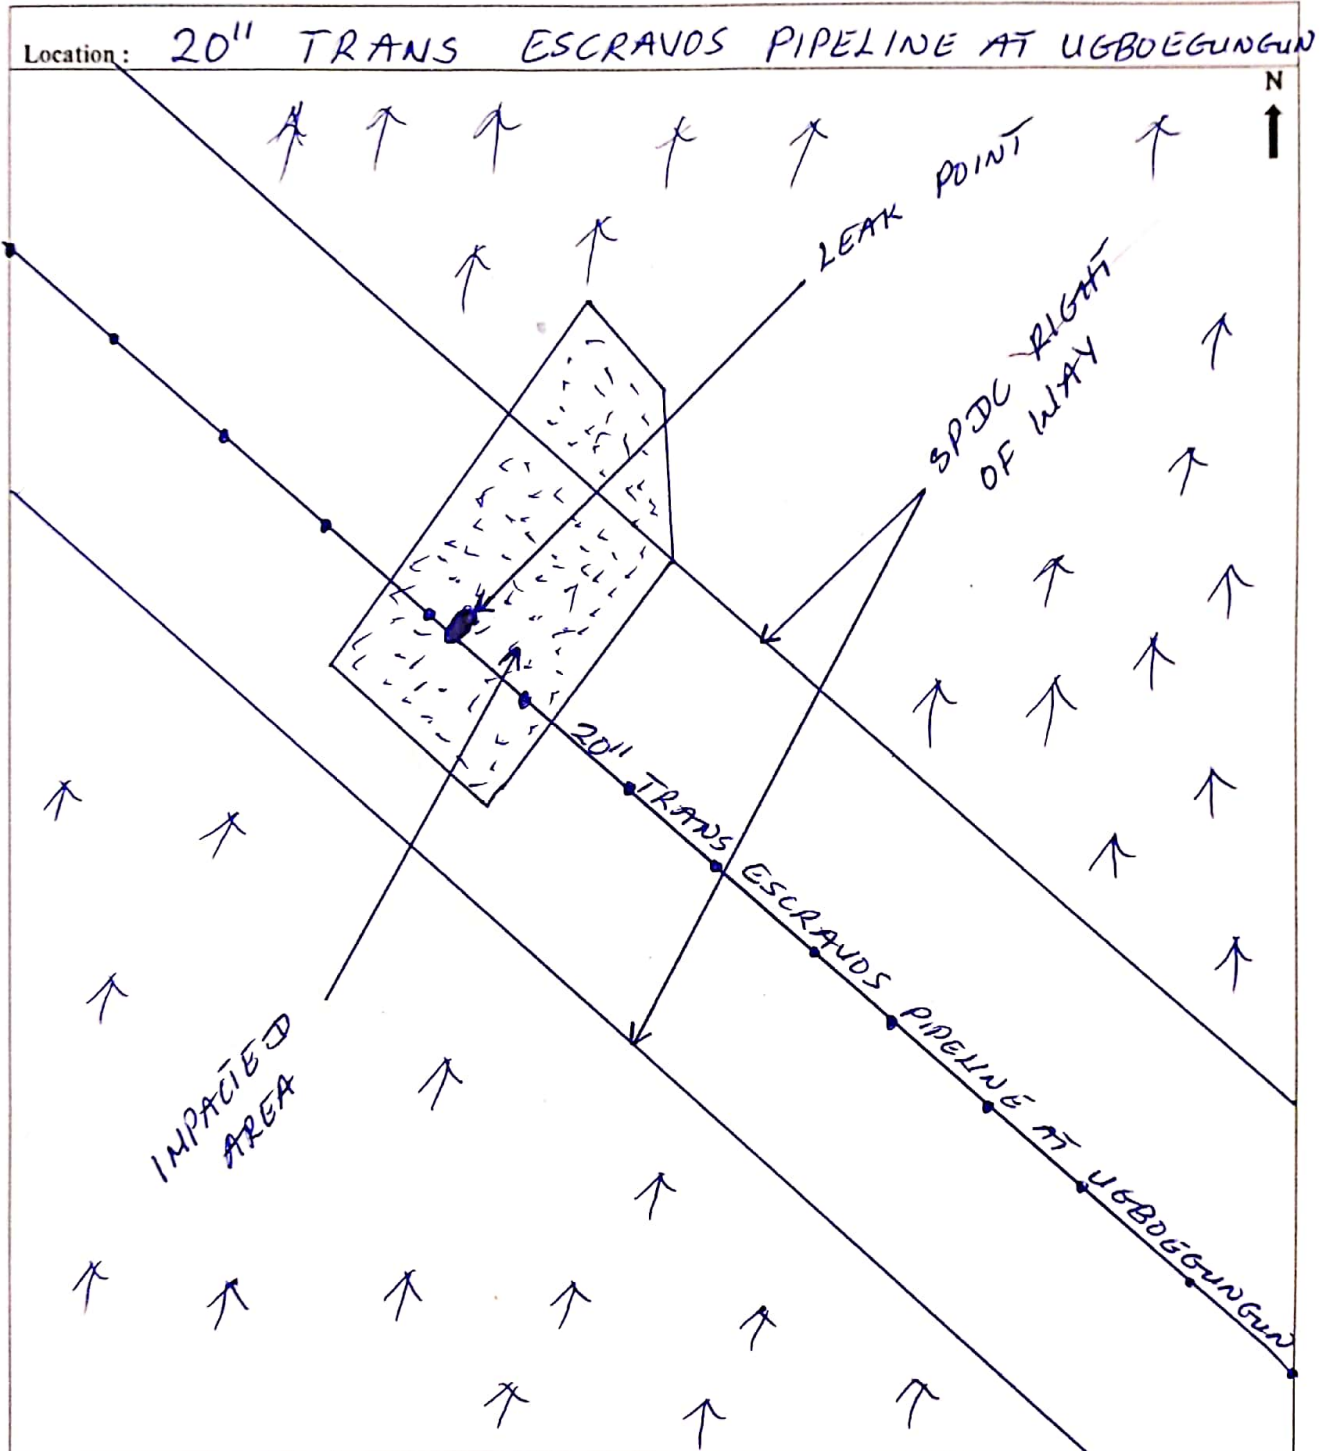
## f. Appendix 1: Overview sketch of the site

| <input checked="" type="checkbox"/> Others (specify) <u>A PIN HOLE DUE TO CORROSION</u> | | |
