JOINT INVESTIGATION REPORT

INCIDENT NO: 2060312 JIV report S/N: 1075

1. Spill incident Number: 2060312 2. Type of incident* OIL SPILL
3. Name of Location 18" ASSA - RUMUEKPE PIPELINE
4. Name of nearest community OCHIA 5. State: IMO 6. LGA OHAJI/EGBEMA
7. Type of Production facility/Installation OIL PIPELINE
8. Asset owner/District THE SHELL PETROLEUM DEVELOPMENT COMPANY OF NIGERIA LTD (SPDC) / PIPELINE

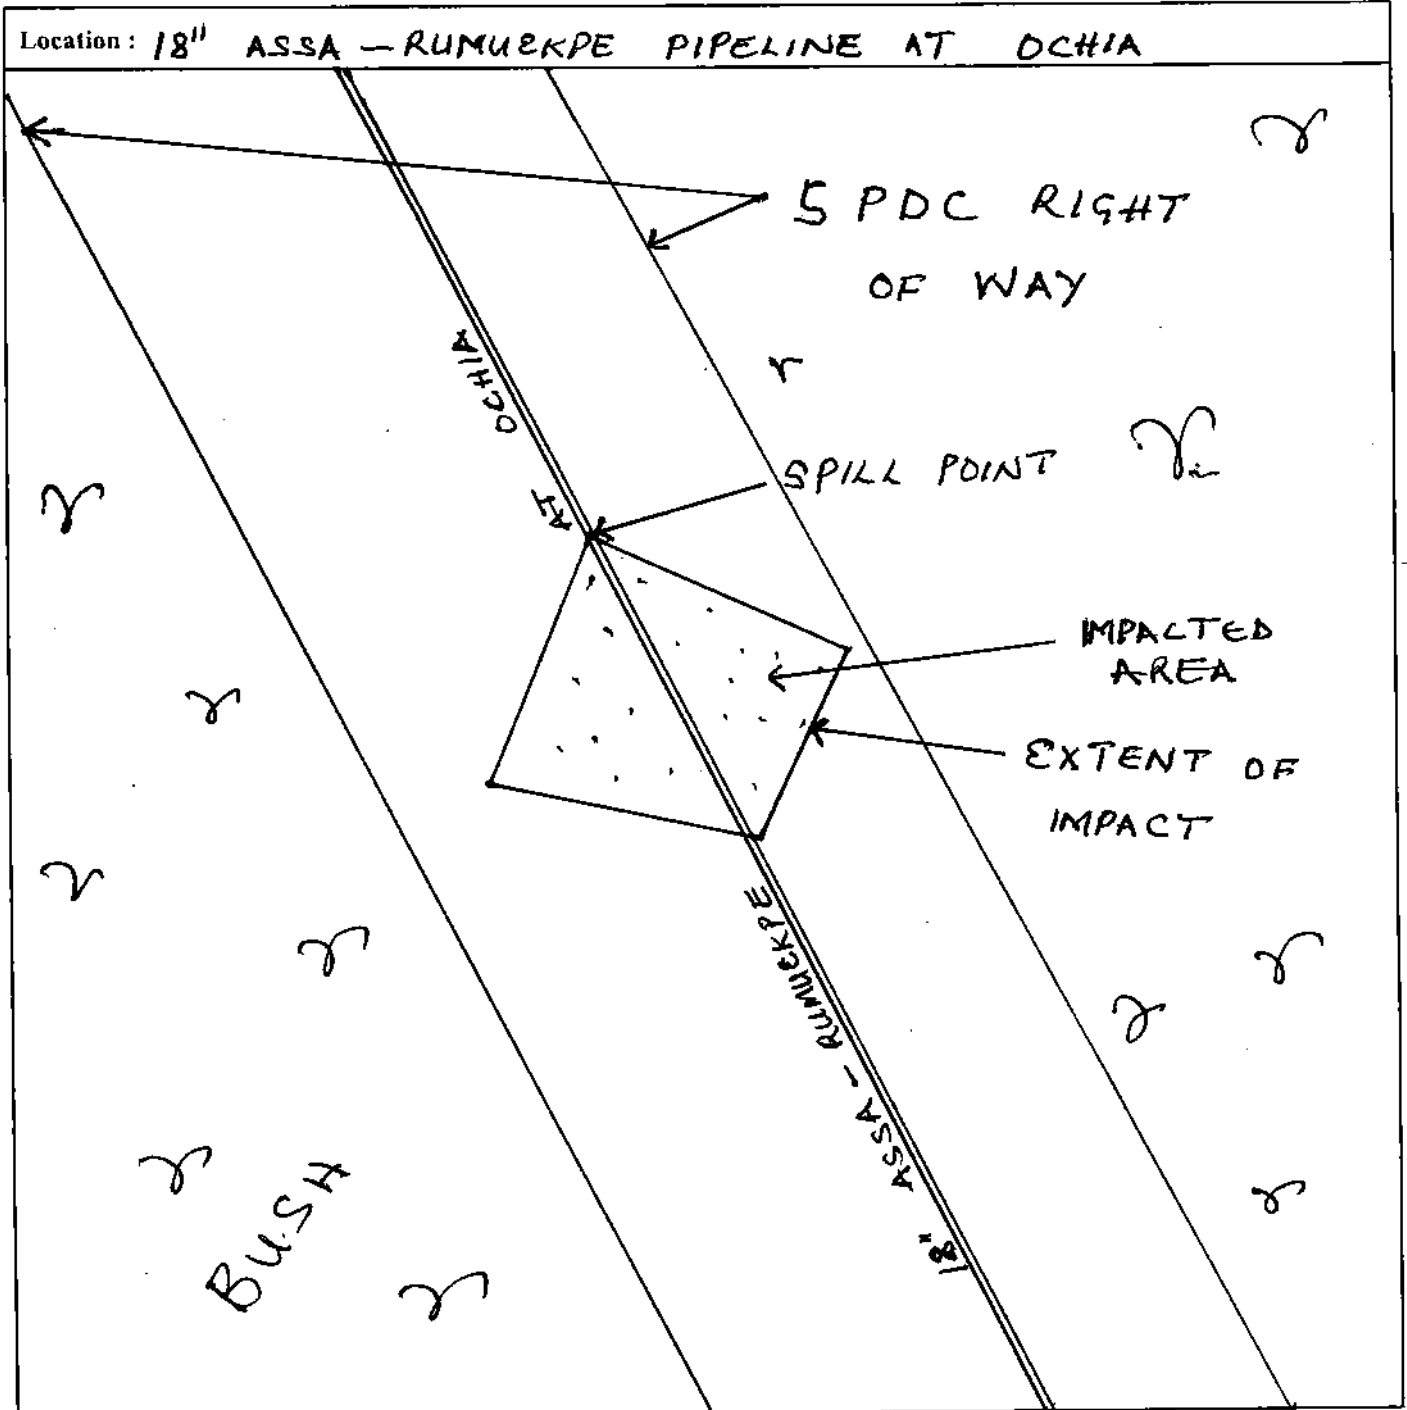
f. Appendix 1: Overview sketch of the site

Additional observations around the spill point: THE JOINT INVESTIGATION TEAM SAW (1) SAND BAGS DURING EXCAVATION (2) A 2" PIPE CONNECTED AT 12 O'CLOCK POSITION WITH 2" VALVES CONNECTED TO THE 2" PIPE

REPAIR BY CLAMPING
