JOINT INVESTIGATION REPORT

INCIDENT NO: 1408364 JIV report S/N: Nº 0000003

1. Spill incident Number: 1408364 2. Type of incident* OIL SPILL AND FIRE
3. Name of Location 28" Nkpoku - Boma Pipeline
4. Name of nearest community KPOGHOR AND GIO 5. State: RIVERS 6. LGA TAI
7. Type of Production facility/Installation OIL PIPELINE
8. Asset owner/District SPDC / PIPELINE

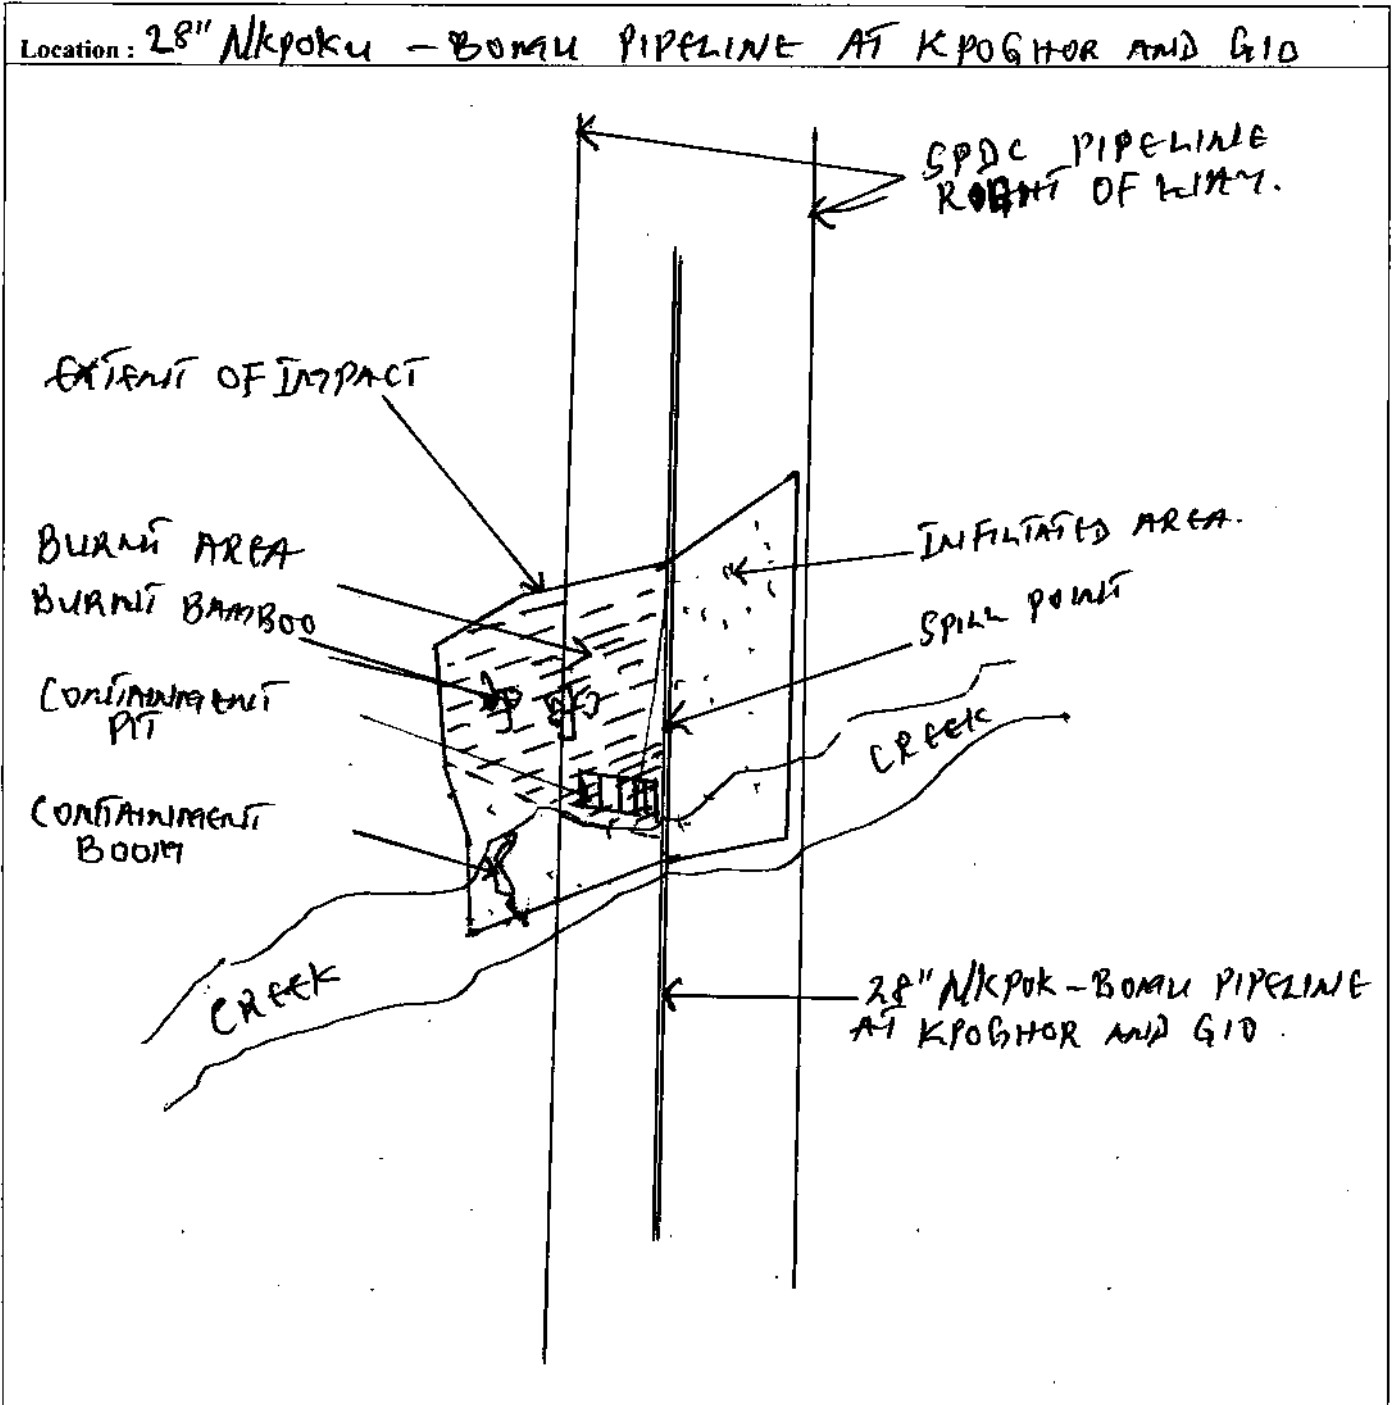
f. Appendix 1: Overview sketch of the site

Additional observations around the spill point: DURING THE JOINT INVESTIGATION VISIT, THE TEAM NOTICED THAT EFFECTIVE PART OF HACK SAW CUT WAS PLUGGED.

RECOVERY ACTIVITIES ONGOING.
REPAIR WORK WAS DONE BY CHIPPING.
