JOINT INVESTIGATION REPORT

INCIDENT NO: 1628051 JIV report S/N: Nº 0000159

1. Spill incident Number: 1628051 2. Type of incident* OIL SPILL
3. Name of Location IBAA MANIFOLD 8" HEADER.
4. Name of nearest community IBAA 5. State: RIVERS 6. LGA EMOTHUA.
7. Type of Production facility/Installation MANIFOLD
8. Asset owner/District THE SHELL PETROLEUM DEVELOPMENT COMPANY OF NIGERIA LIMITED.

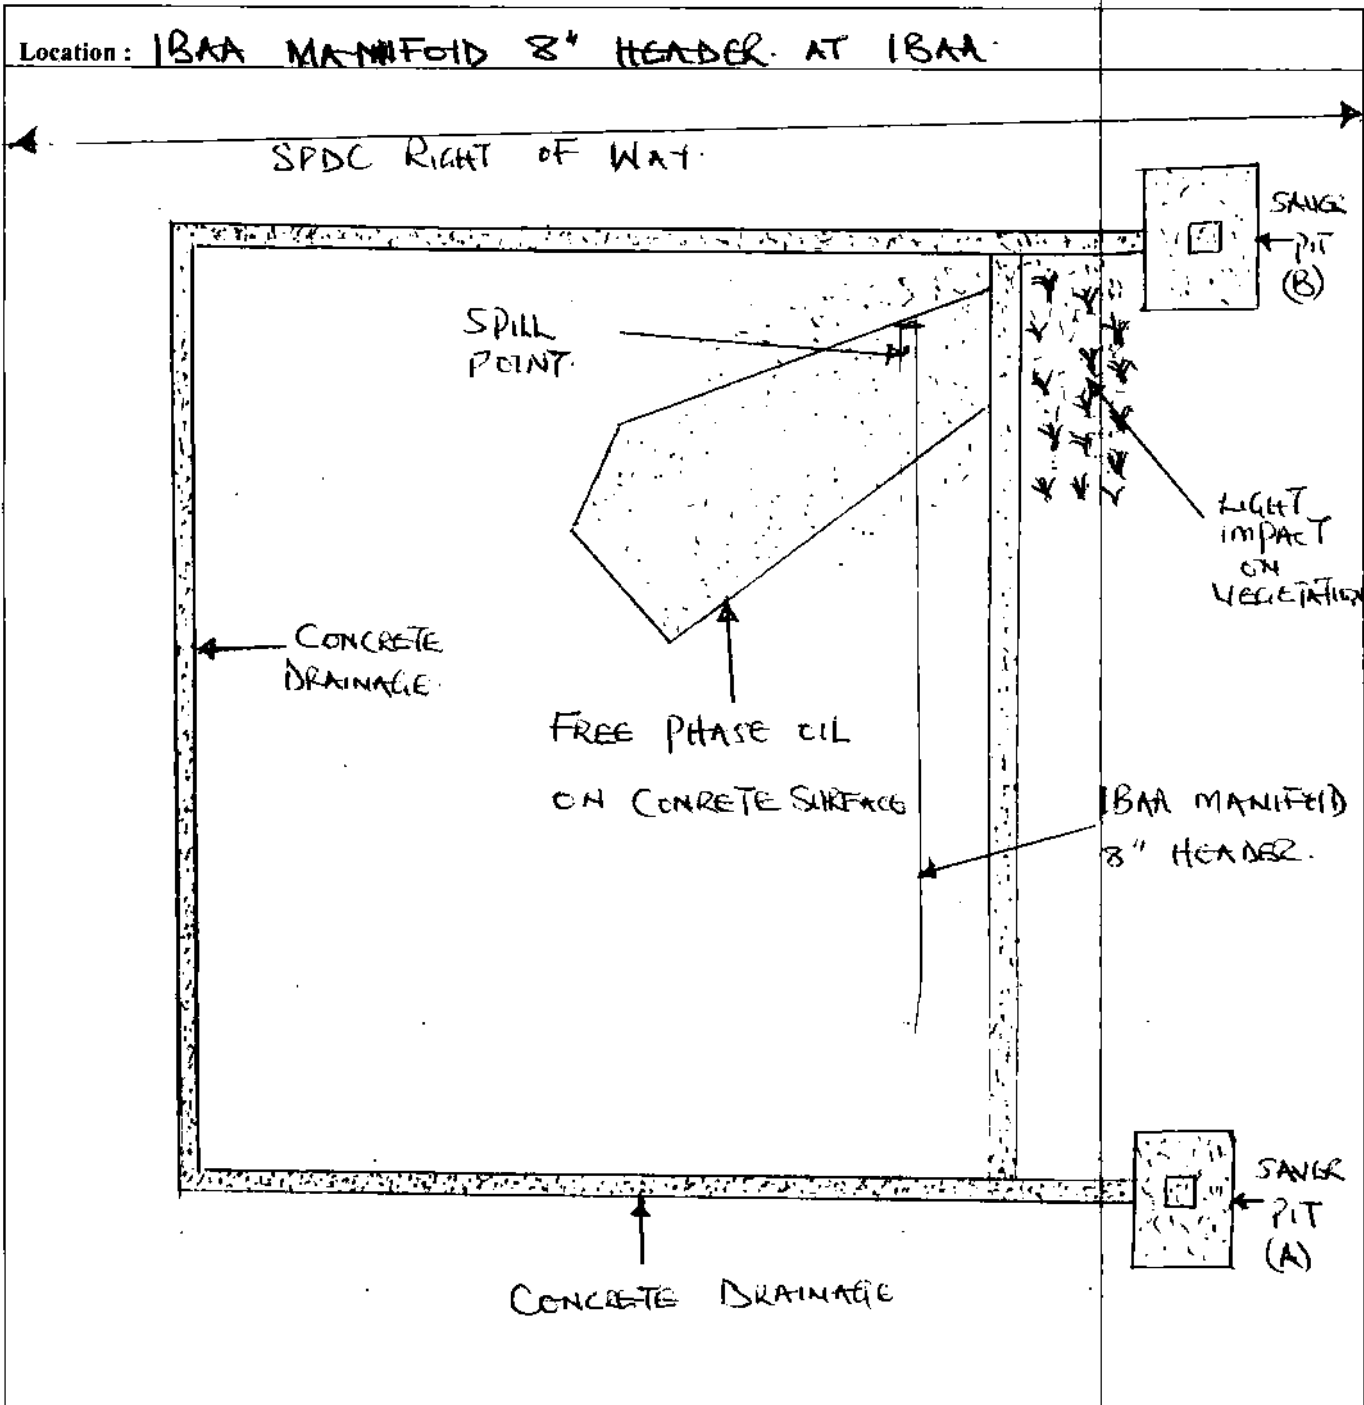
f. Appendix 1: Overview sketch of the site

SECTIONAL VIEW OF IBAA MANIFOLD 8" HEADER AT IBAA, SHOWING
LEAK DUE TO (INTERNAL) CORROSION WITH 5mm RUPTURE.

LEAK IS DUE TO 5mm DIAMETER
RUPTURE CAUSE BY (INTERNAL)
CORROSION:

SPILL WAS SIGNIFICANTLY CONTAINED WITHIN THE CONCRETE SURFACED MANIFOLD BASE INCLUDING ITS INTERNAL PERIMETER DRAINAGES, THEREBY LIMITING OIL INFILTRATION IN SOIL.
