# JOINT INVESTIGATION REPORT

INCIDENT NO: 1863621 JIV report S/N:

1. Spill incident Number: 1863621 2. Type of incident\* OIL SPILL  
3. Name of Location 12" IMO RIVER - OGAE PIPELINE  
4. Name of nearest community LUZUAKU 5. State: ABIA 6. LGA LIKWA WEST  
7. Type of Production facility/Installation OIL PIPELINE  
8. Asset owner/District THE SHELL PETROLEUM DEVELOPMENT COMPANY OF NIGERIA LTD  
(SPDC)

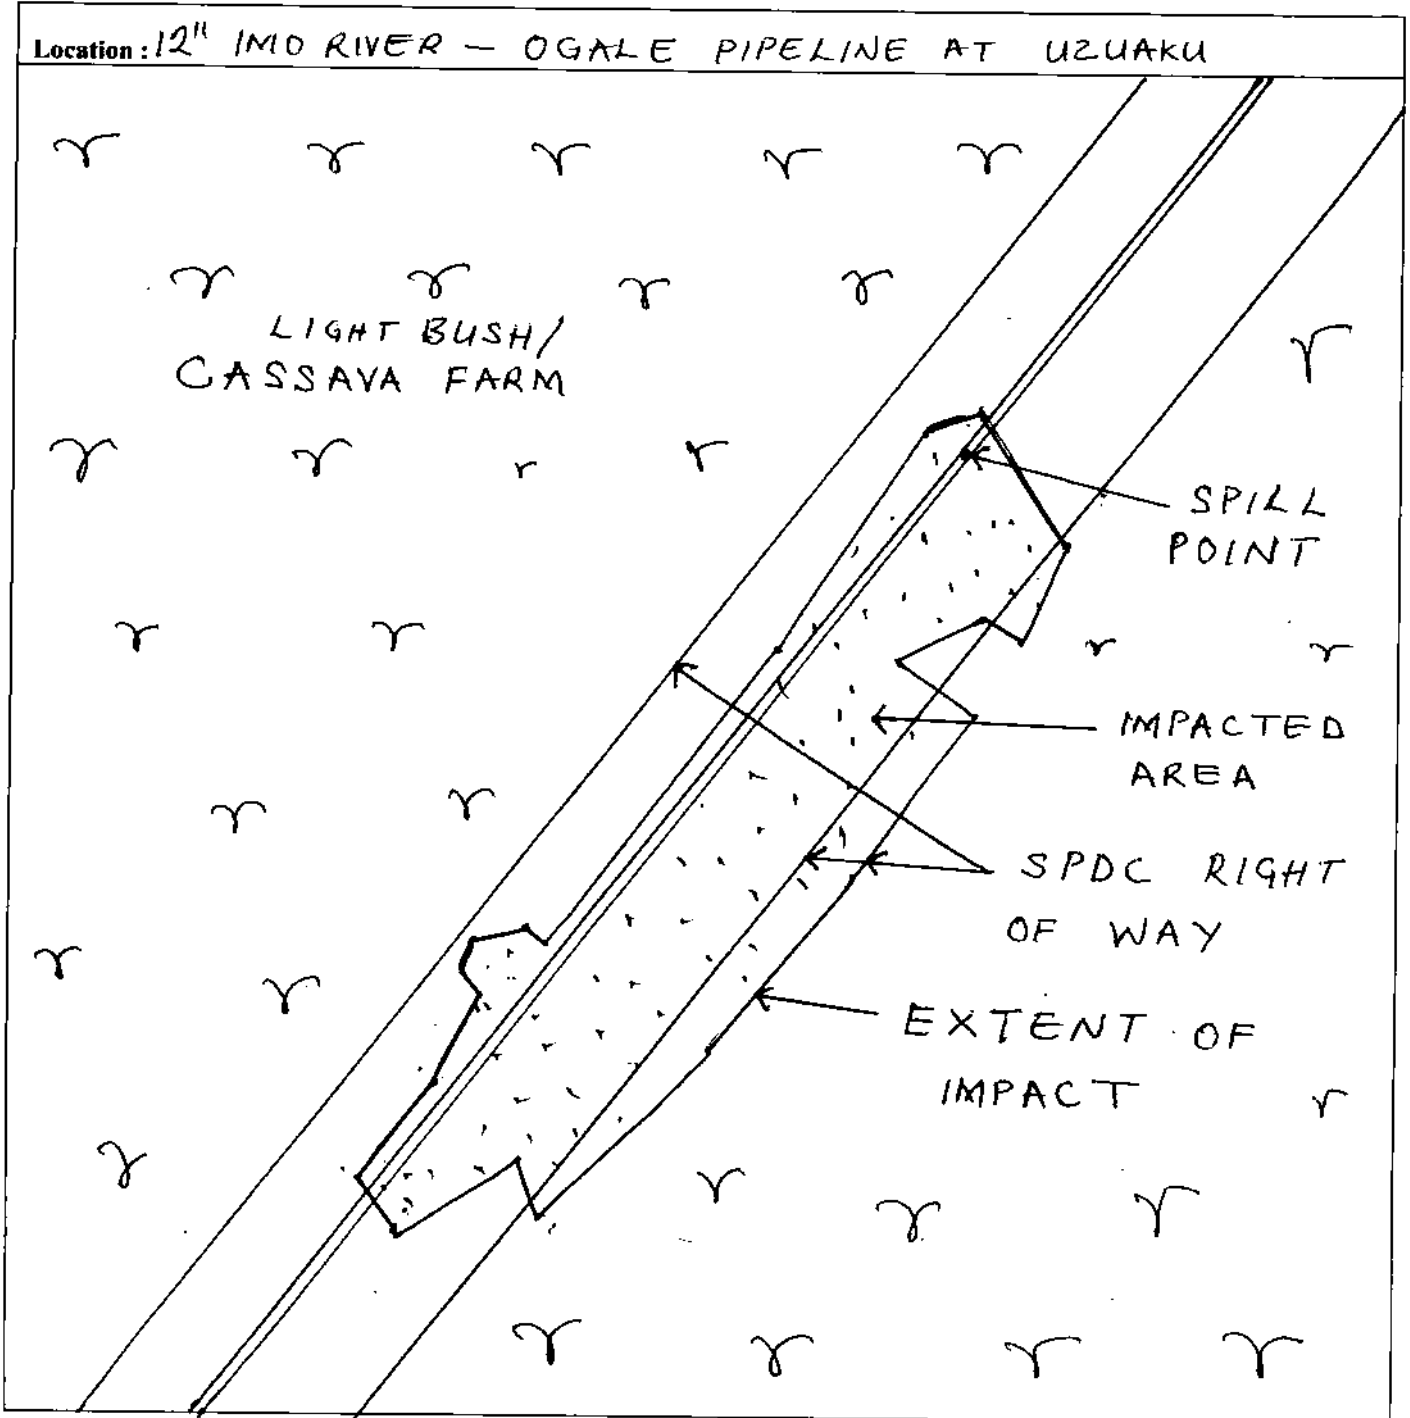
f. Appendix I: Overview sketch of the site

Additional observations around the spill point: THE JOINT INVESTIGATION TEAM SAW A DRILLED HOLE AT 12 O'CLOCK POSITION.

**E. GRAPHIC DESCRIPTION OF LEAK POINT** (while detail report of the leak point should be contained in the leak report, overview sketch of the site should be added as an appendix 1) A SECTION OF 12" IMORIVER - OGALE PIPELINE AT UZUAKU SHOWING A 1cm DRILLED HOLE AT 12 O'CLOCK POSITION BY UNKNOWN PERSONS.

REPAIR BY CLAMPING
