JOINT INVESTIGATION REPORT

INCIDENT NO: 1528955 JIV report S/N: No 0000396

1. Spill incident Number: 1528955 2. Type of incident* OIL SPILL
3. Name of Location BENISEDE WELL-13T WELL HEAD
4. Name of nearest community OJOB0 5. State: BAYELSA LGA EKEREMDR
7. Type of Production facility/Installation WELL HEAD
8. Asset owner/District THE SHELL PETROLEUM DEVELOPMENT COMPANY OF NIGERIA LIMITED / SWAMP WEST

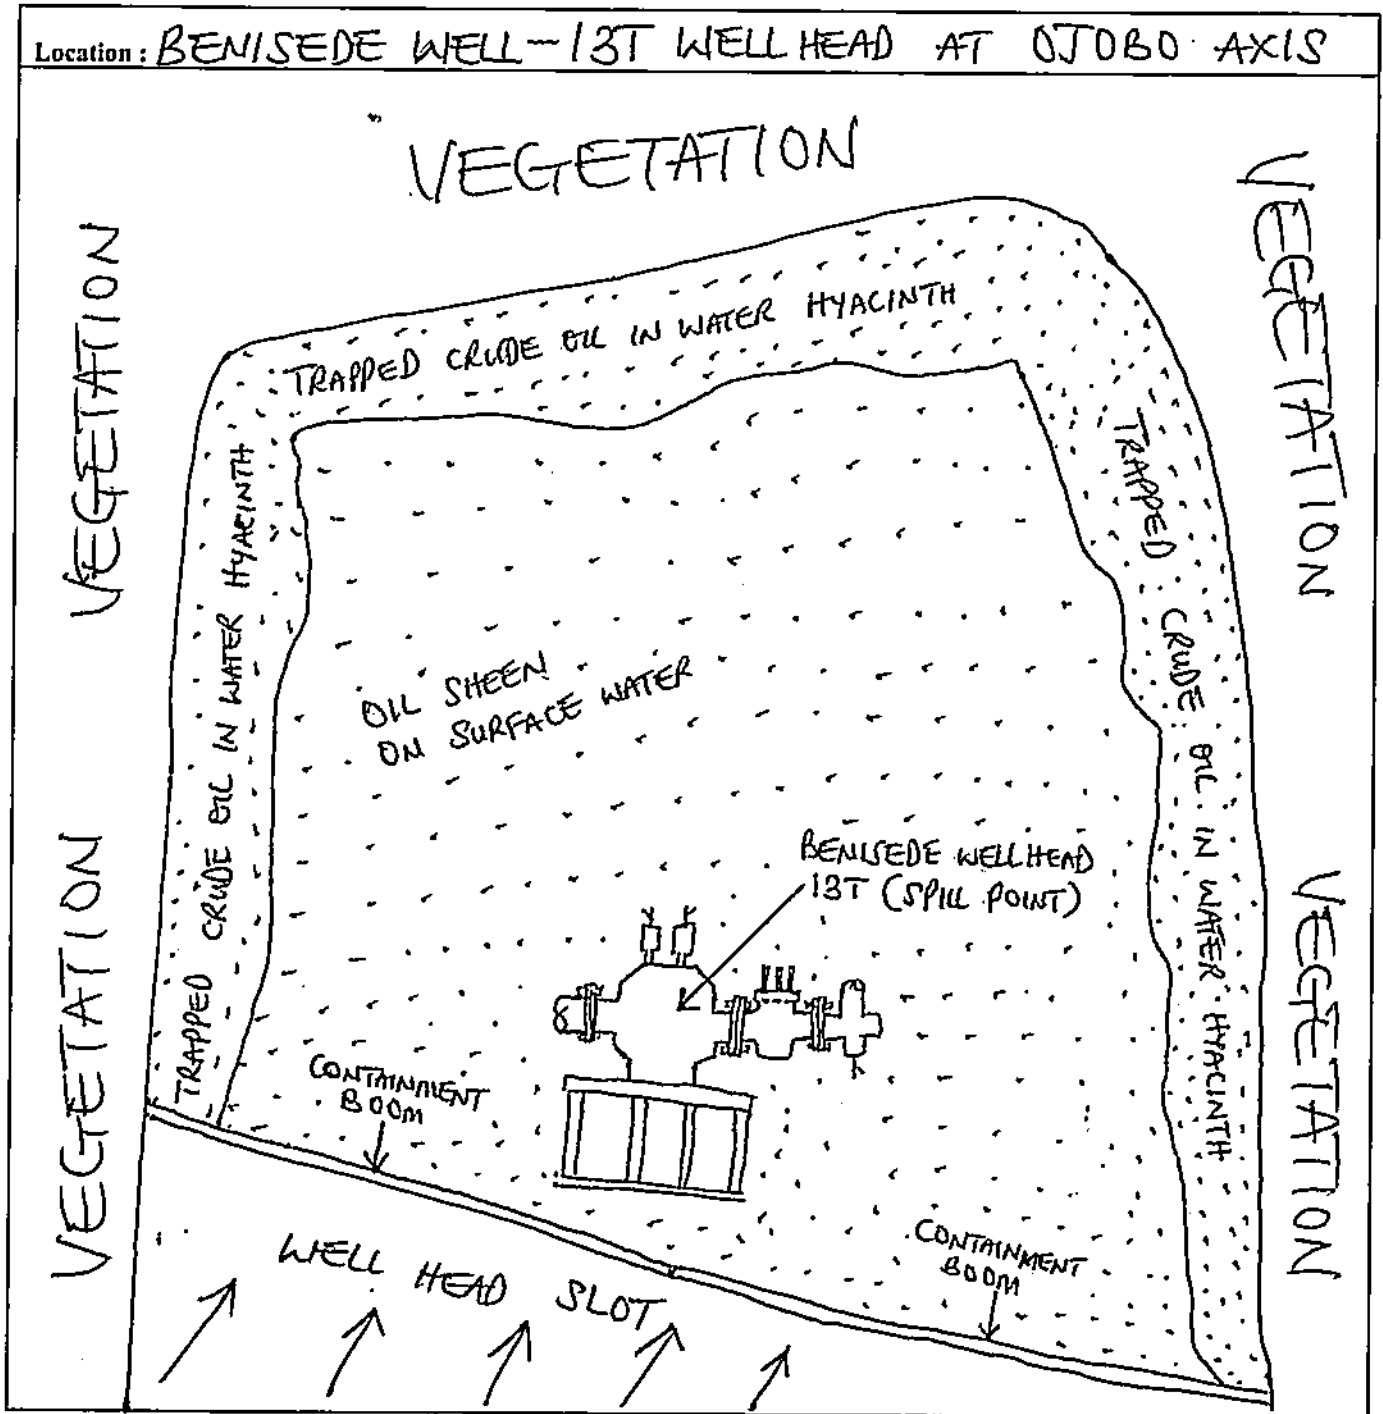
f. Appendix 1: Overview sketch of the site

Additional observations around the spill point: ON ARRIVAL AT SITE, THE JOINT INVESTIGATION TEAM OBSERVED THAT THE SURFACE SAFETY VALVE (SSV) ON BENISEDE WELL-13T WELL HEAD HAS BEEN REMOVED BY UNKNOWN PERSONS.
