# JOINT INVESTIGATION REPORT

INCIDENT NO: 2185038 JIV report S/N: 0165

1. Spill incident Number: 2185038 2. Type of incident\*: OIL SPILL  
3. Name of Location: 20" K. OLODCREEK - RUMUEKPE PIPELINE  
IMDQU -  
4. Name of nearest community: RUMUEKPE 5. State: RIVERS 6. LGA: EMOHUA  
7. Type of Production facility/Installation: OIL PIPELINE  
8. Asset owner/District: THE SHELL PETROLEUM DEVELOPMENT COMPANY OF NIGERIA LTD  
(SPDC) / PIPELINE

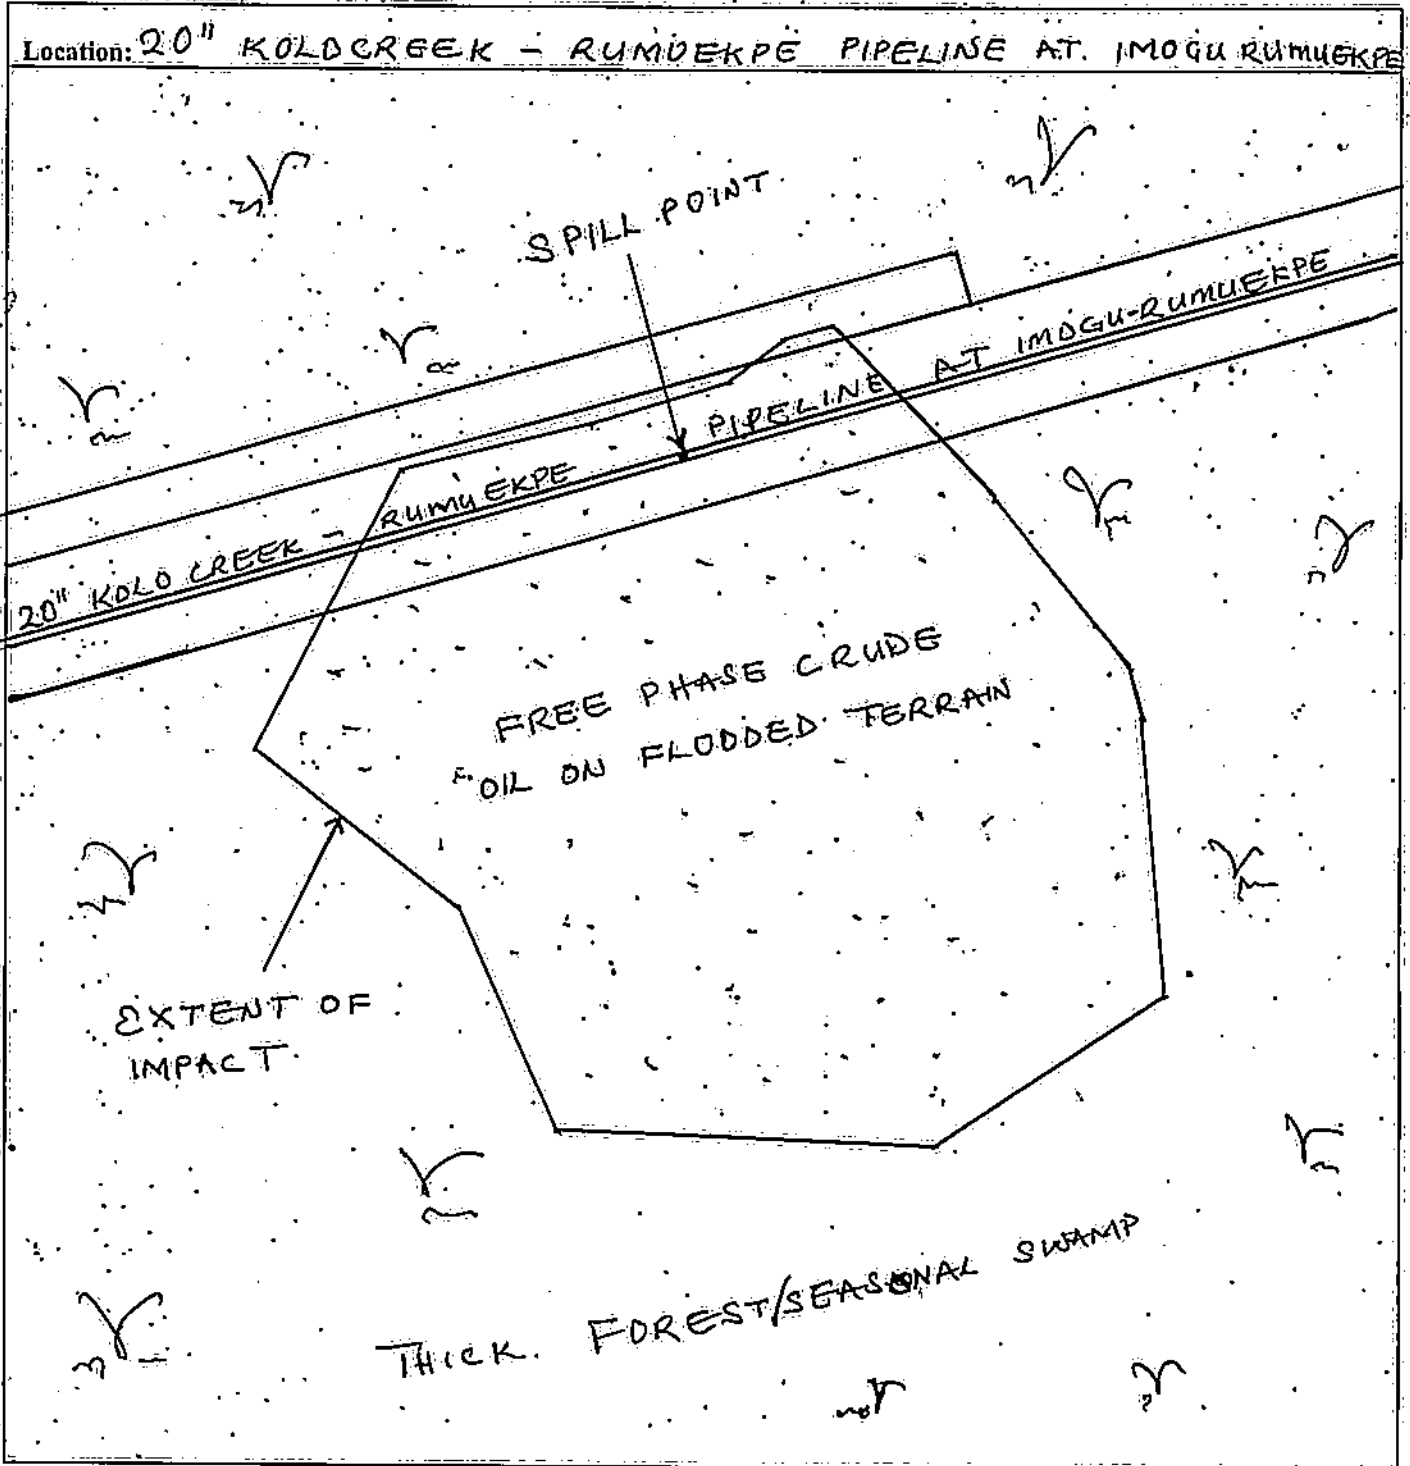
f. Appendix 1: Overview sketch of the site

**E. GRAPHIC DESCRIPTION OF LEAK POINT** (while detailed report of the leak point should be contained in the leak report, overview sketch of the site should be added as an appendix 1) A SECTION OF 20" KOLOCREEK-RUMUEKPE PIPELINE AT IMOGLU-RUMUEKPE SHOWING CONCRETE GROUTING ON AN ILLEGAL CONNECTION AT 12 O'CLOCK POSITION DONE BY SPDC TO PREVENT CONTINUED CRUDE THEFT, FROM PREVIOUSLY REPORTED CRUDE THEFT POINT.

REPAIR BY CLAMPING
