JOINT INVESTIGATION REPO	ORT FOR INCIDENT NO	0031 702 874
(Note: As practicable as possible the JIT re	port is to be signed in the	- · · · · · · · · · · · · · · · · · · ·

A. GENERAL INFORMATION:	J ,	ey we me purpopuling purites)
1. Spill incident Number:7028	.74 2.Type o	of incident* ON SPILE
3. Name of Location 14" OKORD	A - DILAME	VOE DIRELING
	KUIVIUE	RPE PIPELINE

JOINT INVESTIGATION REPORT FOR INCIDENT NO: 0031702874

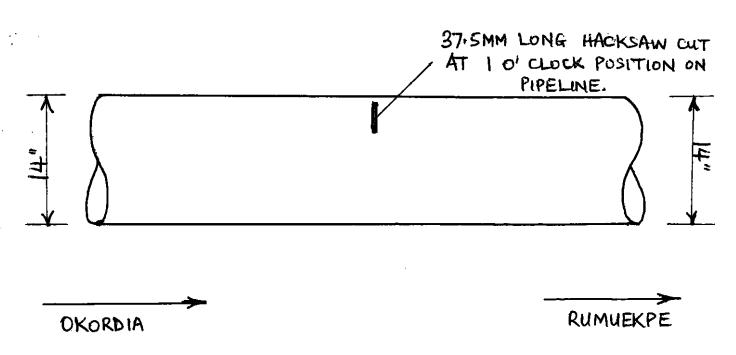
E. GRAPHIC DESCRIPTION OF LEAK POINT (Overview sketch of the site should be added as an appendix 1)

d. Description of leak point (tick as a	pplicable);	Rig
	Hack saw cut	☐ Explosive tear,
☐ Complete Rupture	☐ Inward dent,	☐ Well head tampering
☐ Failed Weld-on illegal hot tap v	alve,	☐ Missing Pipeline/Flowline)
☐ Crude oil theft (illegal bunkerin	g) point,	☐ Third party tampering with Clamp
☐ Third party tampering with valv	e setting,	☐ Third party tampering with flange,
□ External Corrosion	-	□ Internal Corrosion
Saver-pit over flow,	☐ Surge vessel overflow,	
☐ Flare System/Bund wall Failure	☐ Valve Failure	□ com unit failure .
□ Cold vent	☐ Relief valve failure	□ Others (specify) NoT APPLICABLE

SECTION OF 14" OKORDIA - RUMUEKPE PIPELINE AT IKARAMA SHOWING POSITION OF HACKSAW CUT.

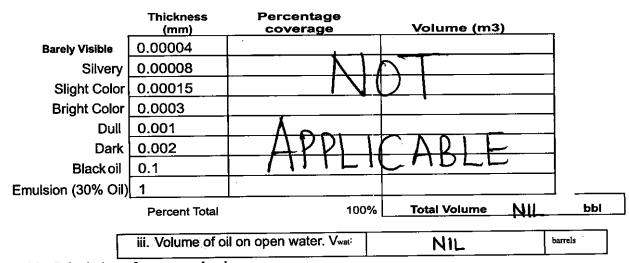
- 21. Computation of volume of oil on open water based on standard coloration.
 - i. Total area of oil on open water:
 - ii. Table of average depth of oil on water based on coloration *
