JOINT INVESTIGATION REPORT FOR INCIDENT NO: ... 0016 7-03073

A. GENERAL INFORMATION:		, .
1. Spill incident Number: 7038	73 2.Type	of incident* SPILL
3. Name of Location 16" EGBEN	1A-ASSA PH	PELINE
4. Name of nearest community EKP	AGHA 5. State: R	WERS 6. LGA ONELGA

#### THE SHELL PETROLEUM DEVELOPMENT COMPANY OF NIGERIA LIMITED JOINT INVESTIGATION REPORT FOR INCIDENT NO: C. RISK ASSESSMENT 10. Type of environment: Land □ Swamp □ Water ☐ Seasonal swamp Type of environment to which oil has spread: \\_/Land □ Swamp □ Water ☐ River (identify) Weather condition Raining □ Sunny 11. Distance from the nearest sensitive habitat ☐ Government reserved and designated protected area ☐ Drinking water source **人**(L ,m] ☐ Built up area ,m] □ Farmlands ,m] ☐ Fish Farm/Pond ,m] ☐ Fishing net **↓**//,m] ☐ Others (specify). 12. Containment measures put in place; □ Booms □ Dyke 13. Any pictures or video coverage? [N]

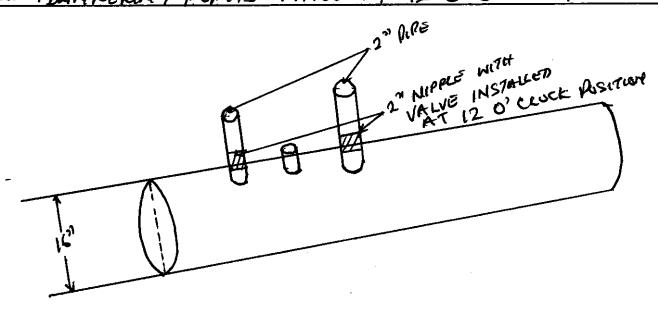
E. GRAPHIC DESCRIPTION OF LEAK POINT (Overview sketch of the site should be added as an appendix 1)

d. Description of leak point (tick as a	pplicable);	
☐ Drilled hole	☐ Hack saw cut	☐ Explosive tear,
□ Complete Rupture	☐ Inward dent,	☐ Well head tampering
Failed Weld-on illegal hot tap v		☐ Missing Pipeline/Flowline)
rude oil theft (illegal bunkerin	g) point,	☐ Third party tampering with Clamp
☐ Third party tampering with valv	e setting,	☐ Third party tampering with flange,
☐ External Corrosion		□ Internal Corrosion
☐ Saver-pit over flow,	☐ Surge vessel overflow	
☐ Flare System/Bund wall Failure		□ com unit failure
□ Cold vent	☐ Relief valve failure	☐ Others (specify)
Total and a		\.\.\.\.\.\.\.\.\.\.\.\.\.\.\.\.\.\.\.

e. Incident due to: Third party interference	□ Operational	□ Others (specify
f. Spill point coordinates  Measuring unit (METER)	(MINNA	MID-BELT)
Northing:		Easting:
156727.0	6	480139.01
·		
·

A SECTION OF 16" EGBEMA-ASSA PIPELINE AT EXPERGIAL
SHOWING BUNKERING POINTS FITTED AT 12 0' CLOCK POSITION
