JOINT INVESTIGATION REPORT FOR INCIDENT NO: 0064 740641

9	, , ,			
A. GENERAL INFORMATION:					
. Spill incident Number: 740641 2. Type of incident* OIL SPILL					
		EMU TRUNKLING @ LYEDG			
. Name of nearest community OG HARD	1-146DE State: DE	CTA 6. LGA ISOKO-NORTH

7. Type of Production facility/Installation	RUNKLING 8. A	sset owner/District PIPELINE			
3. INCIDENT INFORMATION:					
Details of incident a. Date of incident: 15 11 2	011

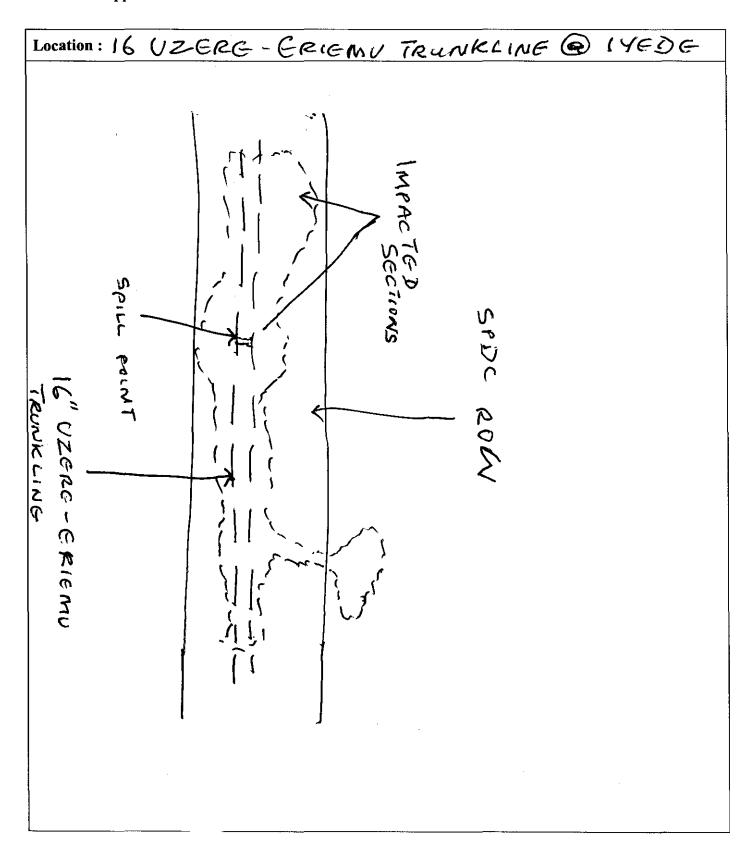
20. Appendix 1: Overview sketch of the site

EXPLOSIVE TEAR
(SPILL POINT)
