THE SHELL PETROLEUM DEVELOPMENT COMPANY OF NIGERIA LIMITED.

JOINT INVESTIGATION REPORT FOR INCIDENT NO: 978498 JIV report S/N: 0086

1. Spill incident Number: 978498 2. Type of incident* OIL SPILL
 3. Name of Location 12" OGUTA - EGBEMA PIPELINE
 4. Name of nearest community OBIAKPU 5. State: IMO 6. LGA OHAJI/EGBEMA
 7. Type of Production facility/Installation OIL PIPELINE 8. Asset owner/District PIPELINE

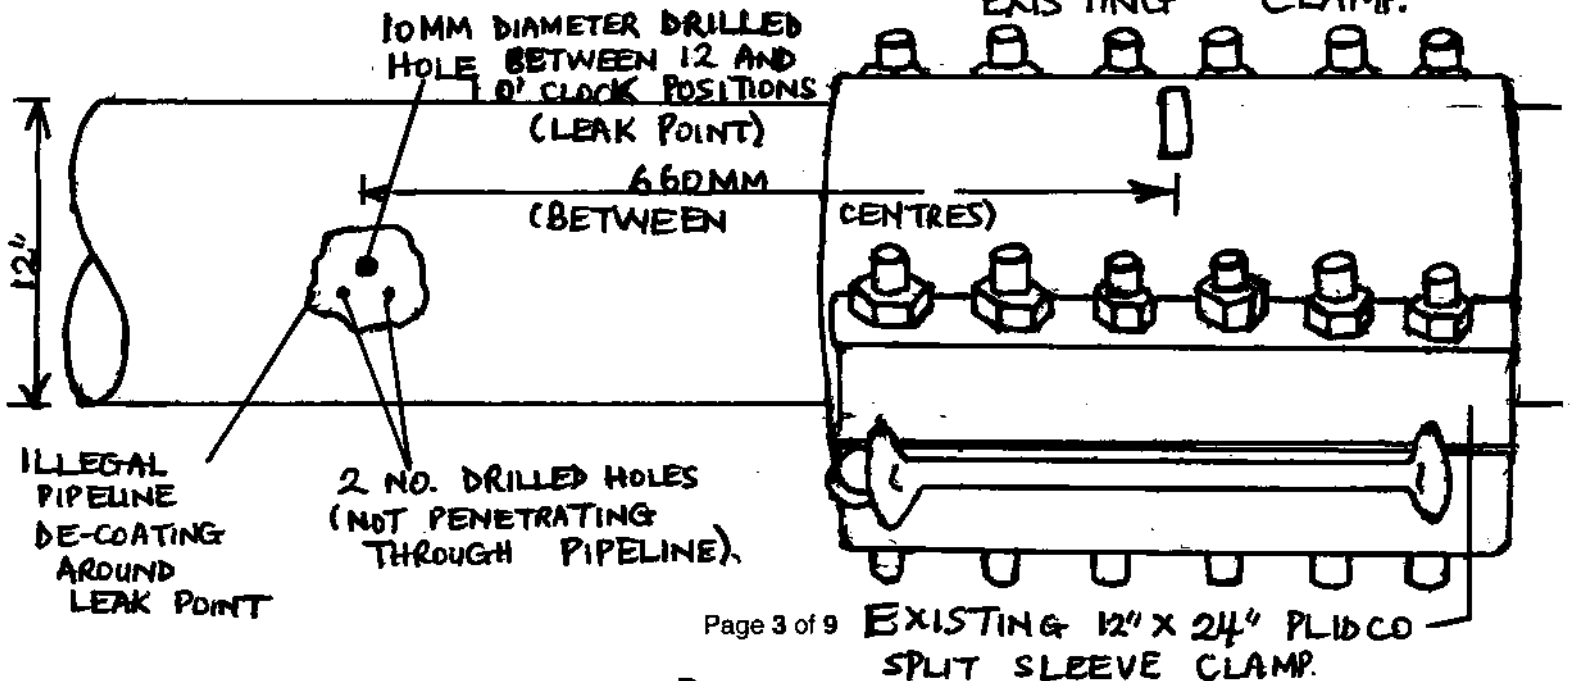
SECTION OF 12" OGUTA - EGBEMA PIPELINE AT OBIAKPU SHOWING POSITION OF DRILLED HOLES ADJACENT TO EXISTING CLAMP.

FROM OGUTA TO EGBEMA.
