THE SHELL PETROLEUM DEVELOPMENT COMPANY OF NIGERIA LIMITED.

JOINT INVESTIGATION REPORT FOR INCIDENT NO: 977219 JIV report S/N: 0003

1. Spill incident Number: 977219 2. Type of incident* OIL SPILL
 3. Name of Location 28" BOMU - BONNY TRANS NIGER PIPELINE
 4. Name of nearest community BODO WEST 5. State: RIVERS 6. LGA GOKANA
 7. Type of Production facility/Installation OIL PIPELINE 8. Asset owner/District PIPELINE/BODO WEST.

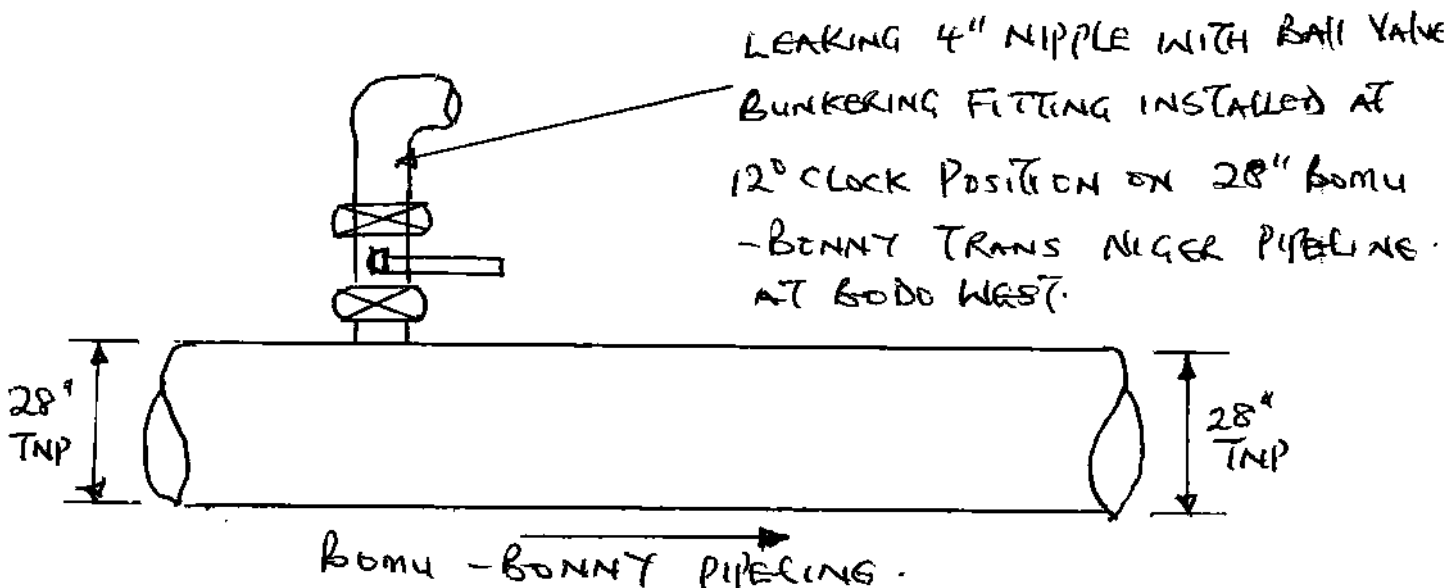
E. GRAPHIC DESCRIPTION OF LEAK POINT (while detail report of the leak point should be contained in the leak report, overview sketch of the site should be added as an appendix I)

e. Description of leak point (tick as applicable);
 Drilled hole Hack saw cut Tear (_____),
 Complete Rupture Inward dent, Well head tampering
 Failed Weld-on illegal hot tap valve, Failed Clamp Missing Pipeline/Flowline
 Crude oil theft (illegal bunkering) point, Third party tampering with Clamp
 Third party tampering with valve setting, Third party tampering with flange,
 Corrosion Saver-pit over flow, Surge vessel overflow,
 Bulging Outward Flare System/Bund wall failure Accidental 3rd party equipment
 impact Valve Failure com unit failure Cold vent
 Relief valve failure Others (specify) _____

- Third party interference (Sabotage ; crude theft ; Line theft ; Accidental 3rd party damage
 Operational Others (including Mystery spills) _____

SECTIONAL VIEW OF 28" BOMU - BONNY TRANS NIGER PIPELINE
SHOWING 4" BUNKERING FITTING
