THE SHELL PETROLEUM DEVELOPMENT COMPANY OF NIGERIA LIMITED.

JOINT INVESTIGATION REPORT FOR INCIDENT NO: 1054978 JIV report S/N: 0284

1. Spill incident Number: 1054978 2. Type of incident* OIL SPILL
 3. Name of Location 6" OBIGBO NORTH - EBUBU PIPELINE
 4. Name of nearest community OBULO 5. State: RIVERS 6. LGA ELEME
 7. Type of Production facility/Installation OIL PIPELINE 8. Asset owner/District PIPELINE

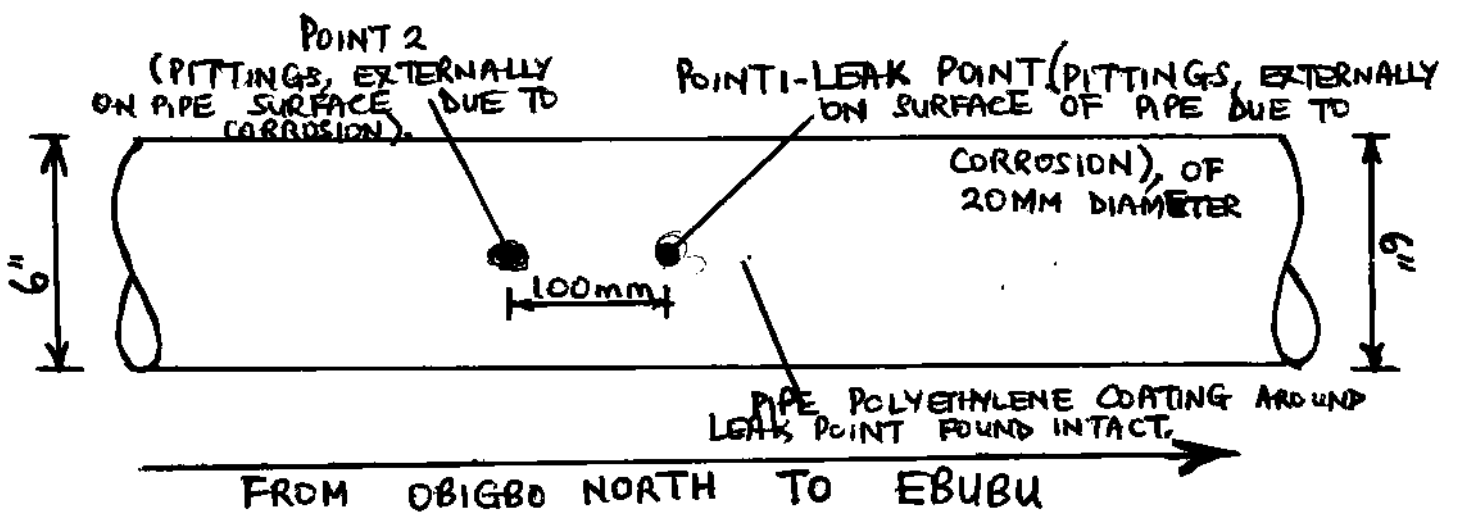
- Firmed soil Loose soil Recently excavated area
NB. PIPE COATING OBSERVED TO BE INTACT AROUND SPILL POINT.
 Under water Swampy Exposed pipe surface
 Well Platform (on Water) Drill Rig

| <input checked="" type="checkbox"/> Corrosion | <input type="checkbox"/> Saver-pit over flow, | <input type="checkbox"/> Surge vessel overflow, |

SECTION OF 6" OBIGBO-NORTH PIPELINE AT
 - EBUBU
 OBOLO SHOWING CORROSION LEAK AT 3 O'
 CLOCK POSITION.

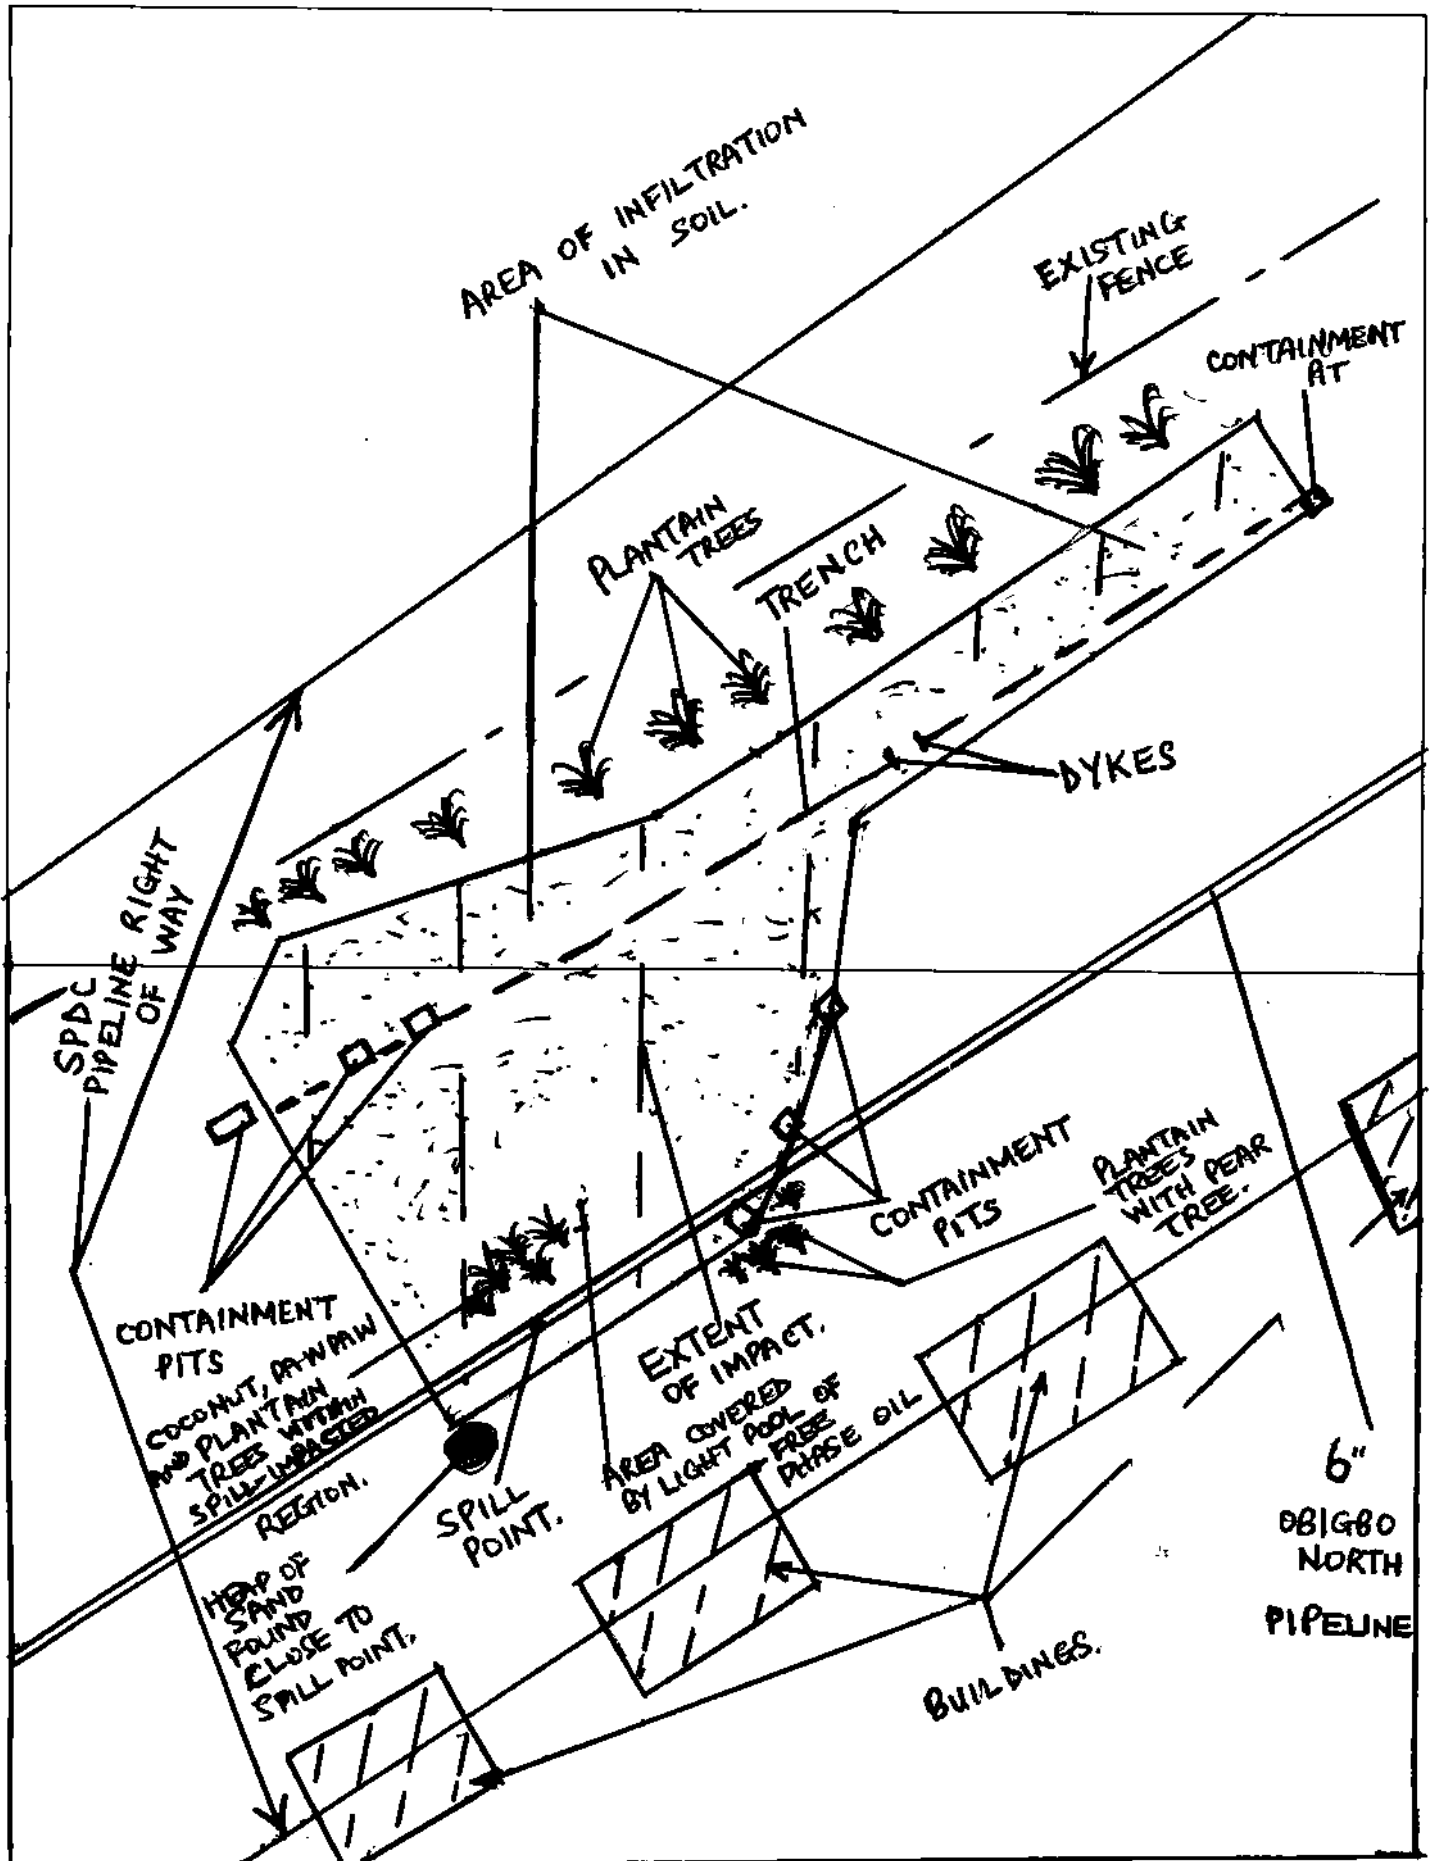
28. Appendix 1: Overview sketch of the site

Location: 6" OBIGBO NORTH PIPELINE AT OBOLO
