THE SHELL PETROLEUM DEVELOPMENT COMPANY OF NIGERIA LIMITED.

JOINT INVESTIGATION REPORT FOR INCIDENT NO: 1057935 JIV report S/N: 0292

1. Spill incident Number: 1057935 2. Type of incident* OIL SPILL
 3. Name of Location 14" OKORDIA - RUMUKEPE PIPELINE
 4. Name of nearest community AKARAWINI 5. State: RIVERS 6. LGA AHONDA WEST
 7. Type of Production facility/Installation OIL PIPELINE 8. Asset owner/District PIPELINE

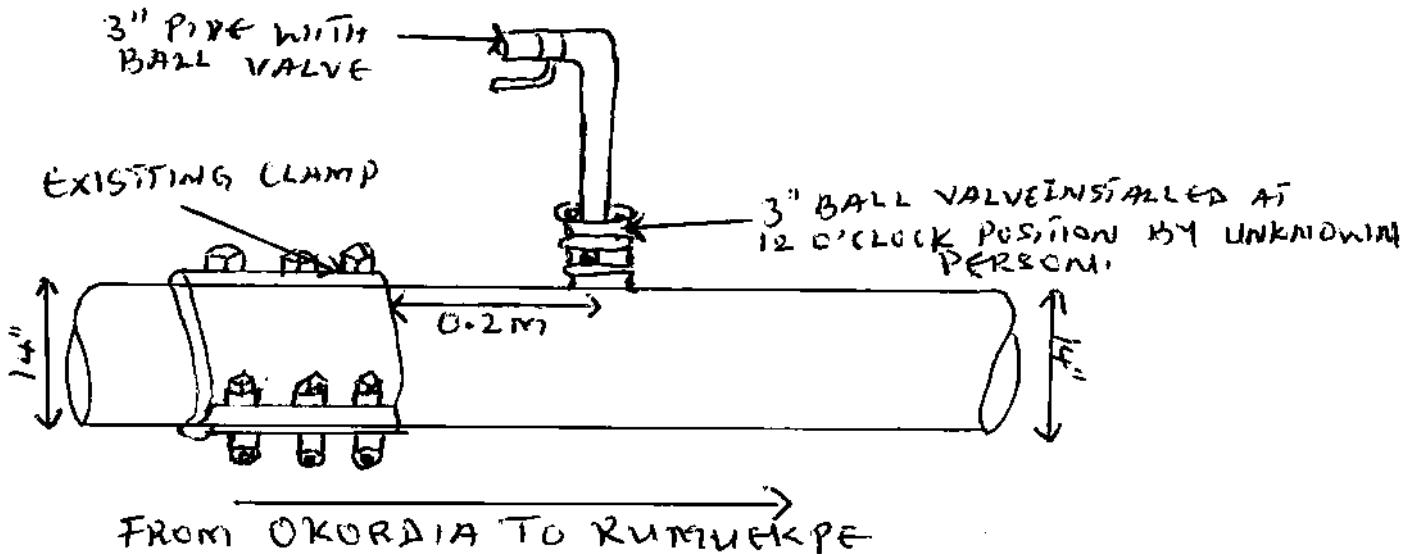
SECTION OF 14" OKORDIA - RUMUKEPE PIPELINE AT AKARAMINI SHOWING POSITION OF CRUDE OIL THEFT POINT INSTALLED AT 12 O'CLOCK POSITION.

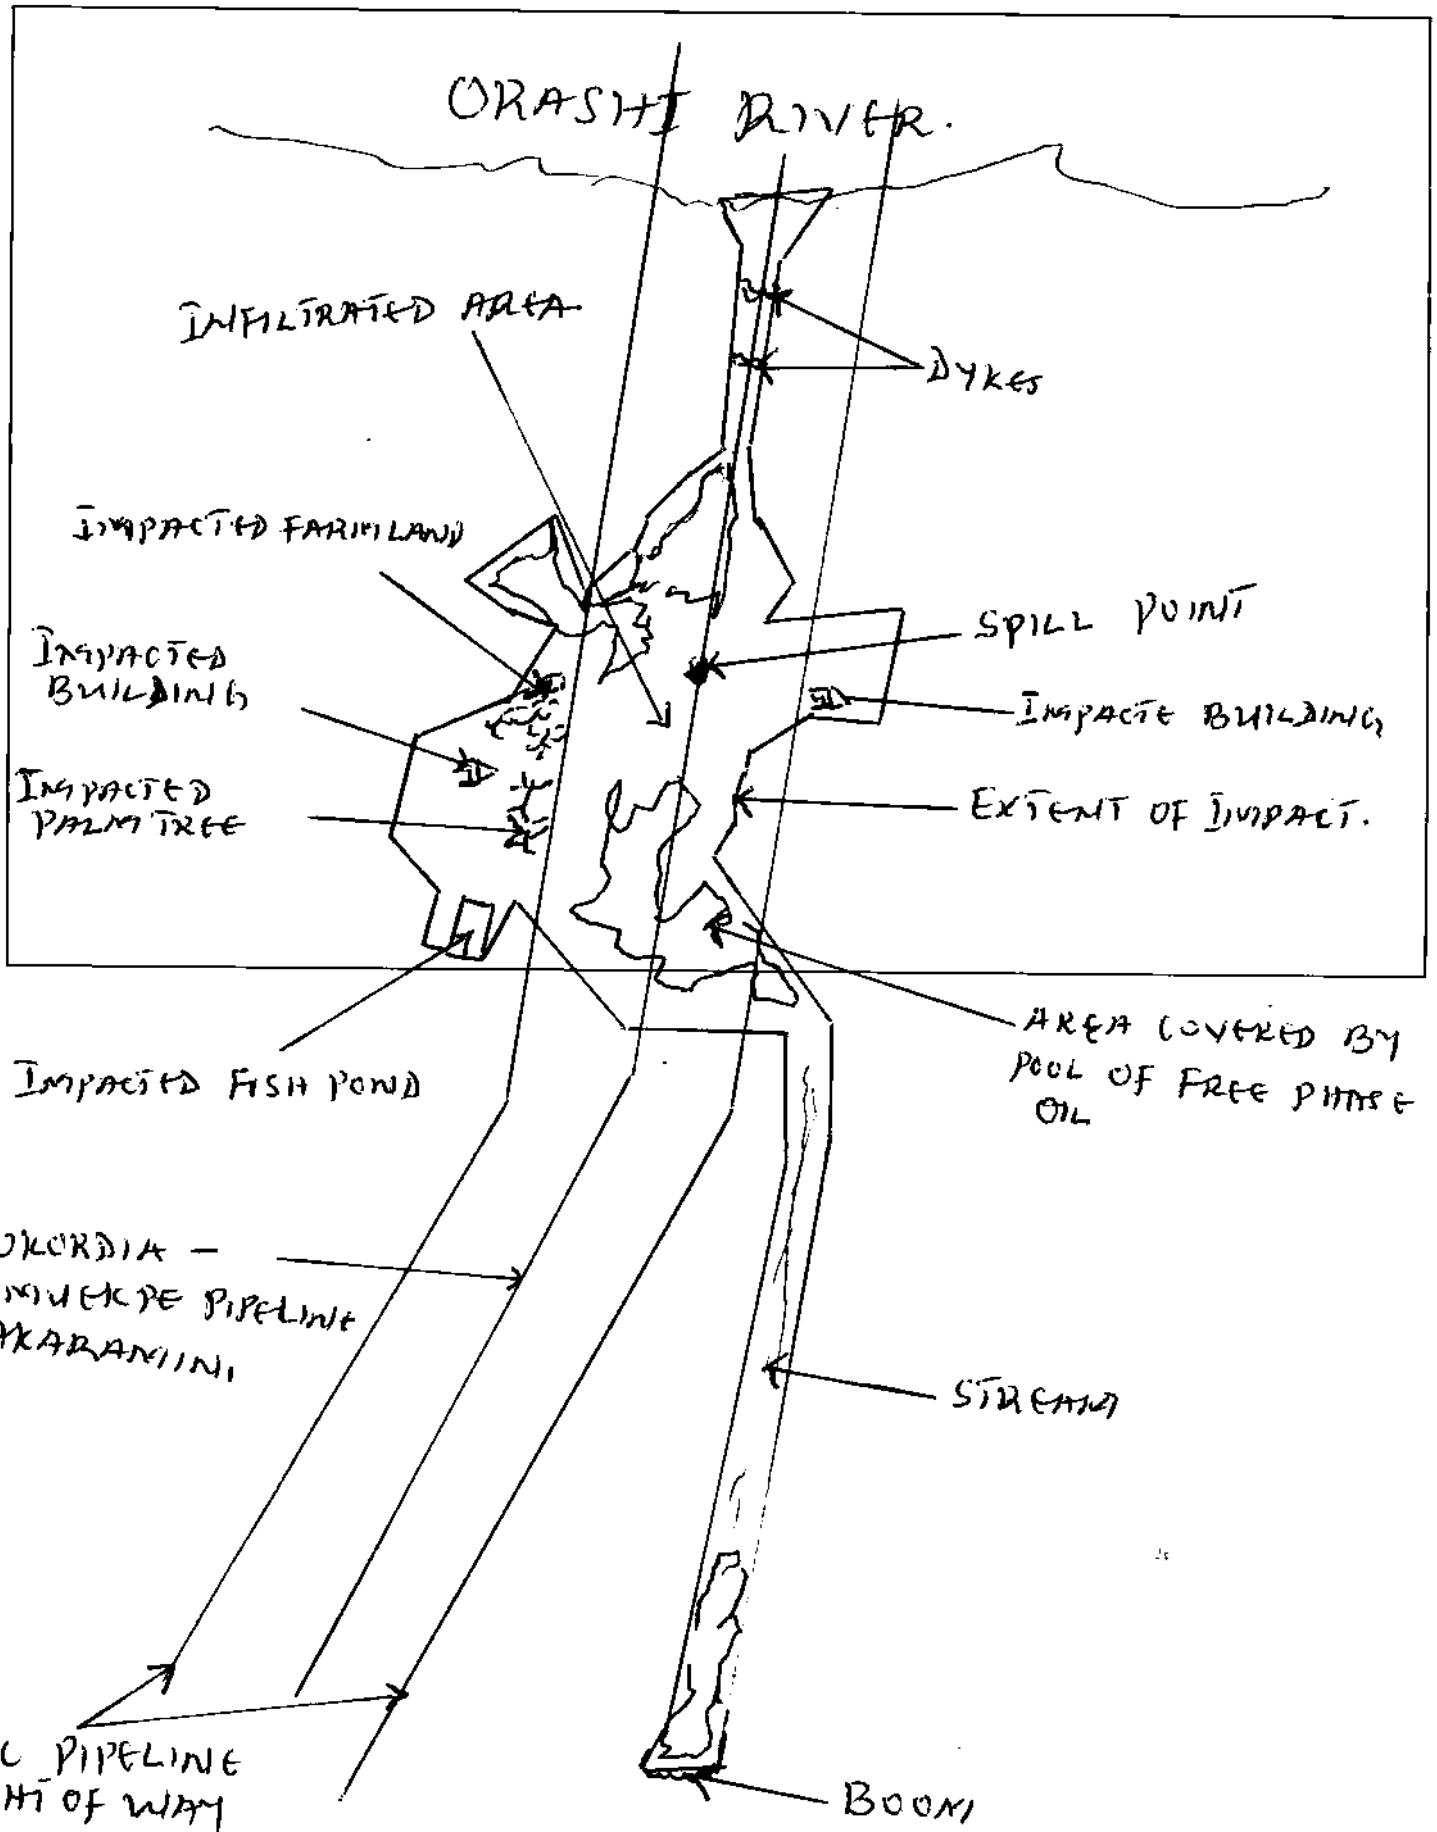
28. Appendix 1: Overview sketch of the site

Location: 14" OKORDIA - RUMUEKPE PIPELINE AT ALARAKINI
