THE SHELL PETROLEUM DEVELOPMENT COMPANY OF NIGERIA LIMITED.

JOINT INVESTIGATION REPORT FOR INCIDENT NO: 1247932 JIV report S/N: 00702

1. Spill incident Number: 1247932 2. Type of incident* OIL SPILL
3. Name of Location 10" DIEBU CREEK - NUM RIVER PIPELINE
4. Name of nearest community EKOWE 5. State: BAYELSA 6. LGA SOUTHERN IJAW
7. Type of Production facility/Installation OIL PIPELINE 8. Asset owner/District PIPELINE

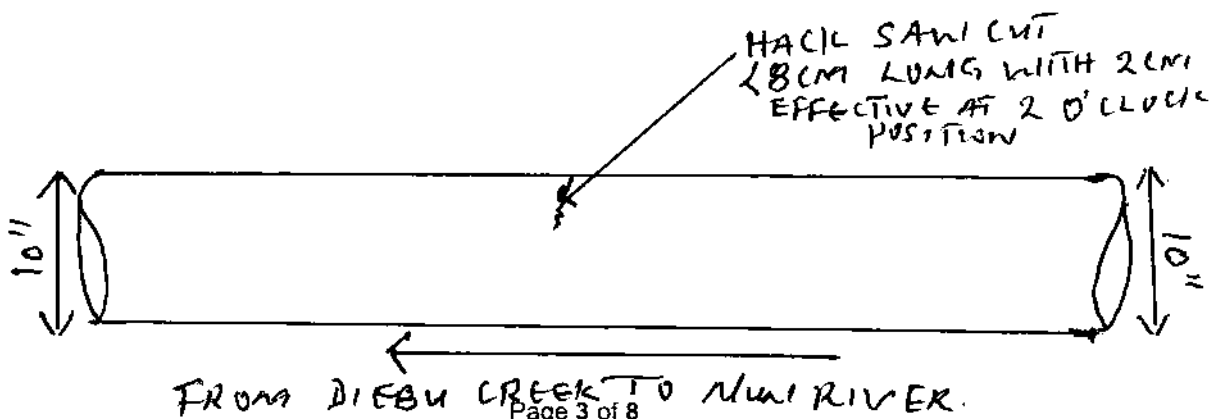
E. GRAPHIC DESCRIPTION OF LEAK POINT (while detail report of the leak point should be contained in the leak report, overview sketch of the site should be added as an appendix 1)

| <input type="checkbox"/> Drilled hole | <input checked="" type="checkbox"/> Hack saw cut | <input type="checkbox"/> Tear (_____), | |

SECTION OF 10" DIEBU CREEK - NUNI RIVER PIPELINE AT EKOWIE SHOWING POSITION OF HACK SAW CUT AT 2 O'CLOCK POSITION.

If yes to item 14, give brief description: REPAIR WORK WAS DONE BY CLAMPING.
