THE SHELL PETROLEUM DEVELOPMENT COMPANY OF NIGERIA LIMITED.

JOINT INVESTIGATION REPORT FOR INCIDENT NO: 1227576 JIV report S/N: 00681

1. Spill incident Number: 1227576 2. Type of incident* OIL SPILL
 3. Name of Location 8" OBIGBO NORTH - NEW ELELEMI
 4. Name of nearest community UMUDKOLUBE 5. State: RIVERS 6. LGA OYIGBO
 7. Type of Production facility/Installation OIL PIPELINE 8. Asset owner/District PIPELINE

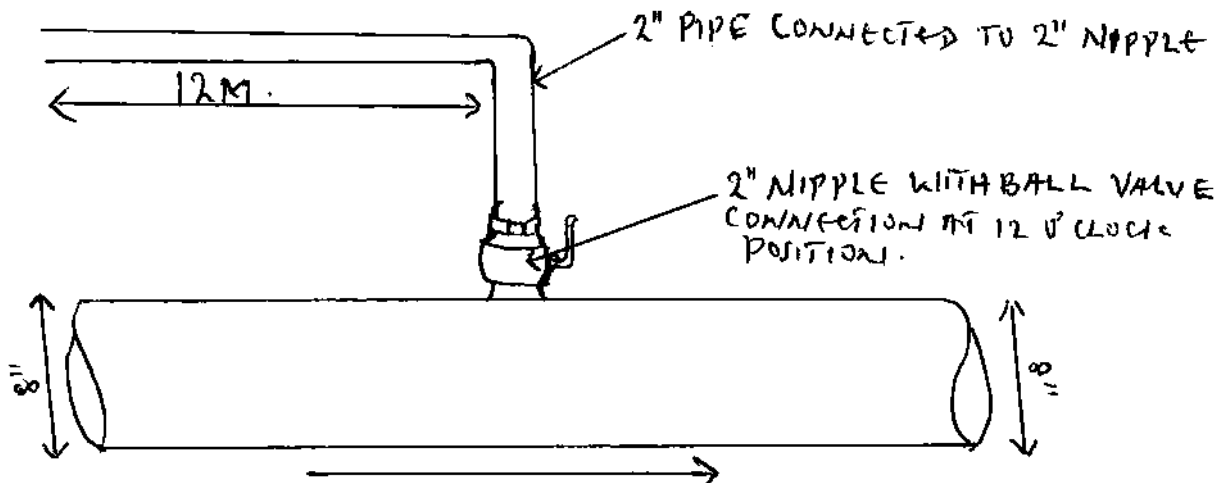
| <input checked="" type="checkbox"/> Failed Weld-on illegal hot tap valve, | <input type="checkbox"/> Failed Clamp | <input type="checkbox"/> Missing Pipeline/Flowline |
| <input checked="" type="checkbox"/> Crude oil theft (illegal bunkering) point, | | <input type="checkbox"/> Third party tampering with Clamp |

SECTION OF 8" OBIGBO NORTH - NEW ELELENWO PIPELINE AT UMUOKOLOBE SHOWING POSITION OF CRUDE TEE POINT AT 12 O'CLOCK POSITION.

FROM OBIGBO NORTH TO NEW ELELENWO

REPAIR BY CLAMPING WAS DONE ON
AFFECTED SECTION OF THE PIPELINE.
