**THE SHELL PETROLEUM DEVELOPMENT COMPANY OF NIGERIA LIMITED.**

JOINT INVESTIGATION REPORT FOR INCIDENT NO: 1228508 JIV report S/N: 00690

1. Spill incident Number: 1228508 2. Type of incident\* OIL SPILL  
 3. Name of Location 8' OBIGBO NORTH - NEW ELECTRICITY PIPELINE  
 4. Name of nearest community UMUDKOLUBES. State: RIVERS 6. LGA OYIGBO  
 7. Type of Production facility/Installation OIL PIPELINE 8. Asset owner/District PIPELINE

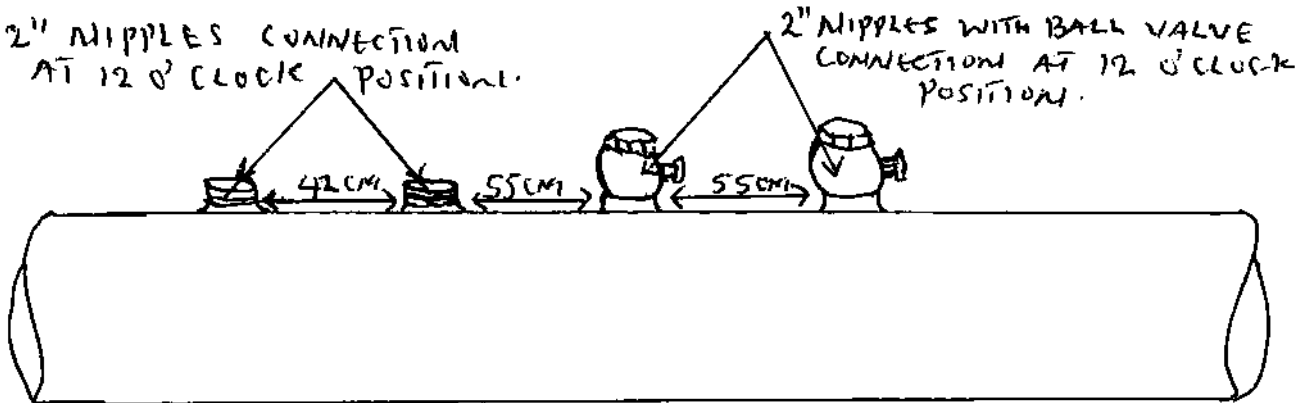
E. GRAPHIC DESCRIPTION OF LEAK POINT (while detail report of the leak point should be contained in the leak report, overview sketch of the site should be added as an appendix 1)

Additional observations around the spill point:  
 SOME SAND BAGS WERE OBSERVED AT THE SPILL POINT. TWO CRUDE OIL THEFT POINTS WITH CONCRETE CAST WERE ALSO OBSERVED.

SECTION OF 8" OBIGBO NORTH - NIEMI ELELEKWO PIPELINE AT UMOOKOLOBE SHOWING POSITION OF CRUDE OIL LEAK POINTS AT 12 O' CLOCK POSITION.

FROM OBIGBO NORTH TO NIEMI ELELEKWO
