THE SHELL PETROLEUM DEVELOPMENT COMPANY OF NIGERIA LIMITED.

JOINT INVESTIGATION REPORT FOR INCIDENT NO: 1303850 JIV report S/N: 00805

1. Spill incident Number: 1303850 2. Type of incident* OIL SPILL
 3. Name of Location 28" Nkpoku - BOMU PIPELINE
 4. Name of nearest community ELEGBUO 5. State: RIVERS 6. LGA OBUO/AKPO
 7. Type of Production facility/Installation OIL PIPELINE 8. Asset owner/District PIPELINE

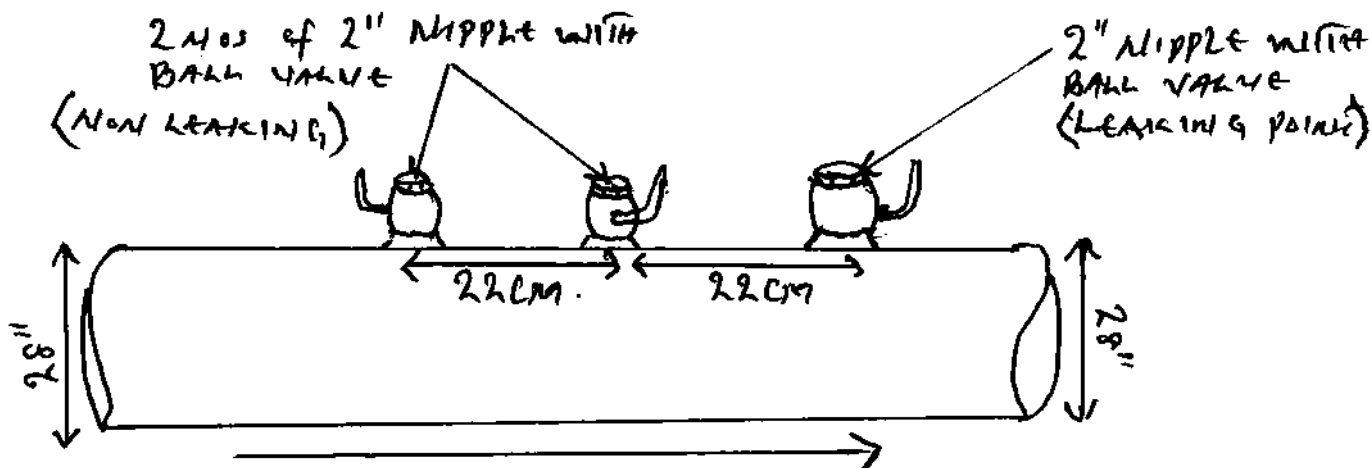
| <input checked="" type="checkbox"/> Failed Weld-on illegal hot tap valve, | <input type="checkbox"/> Failed Clamp | <input type="checkbox"/> Missing Pipeline/Flowline |
| <input checked="" type="checkbox"/> Crude oil theft (illegal bunkering) point, | | <input type="checkbox"/> Third party tampering with Clamp |

SECTION OF 28" NIKPOKU - BOMU PIPELINE AT ELELEWU SHOWING POSITION OF 3 NOS CRUDE OIL TIGHT POINTS AT 12 O'CLOCK POSITION.

FROM NIKPOKU TO BOMU.

AFFECTED SECTION OF THE PIPELINE
WAS REPAIRED BY CLAMPING.

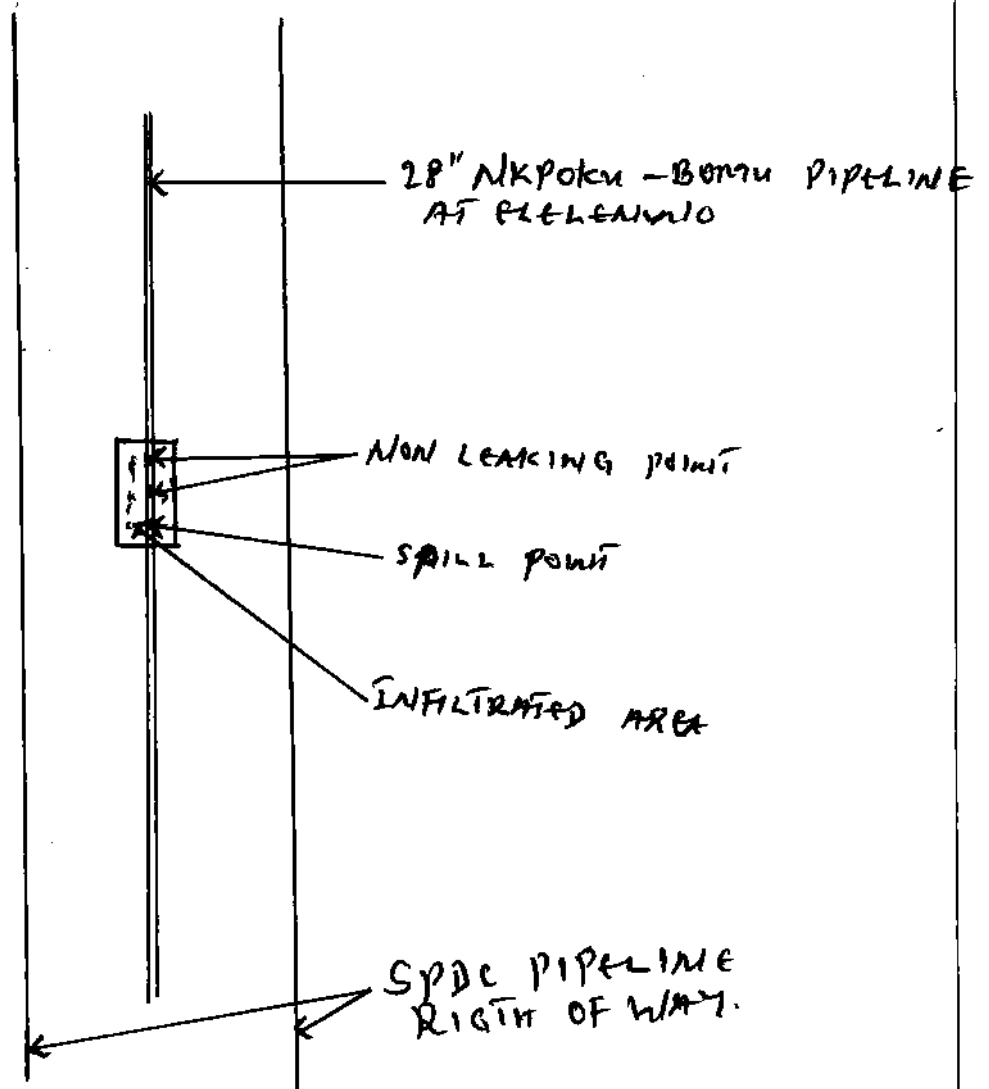
25. Appendix 1: Overview sketch of the site

Location: 28" Nkpoku - Boma Pipeline AT ELELENW/O
