THE SHELL PETROLEUM DEVELOPMENT COMPANY OF NIGERIA LIMITED.

JOINT INVESTIGATION REPORT FOR INCIDENT NO: 1304865 JIV report S/N: 00807

1. Spill incident Number: 1304865 2. Type of incident* OIL SPILL
 3. Name of Location 28" BOMU - BONNY PIPELINE
 4. Name of nearest community BODO-CITY 5. State: RIVERS 6. LGA GOKANA
 7. Type of Production facility/Installation OIL PIPELINE 8. Asset owner/District PIPELINE

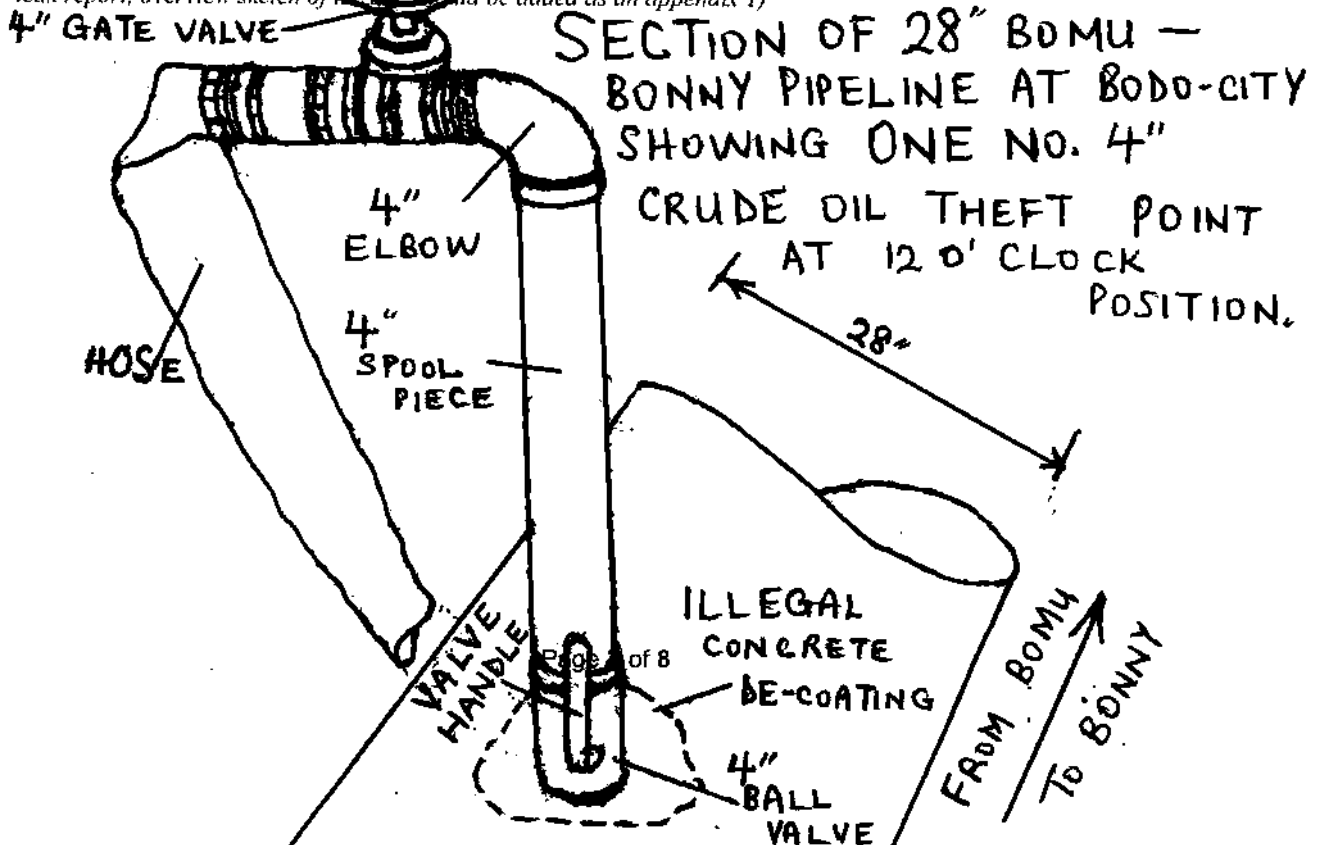
E. GRAPHIC DESCRIPTION OF LEAK POINT (while detail report of the leak point should be contained in the leak report, overview sketch of the leak point should be added as an appendix 1)

Additional observations around the spill point: **ALTHOUGH THE CRUDE OIL THEFT POINT (AS THEN SUSPECTED) WAS OBSERVED AS NON-LEAKING ON THE INCIDENT DATE OF 28TH NOVEMBER 2014, BY WHICH TIME THE PIPELINES MAINTENANCE TEAM, ON BEHALF OF THE ASSET OWNER, CONSTRUCTED A COFFERDAM AROUND THE SUSPECTED CRUDE OIL THEFT POINT (COVERING THE COFFERDAM WITH PILING SHEETS TO RESTRICT ACCESS TO CRUDE OIL THIEVES SUSPECTED TO OPERATE WITHIN THE AREA)**

- e. Description of leak point (tick as applicable); **PRIOR AND PREPARATORY TO SHUTDOWN OF PIPELINE FACILITY TO ENABLE JIV AND REPAIRS; ON JIV DATE, THE JOINT INVESTIGATION TEAM OBSERVED SPILL IMPACT WITHIN AND OUTSIDE THE COFFERDAM DUE TO AN ILLEGAL HOSE OBSERVED TO BE CONNECTED TO THE CRUDE THEFT POINT OUTLET (ON EXPOSURE BY EXCAVATION DURING JIV). SOIL IMPACTED ON SITE IS DARK BROWN SILTY CLAY WITH ORGANIC MATTER.**

| <input checked="" type="checkbox"/> Crude oil theft (illegal bunkering) point, | | <input type="checkbox"/> Third party tampering with Clamp |

MAPPING OF SPILL IMPACT WITH ABSORBENT MATERIALS WAS DONE
WHILE REPAIRS WERE TEMPORARILY EFFECTED ON THE AFFECTED PIPELINE
SECTION BY SCREW-PLUGGING THE CRUDE THEFT POINT VALVE WITH A 4"
 15. Was there any disruption to the investigation? [Y] ☒ [N] SCREW PLUG AND
DISCONNECTING THE
VALVE
HANDLE.
