THE SHELL PETROLEUM DEVELOPMENT COMPANY OF NIGERIA LIMITED.

JOINT INVESTIGATION REPORT FOR INCIDENT NO: 1196049 JIV report S/N: 0549

1. Spill incident Number: 1196049 2. Type of incident* OIL SPILL
 3. Name of Location IMD RIVER WELL IT FLOWLINE
IGIRIUKWU
 4. Name of nearest community (OWAZA) 5. State: ABIA 6. LGA UKWA-WEST
 7. Type of Production facility/Installation OIL FLOWLINE, Asset owner/District LAND 1

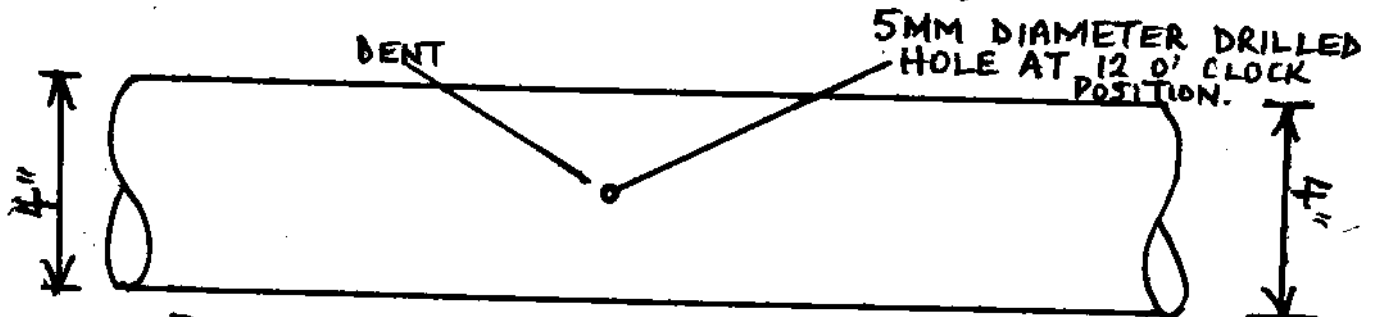
Additional observations around the spill point:
THE PIPELINE SURFACE AROUND THE SPILL POINT WAS NOTICED TO BE DENTED. IMPACTED SOIL IS LIGHT BROWN SILT WITH LOOSE PARTICLES. A SMALL PIT WAS OBSERVED DUG AROUND THE SPILL POINT, IN WHICH CRUDE OIL BUBBLING WAS

SECTION (SHOWING PLAN) OF IMO RIVER WELL IT FLOWLINE AT IGIRIUKWU (OWAZA) SHOWING POSITION OF LEAK POINT (DRILLED HOLE).

FROM IMO RIVER WELL IT
 TO IMO RIVER 3 FLOW STATION.
