**THE SHELL PETROLEUM DEVELOPMENT COMPANY OF NIGERIA LIMITED.**

**JOINT INVESTIGATION REPORT FOR INCIDENT NO: 1383004 JIV report S/N: 00876**

1. Spill incident Number: 1383004 2. Type of incident\* OIL SPILL  
 3. Name of Location 16" Nun River - Kolo Creek Pipeline  
 4. Name of nearest community OPOROMA 5. State: BAYELSA 6. LGA SOUTHERN IJAW  
 7. Type of Production facility/Installation OIL PIPELINE Asset owner/District PIPELINE

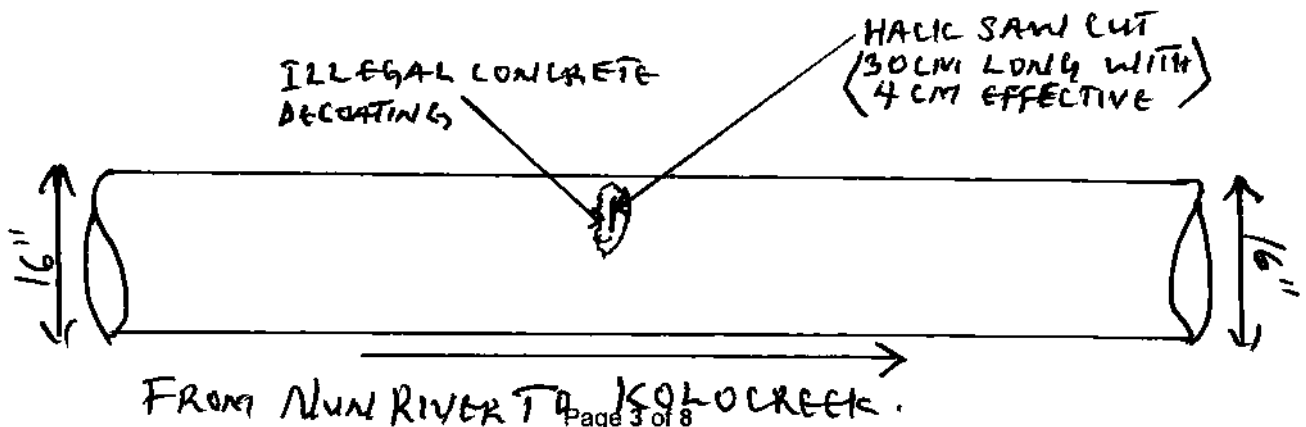
**E. GRAPHIC DESCRIPTION OF LEAK POINT** (while detail report of the leak point should be contained in the leak report, overview sketch of the site should be added as an appendix 1)

| <input type="checkbox"/> Drilled hole | <input checked="" type="checkbox"/> Hack saw cut | <input type="checkbox"/> Tear (_____). |

- ☒ Third party interference (Sabotage ☒, crude theft ☐; Line theft ☐; Accidental 3<sup>rd</sup> party damage ☐  
☐ Operational ☐ Others (including Mystery spills) \_\_\_\_\_

SECTION OF 16" MUNI RIVER - KOLO CREEK PIPELINE AT OPOROMIA  
SHOWING POSITION OF HALL SAW CUT AT 2 O'CLOCK POSITION.

RECOVERY ACTIVITIES ONGOING.  
REPAIR WAS DONE BY CLAMPING.
