THE SHELL PETROLEUM DEVELOPMENT COMPANY OF NIGERIA LIMITED.

JOINT INVESTIGATION REPORT FOR INCIDENT NO: 1320577 JIV report S/N: 00813

1. Spill incident Number: 1320577 2. Type of incident* OIL SPILL
3. Name of Location NEMBE WELL 40L WELL HEAD (FLOWLINE)
4. Name of nearest community IKOVIA 5. State: BAYELSA 6. LGA NEMBE
7. Type of Production facility/Installation WELL HEAD 8. Asset owner/District SWAMP II / NEMBE

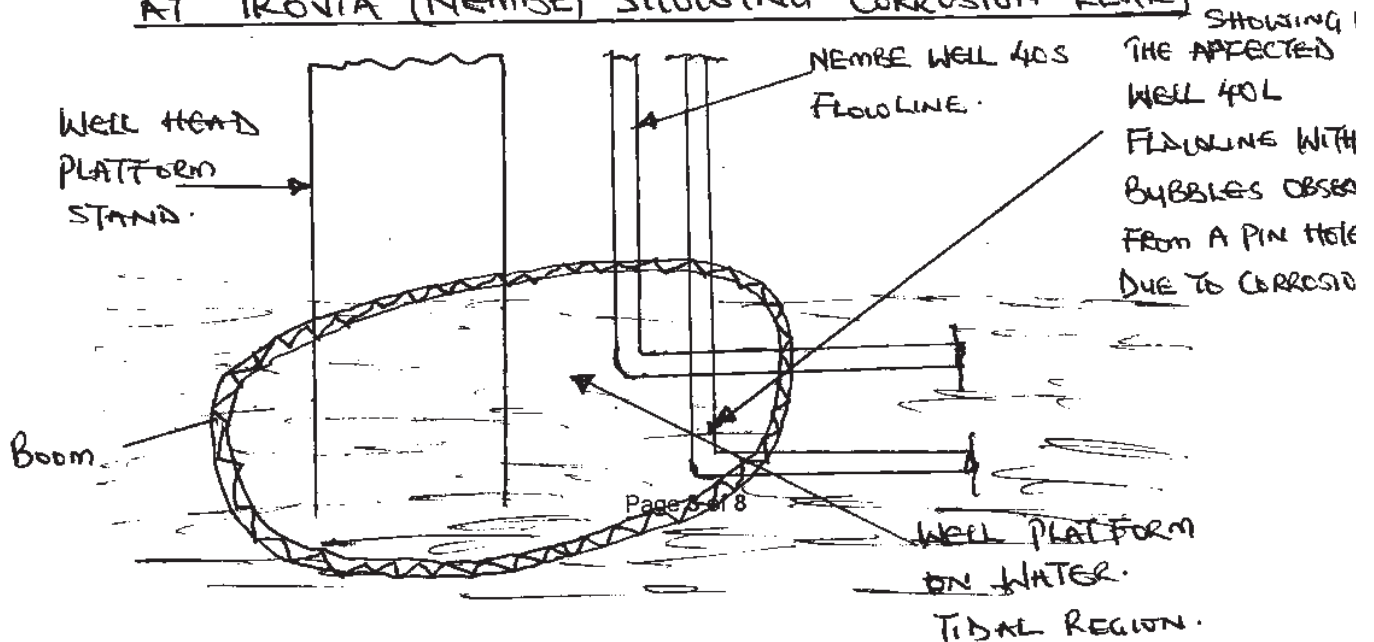
Additional observations around the spill point: THE JOINT INVESTIGATING TEAM OBSERVED EVIDENCE OF HEAVY PITTING ON THE AFFECTED LINE.

| <input checked="" type="checkbox"/> Corrosion | <input type="checkbox"/> Saver-pit over flow, | <input type="checkbox"/> Surge vessel overflow, |

SECTIONAL VIEW OF NEMBE WELL 40L WELL HEAD FLOWLINE

AT IKOVIA (NEMBE) SHOWING CORROSION LEAK

REPAIR WORK PLANNED

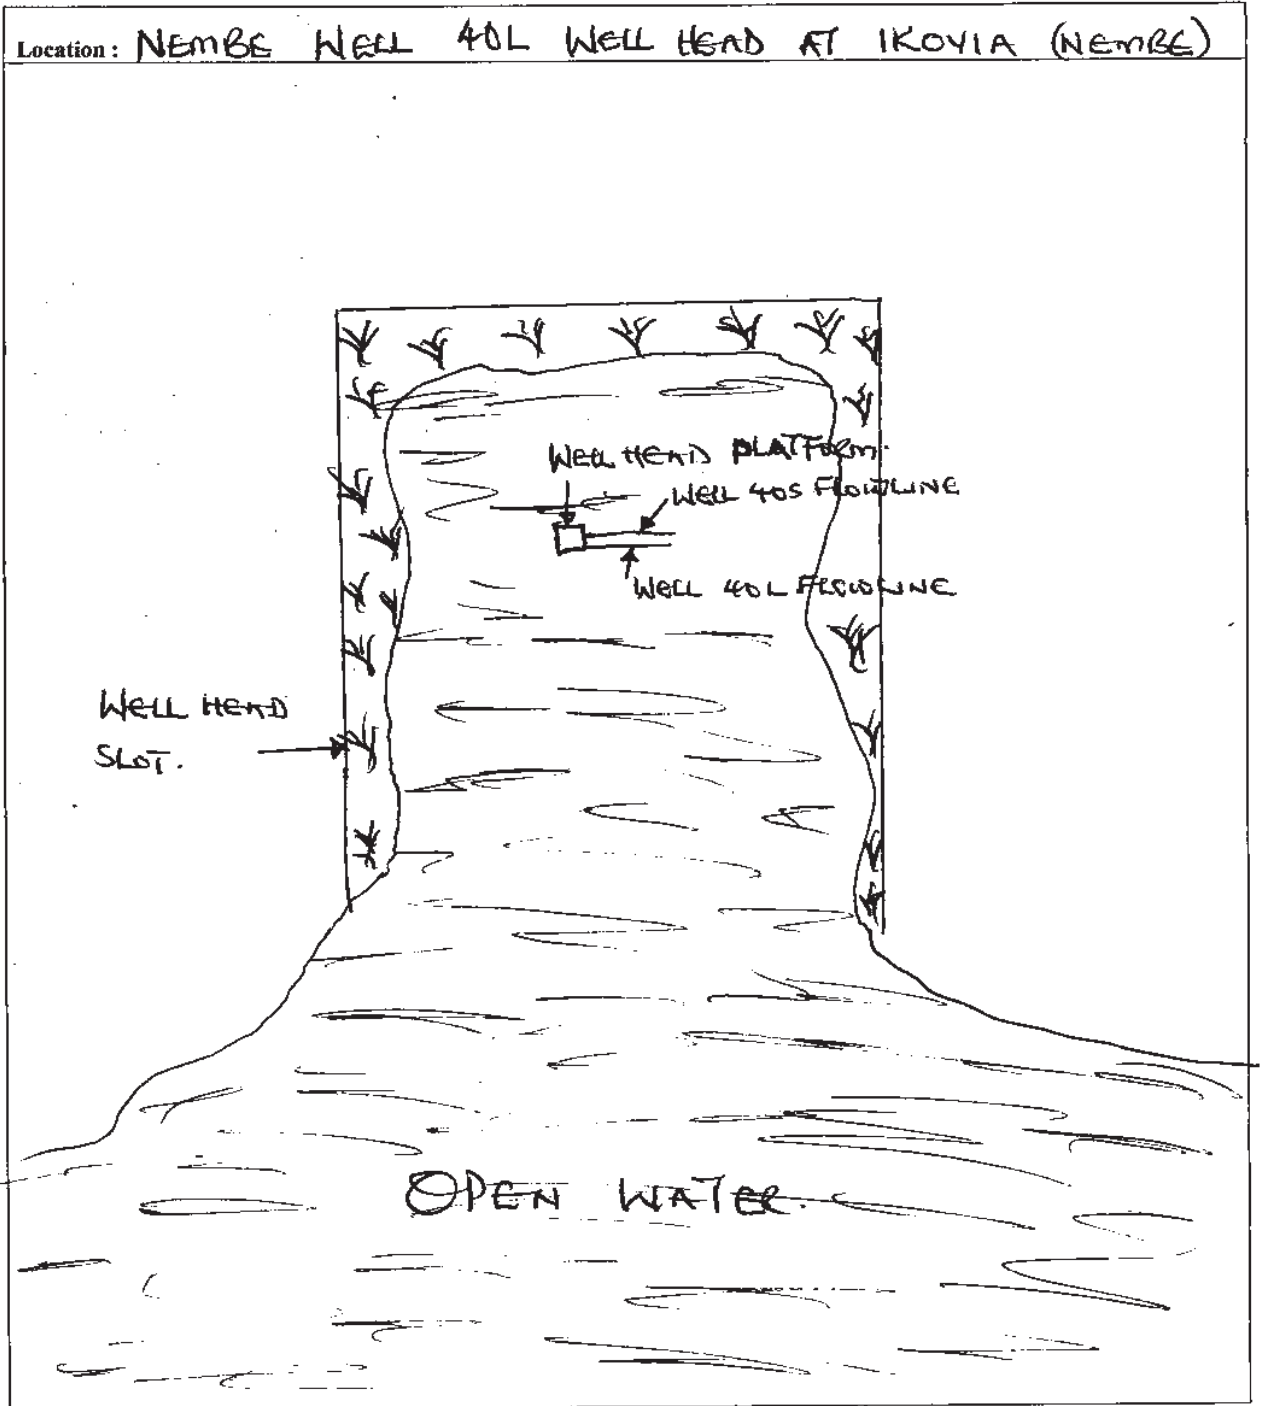
25. Appendix 1: Overview sketch of the site

AT THE TIME OF JIV, SHEEN (OIL) WAS OBSERVED WITHIN THE BOOMED AREA AROUND THE WELL HEAD PLATFORM. THE IMPACTED AREA OF SPILL SITE IS TIDAL. THE PRODUCTION TEAM BEFORE SHUT DOWN REPORTEDLY OBSERVED AIR BUBBLES ^{AND OIL} EVOLVING FROM THE WATER SURFACE AROUND THE PIPELINE (FLOWLINE) CONNECTED TO THE WELL HEAD.
