**THE SHELL PETROLEUM DEVELOPMENT COMPANY OF NIGERIA LIMITED.**

JOINT INVESTIGATION REPORT FOR INCIDENT NO: 1322775 JIV report S/N: 00814

1. Spill incident Number: 1322775      2. Type of incident\* OIL SPILL  
 3. Name of Location NEMBE 1 WELL 11(6)4" FLOWLINE  
 4. Name of nearest community NEMBE CREEK. State: BAYELSA 6. LGA NEMBE  
 7. Type of Production facility/Installation FLOWLINE      8. Asset owner/District SWAMP II | NEMBE

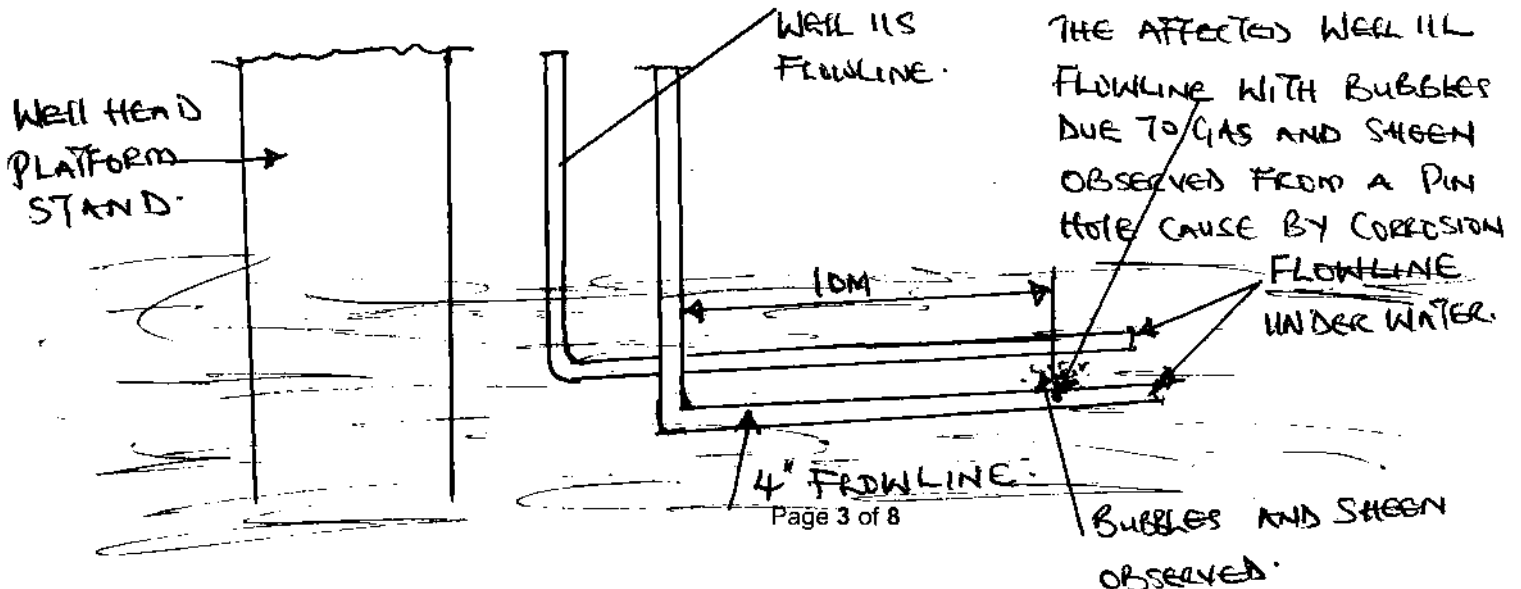
E. GRAPHIC DESCRIPTION OF LEAK POINT (while detail report of the leak point should be contained in the leak report, overview sketch of the site should be added as an appendix 1)

SECTIONAL VIEW OF NEMBE 1 WELL U/L FLOWLINE AT NEMBE CREEK

SHOWING CORROSION LEAK FROM A PIN HOLE
