JOINT INVESTIGATION REPORT

INCIDENT NO: 1713134 JIV report S/N: Nº 0000191

1. Spill incident Number: 1713134 2. Type of incident* OIL SPILL
3. Name of Location 12th IMO RIVER - OGALE PIPELINE
4. Name of nearest community OGALE 5. State: RIVERS 6. LGA ELERME
7. Type of Production facility/Installation OIL PIPELINE
8. Asset owner/District THE SHELL PETROLEUM DEVELOPMENT COMPANY OF NIG
LIMITED | PIPELINE

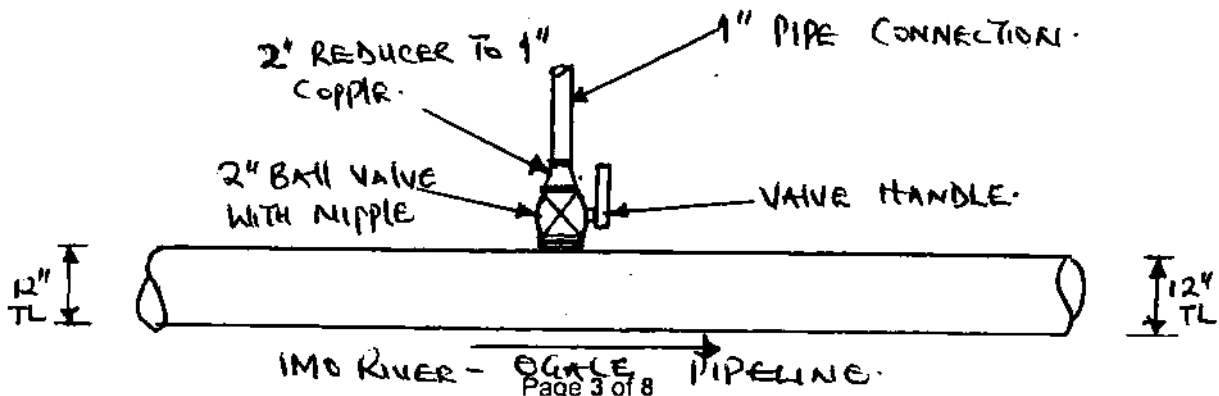
E. GRAPHIC DESCRIPTION OF LEAK POINT (while detail report of the leak point should be contained in the leak report, overview sketch of the site should be added as an appendix 1)

SECTION OF 12" IMO RIVER - OGALE PIPELINE AT OGALE SHOWING ONE (1) NO 2" REDUCE TO 1" CRUDE OIL THEFT POINT INSTALLED AT 12 O' CLOCK POSITION BY UNKNOWN PERSON(S)

MOPPING OF SPILL IMPACT USING ABSORBENT MATERIAL
WHILE REPAIR WAS DONE ON THE AFFECTED PIPELINE SECTION BY
CLAMPING
