JOINT INVESTIGATION REPORT

INCIDENT NO: 1796265 JIV report S/N: No 000291

1. Spill incident Number: 1796265 2. Type of incident* OIL SPILL
3. Name of Location 12" IMORIVER - OGALE PIPELINE
4. Name of nearest community UMUDLADO 5. State: ABIA 6. LGA UKWA WEST
7. Type of Production facility/Installation OIL PIPELINE
8. Asset owner/District THE SHELL PETROLEUM DEVELOPMENT COMPANY OF NIGERIA LTD (SPDC)

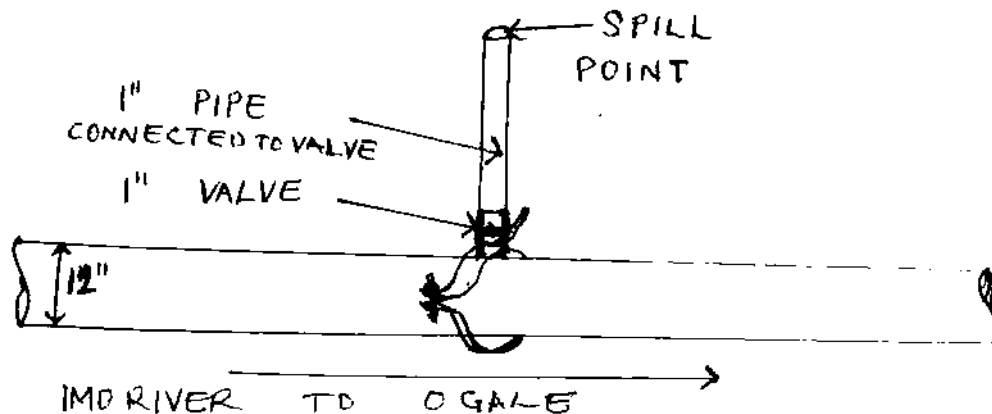
E. GRAPHIC DESCRIPTION OF LEAK POINT (while detail report of the leak point should be contained in the leak report, overview sketch of the site should be added as an appendix 1)

Additional observations around the spill point: THE JOINT INVESTIGATION TEAM SAW A CRUDE OIL THEFT POINT INSTALLED AT 12 O'CLOCK POSITION. THE CRUDE THEFT POINT WAS CONFIRMED LEAKING AT THE TIME OF JOINT INVESTIGATION

A SECTION OF 12" IMORIVER - OGALE PIPELINE AT UMUDOLD SHOWING 1" VALVE CRUDE THEFT POINT INSTALLED AT 12 O'CLOCK POSITION BY UNKNOWN PERSONS.

REPAIR BY CLAMPING
