**THE SHELL PETROLEUM DEVELOPMENT COMPANY OF NIGERIA LIMITED**

JOINT INVESTIGATION REPORT FOR INCIDENT NO: 0012 / 698080

1. Spill incident Number: 698080 2. Type of incident\* OIL SPILL  
 3. Name of Location OBELE FLOW STATION  
 4. Name of nearest community OBELE 5. State: RIVERS 6. LGA EMOTHUA  
 7. Type of Production facility/Installation FLOWSTATION 8. Asset owner/District NEL1

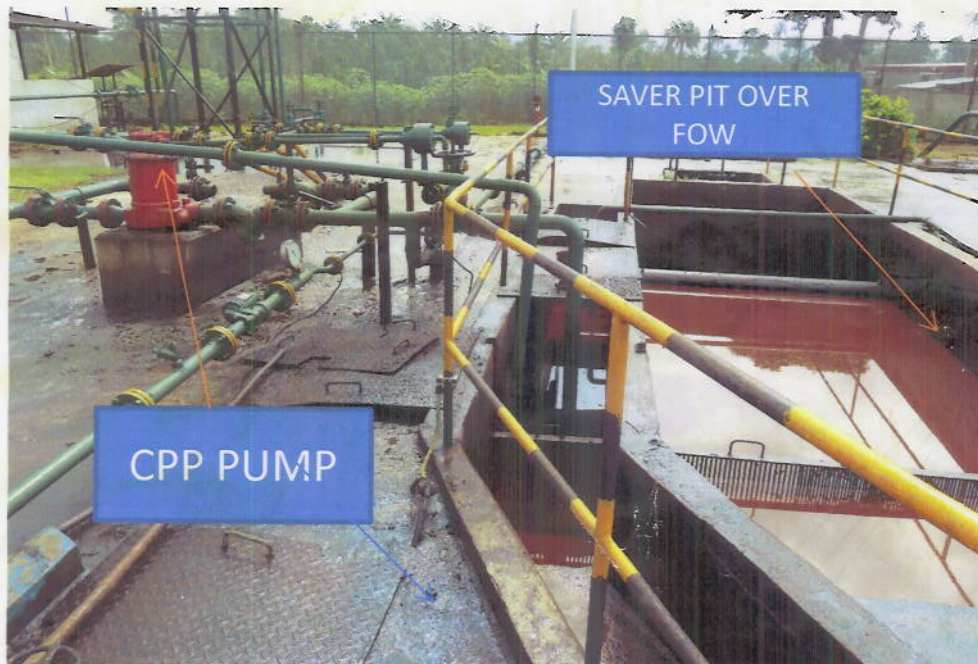
**E. GRAPHIC DESCRIPTION OF LEAK POINT** *(Overview sketch of the site should be added as an appendix1)*

- Drilled hole  Hack saw cut  Explosive tear,  
 Complete Rupture  Inward dent,  Well head tampering  
 Failed Weld-on illegal hot tap valve,  Missing Pipeline/Flowline)  
 Crude oil theft (illegal bunkering) point,  Third party tampering with Clamp  
 Third party tampering with valve setting,  Third party tampering with flange,  
 External Corrosion  Internal Corrosion  
 Saver-pit over flow,  Surge vessel overflow,  Outward dent  
 Flare System/Bund wall Failure  Valve Failure  com unit failure  
 Cold vent  Relief valve failure  Others (specify) CPP PUMP FAILED

**OBELE FLOW STATION SPILL**

SAVER PIT OVER FLOW CAUSE BY CPP PUMP FAILURE
